KATES BASIN FATALITY REPORT

August 11, 2000

U.S. Department of Interior
Bureau of Indian Affairs
Wind River Agency
Fort Washakie, Wyoming

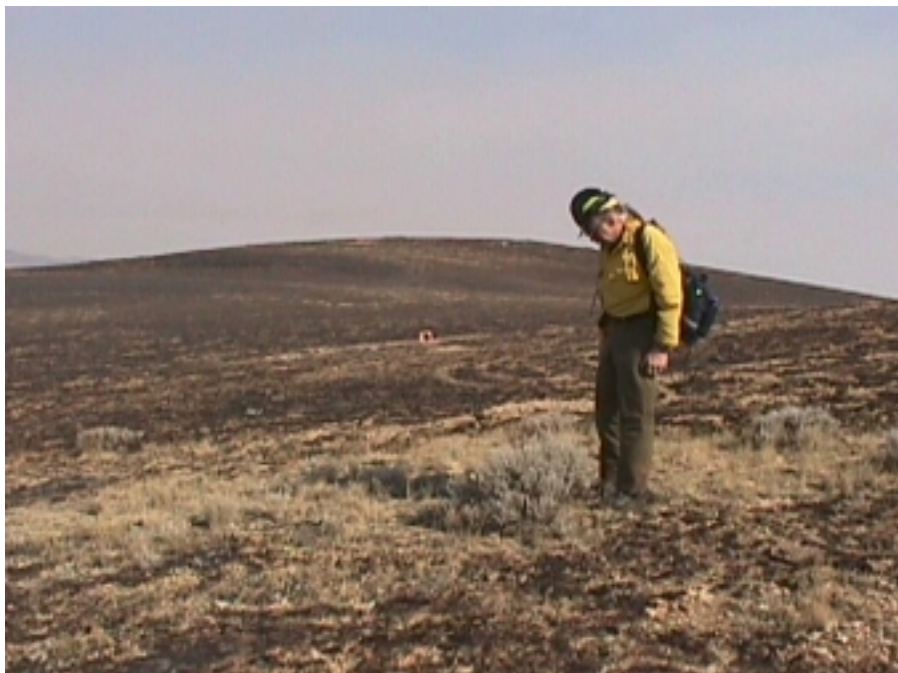
APPENDIX 4 - OKLAHOMA ENGINE #2 FINDINGS

Oklahoma State Engine Two (Tag #1-20006) attempted to escape the on-coming flaming front by backing up a two-track road. The driver of the vehicle, Presley Byington, stated that after backing approximately 60 feet Engine #2 began to bog down and would not climb the hill behind it. Jim Burnett, Engine Boss, exited the vehicle and attempted to use the engine's pump to provide protection for the vehicle and themselves. Byington stated the pump's engine operated only for a few seconds before quitting. Engine #2 was backed a few more feet up the two-track road before its engine stalled. The vehicle was hit by the flaming front moments later.
