**Event Type:** Crew Carrier Rollover

**Date:** June 25, 2023

**Location:** Glenwood, New Mexico (5 miles south)

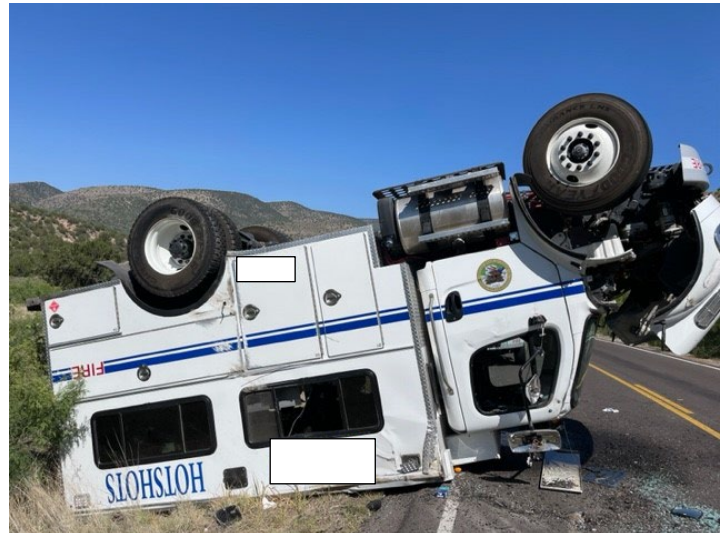
At approximately 0930, while traveling on a downgrade "S" curve, on a two-lane highway, crew carrier 2 (C2), carrying eight personnel, veered off the road on the outside curve striking a road sign. The driver of the vehicle was able to steer the vehicle back on to the highway, crossing into the oncoming lane. The vehicle rolled over on to the driver's side and slid approximately 45 feet, coming to rest upside down and partially into the oncoming lane of traffic.

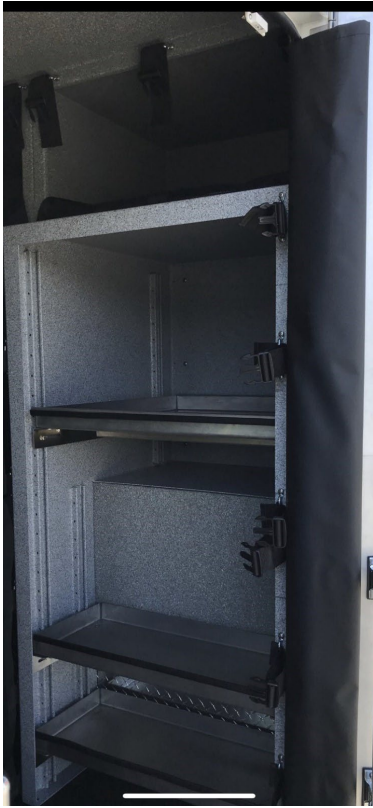
The chase vehicle and civilian responders immediately stopped to assist C2. The crew carrier compartment is equipped with 5 safety exits. One exit, on the top of the vehicle, was inaccessible. The main exit door to the rear of the crew carrier compartment was blocked by shelving that broke loose within the crew compartment and slid into the aisle. The driver and front passenger were able to exit the vehicle through their respective doors. Responders looked through the windows of the crew compartment and saw crew members seat belted in and upside down. With concern for the individuals within, responders broke two crew carrier windows to gain access to the crew compartment and provide an immediate exit for personnel. Two crew compartment personnel's seatbelts were cut to allow the individuals to exit the compartment. C1 arrived on scene and immediately began traffic control and provided immediate first aid to individuals from C2. Civilian responders also provided immediate first aid to personnel from C2 and remained on scene to assist. One civilian

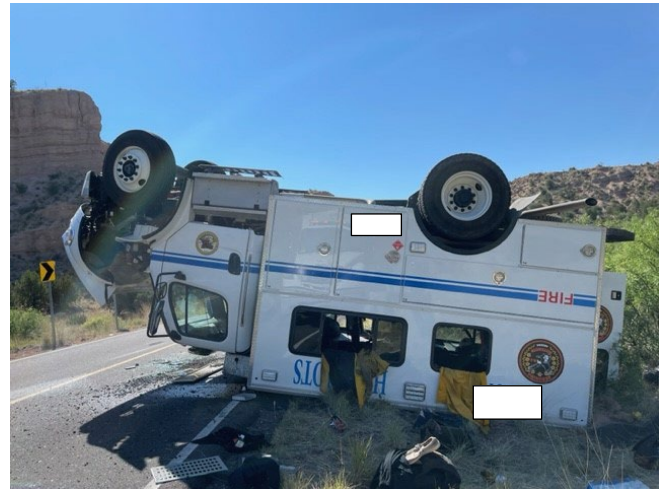
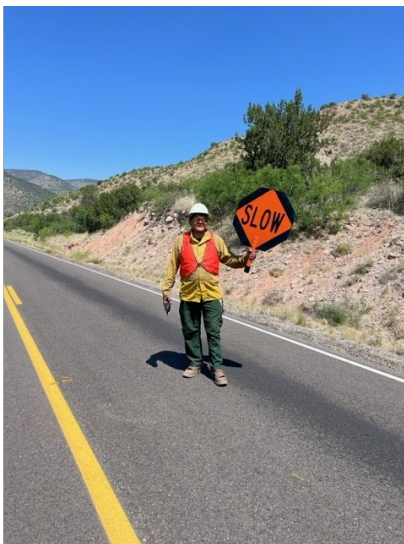
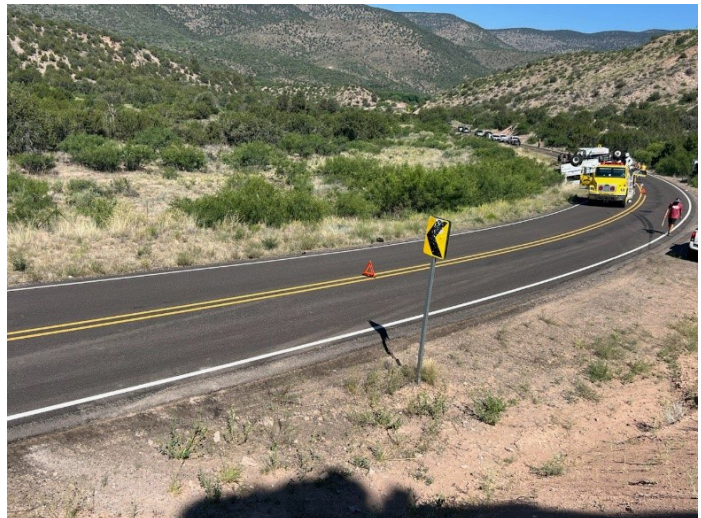
**Discussion:** The crew compartment storage locker in the rear of the passenger area of the CCV broke loose from its location during the accident. This locker normally stores approximately three hundred pounds of miscellaneous firefighting equipment and gear. Had an additional passenger been sitting in the rear-most seat of the CCV, they would have been impacted by the locker, which could have resulted in more serious injuries. Once the locker broke loose of its location, it also blocked the primary exit route of the vehicle post-accident, which also made removing passengers from the vehicle more difficult.

- Response to wildland fire will require vehicle travel by a wide range of equipment and over roadway systems of varying conditions. When conditions are out of the ordinary, all necessary steps should be implemented for safe travel. At times, it may be necessary to drive well below the recommended safe travel speed.
- All safety equipment, including braking systems and restraint systems, should always be utilized fully and as designed to maximize safety.
- Improvements in engineering modifications have resulted in safer wildland fire equipment.
- An [Equipment Bulletin](#) has been issued and instructions have been provided to secure the storage cabinet within the crew compartment of the CCV.

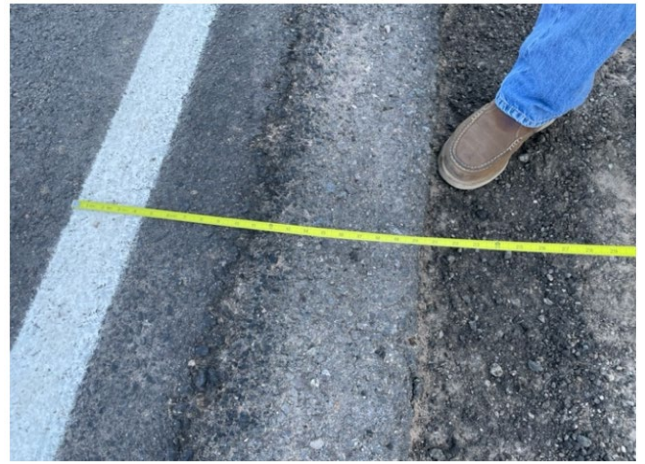
**Finding 3.** Road Conditions. The section of highway where the accident occurred had recently been repaved. The original pavement, combined with the new pavement, created a measurement of approximately nine inches from the top of the pavement to the dirt/gravel shoulder. The distance from the outside edge of the white line to the shoulder was approximately twenty inches. The lane of travel measured approximately nine and a half feet and the width of the crew carrier measured approximately eight and a half feet.

possibility of oncoming traffic would naturally incline a driver to steer as far right in their own lane as possible. The height variation between the road surface and the shoulder was a factor in the incident, when the right rear dually tires exited the road surface onto the shoulder. The combination of the shoulder height, height of the old pavement, and height of the new pavement created a step affect which could easily pull the dually tire(s) on to the shoulder if the vehicle moved slightly off the new pavement.
