Trout Fire Dozer Entrapment

Facilitated Learning Analysis

Gila National Forest

June 17, 2025

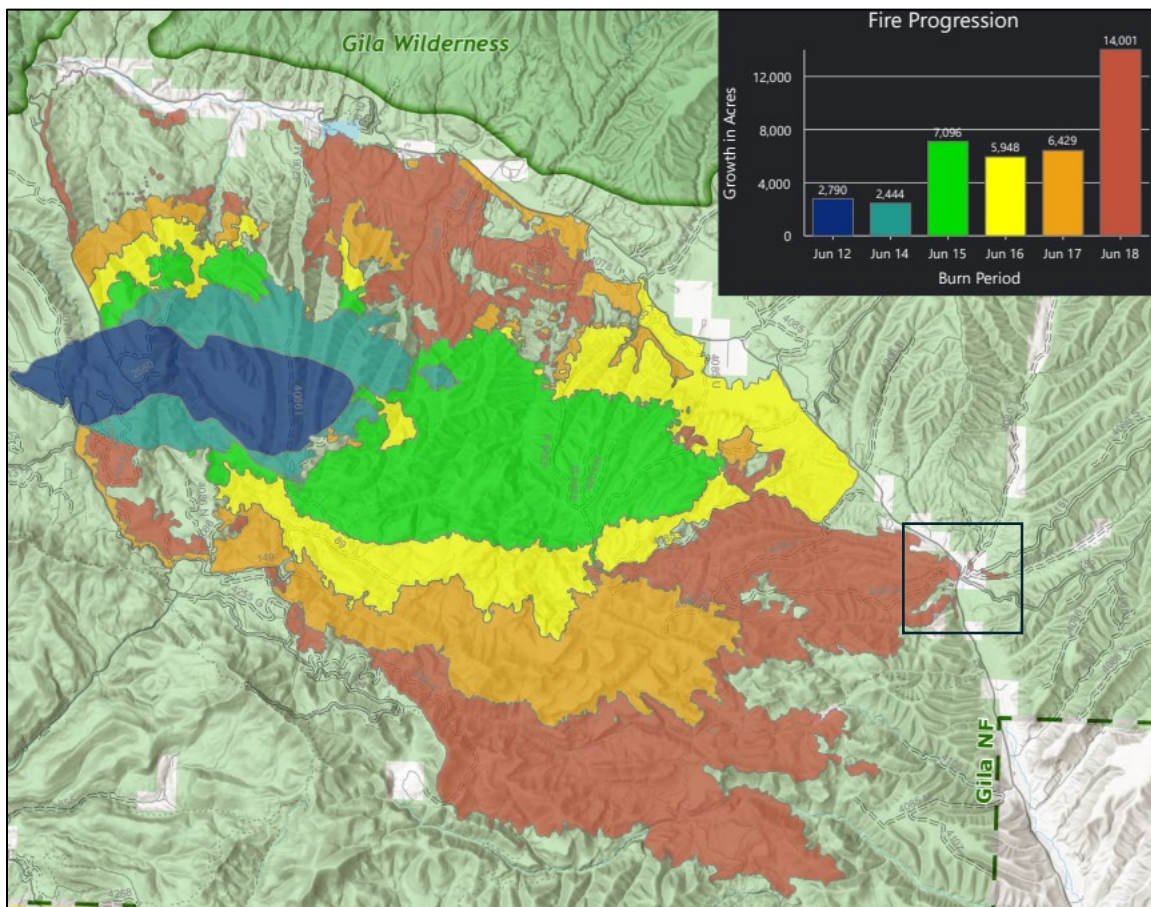
Figure 1 – Fire progression map of the Trout Fire from June 12 through 0126 June 18, 2025. The June 17 entrapment area is indicated by the black-outlined box. (Map courtesy SW CIMT4 GIS)

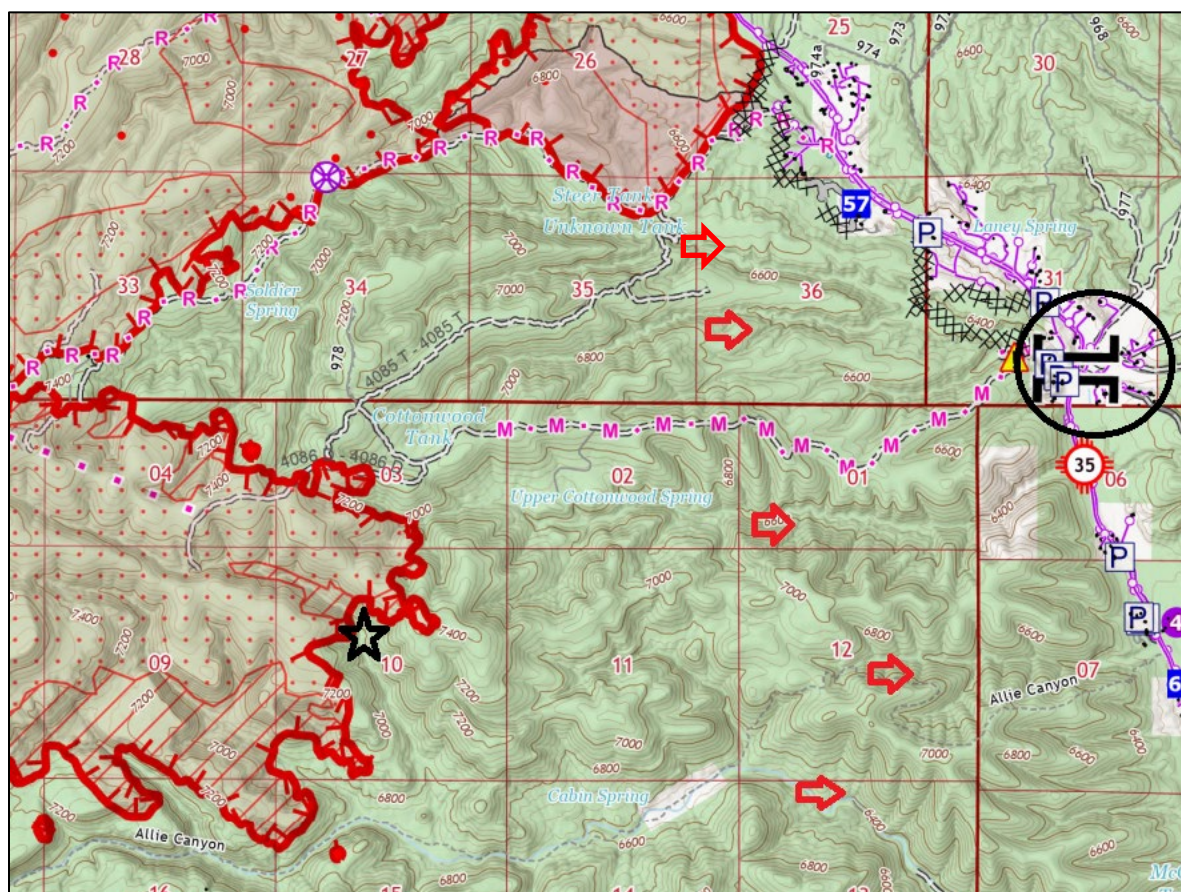
Figure 2 – Operational map for June 17 showing infrared-detected heat. Added by the FLA Team: Red arrows indicate possible routes from wind-drainage alignment to the east toward Hwy 35. Black star is Hightower Canyon trigger point. Black circle marks the general entrapment area.

While scouting in the first half of the day on June 17, Div H realized that the fire would impact Hwy 35 that day. The trigger point—fire reaching the bottom of Hightower Canyon—was about to be reached. The problem was there were so many drainages leading east (Figure 2), it was not clear what path the fire would take to reach the highway.

A hotshot crew started to fire the junction of the dozer line and the road marked “M – M – M” in Figure 2. Almost immediately, however, spot fires from the main fire itself ignited south of this road. The crew ceased ignitions and pulled back.
