Rapid Lesson Sharing

Event Type: Fall from Vehicle, Medical Evacuation

Date: July 22, 2025

Location: Pomas Fire
Okanogan-Wenatchee National Forest

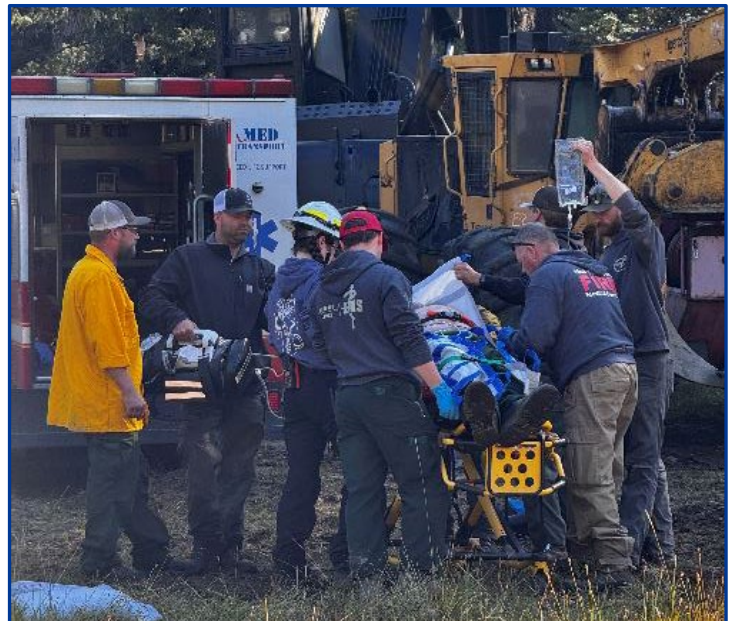
When exiting the water tender, the operator slipped on the diamond-plate step, falling approximately 4 to 4.5 feet. The fall caused an impact to the ribcage on the corner of the diamond plate step.

The accident site
