# **Ninety-eight Fire Facilitated Learning Analysis Airboat Collision July 11, 2025**

## Executive Summary

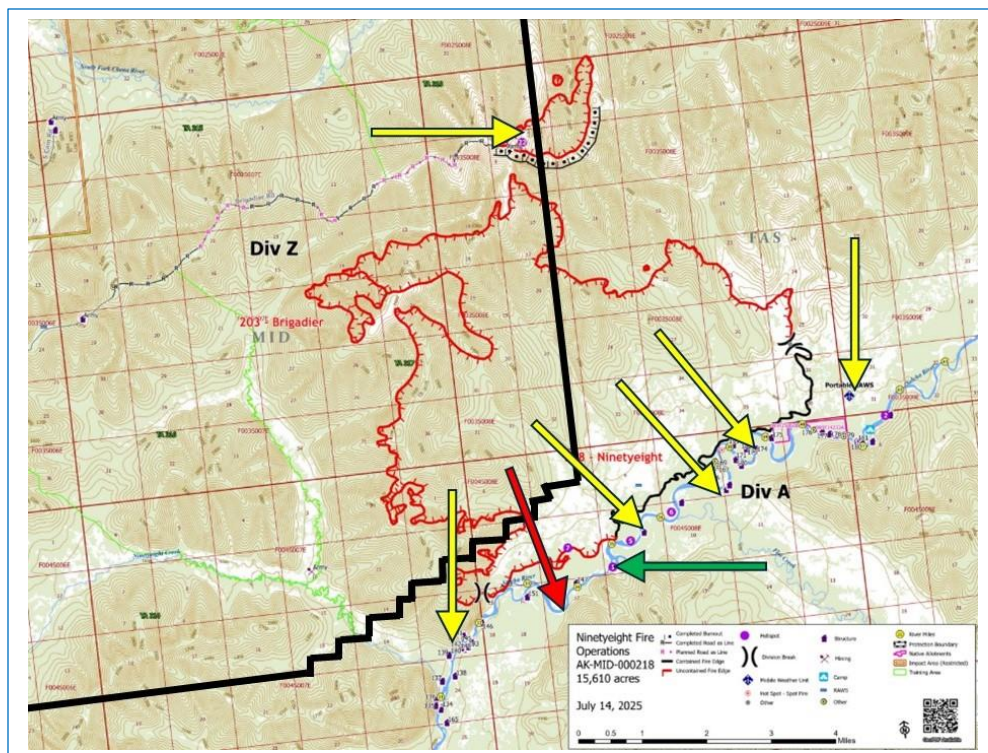
*Image shows the yellow arrows as values at risk, the red arrow is the accident site, the green arrow is H1, and the black line is the military boundary.*

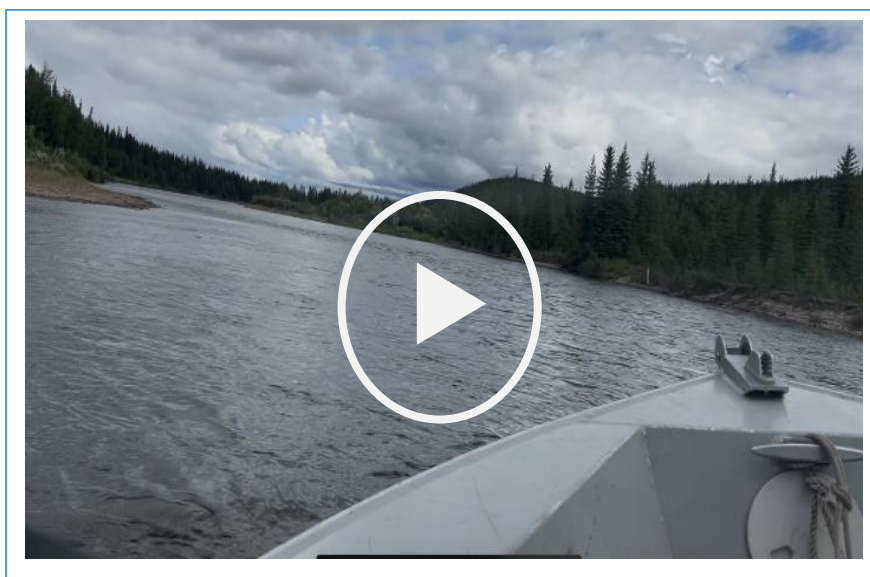
*Video shows the view of the supply airboat coming up-stream, without the morning glare.*
