Event Type: Bulldozer Fire
Date: March 22, 2026
**Location: Ouachita National Forest,
Region 8**

Ouachita National Forest Bulldozer Fire Facilitated Learning Analysis

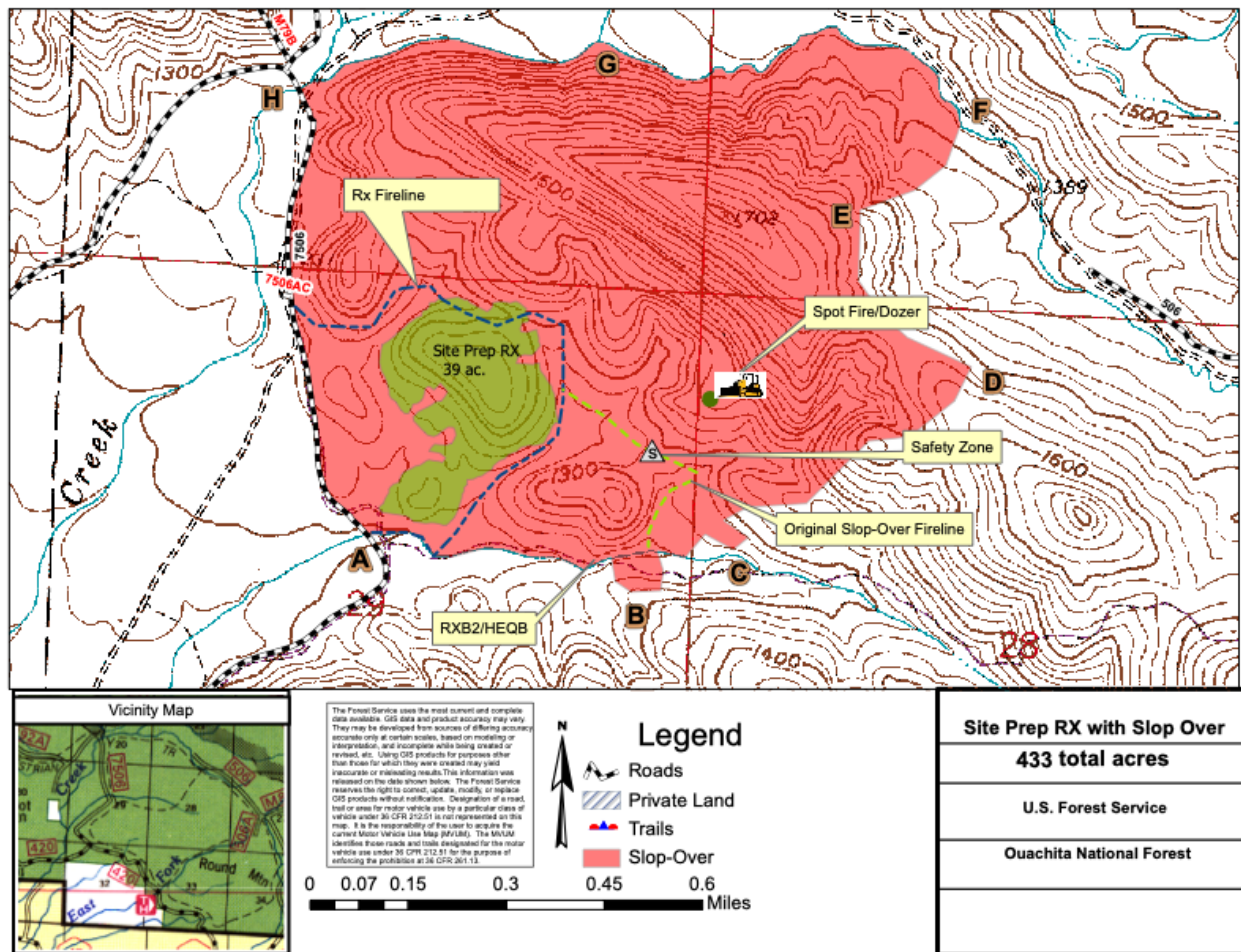
Figure 1: Map of Burned Area

The RXB2 arrived at 0730 on March 22nd to check the unit and found a small slop over of approximately two acres smoldering with minimal spread. He texted the Heavy Equipment Boss (HEQB) and Dozer Operator Initial Attack (DZIA), who responded from the Work Center, approximately 11 miles away.

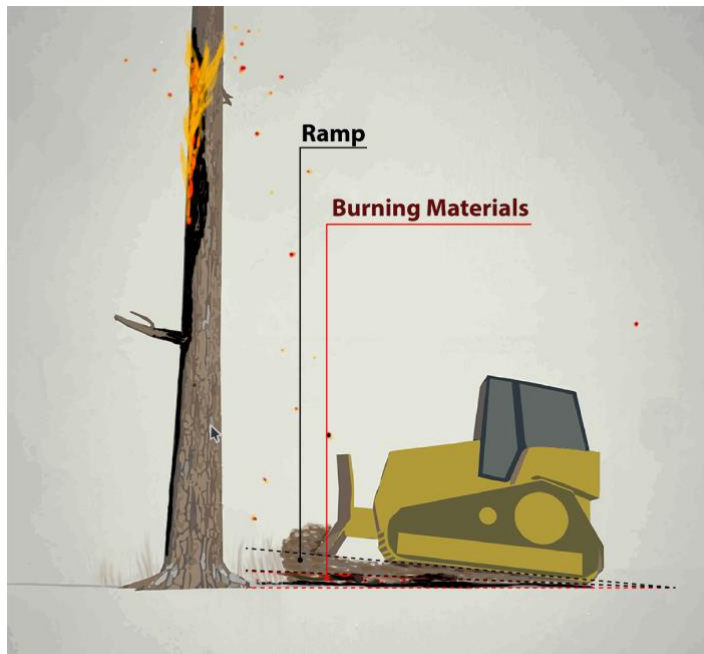
Figure 2: Diagram of "Ramping"

spot fire of about 20 by 20 feet in a draw above him. He engaged with the dozer, intending to keep this fire from spreading into the rough terrain uphill by removing a burning snag along the north edge within the spot. He "ramped" the area leading up to the snag by pushing dirt and rocks downhill to create a nonflammable platform on which the dozer could sit while he pushed the snag. As he pushed the flaming snag, burning embers floated and fell.

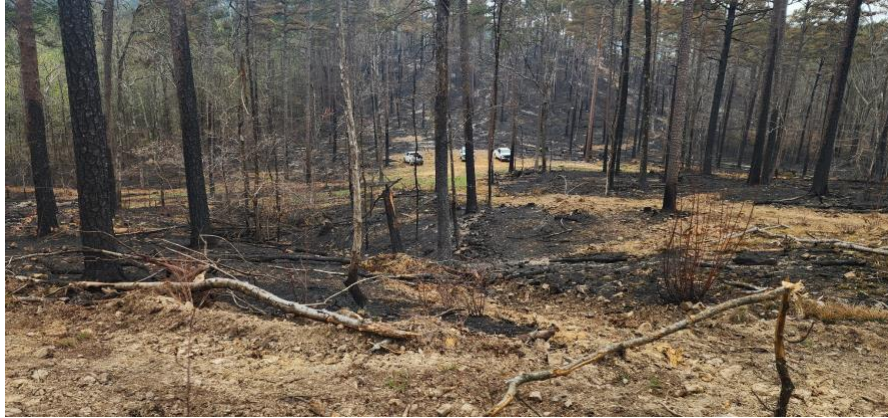
Photo 3: View from dozer down cleared skid trail to safety zone.

At this elevated vantage point, the DZIA observed multiple spot fires upslope from his location. He determined that with the number of spots, the terrain, and the fuel type, a different strategy was necessary. He decided to disengage and to move the dozer to a safer place where he could meet with the HEQB and RXB2 to develop a new plan.
