# Rapid Lesson Sharing

**Event Type:** Non-Fire, Engine Rollover

**Date:** February 26, 2023

**Location:** Tuba City, Arizona

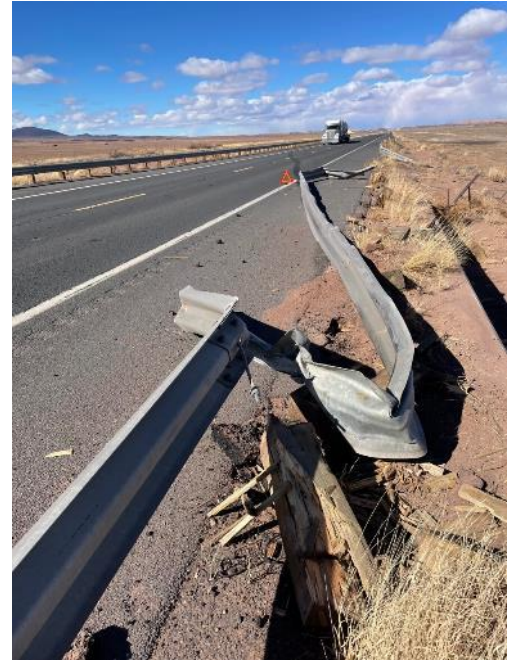
counterclockwise, resulting in further damage along the passenger side of the vehicle and extensive damage to that section of the guard rail. The engine crossed over the guard rail and came to rest approximately five feet below and sixty feet from the edge of the roadway, facing the opposite direction of travel. Photos, vehicle damage, and other evidence at the scene, indicated that the engine impacted multiple wooden guard rail posts and crush blocks, exited the roadway at a cement culvert, and rolled a minimum of one full revolution before coming to rest on the passenger side. Both the driver and passenger remained in their seat belts throughout the incident. Both side curtain air bags and the passenger side seat air bag deployed. Upon coming to rest, the passenger was able to release his seat belt. He checked on the driver, who seemed a bit disoriented. Assessing no immediate injuries to either himself or the driver, the passenger gathered cell phones and made emergency notifications to the home unit. The driver was unable to free himself as his seat belt was locked in place. Civilians arrived on scene and announced that they called emergency services and attempted to break the windshield, freeing the occupants inside. Eventually someone climbed on to the driver's side of the vehicle and opened the driver's door. The driver's seat belt remained locked, and a civilian used a knife to cut the driver free. Both personnel were able to exit the vehicle through the driver's door. Emergency responders were in the area and quickly arrived on scene. Emergency Medical personnel arrived and assessed the individuals. The passenger reported he was uninjured and did not need medical care. During medical assessment of the driver, the passenger secured the scene and gathered items as best as possible. The driver was assessed and though no injuries were initially found, the determination was made to transport the driver to the local medical center for further evaluation and the passenger rode with the driver. Home unit personnel arrived at the hospital within a couple hours and the driver was released from care. Personnel remained overnight and the next day they returned to the medical facility in an attempt to gather copies of all medical documentation. The following day personnel traveled to the tow yard and took additional photos of the vehicle. All personnel traveled back to the home unit and were released.
