# LYONS FERRY FIRE

## BURNOVER

### Consolidated Incident Report and Lessons Learned

*Incident Date: July 16, 2026*

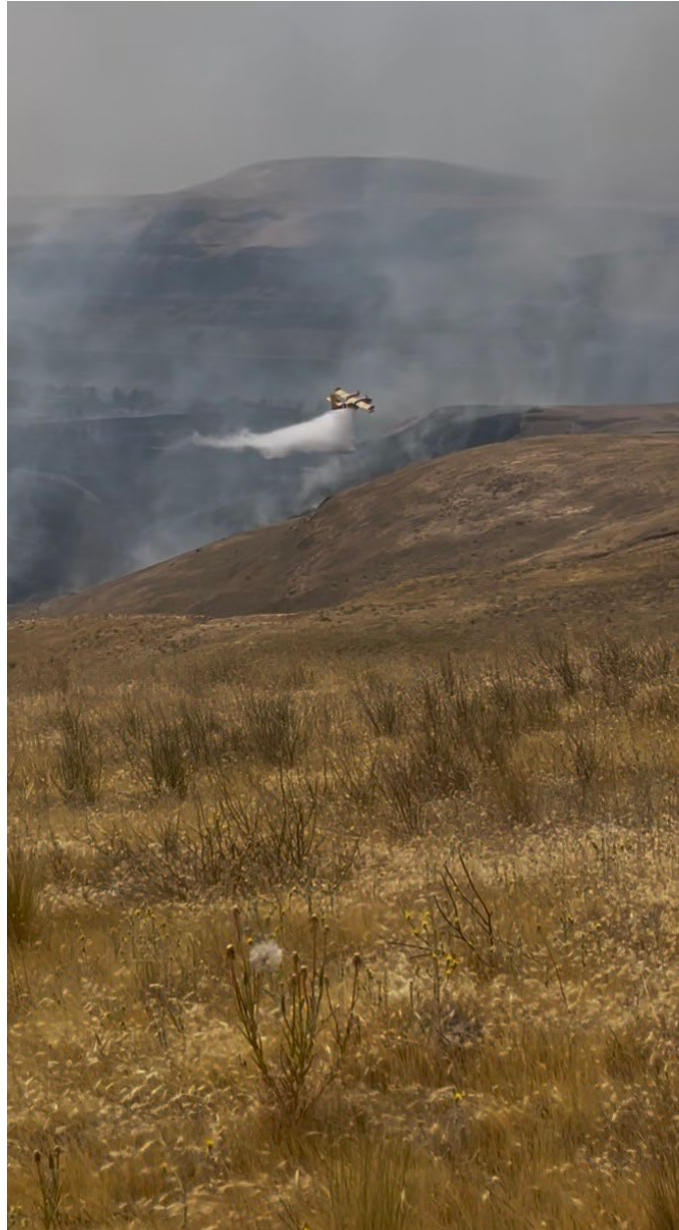
***Fire activity and aviation operations near the burnover incident area.***

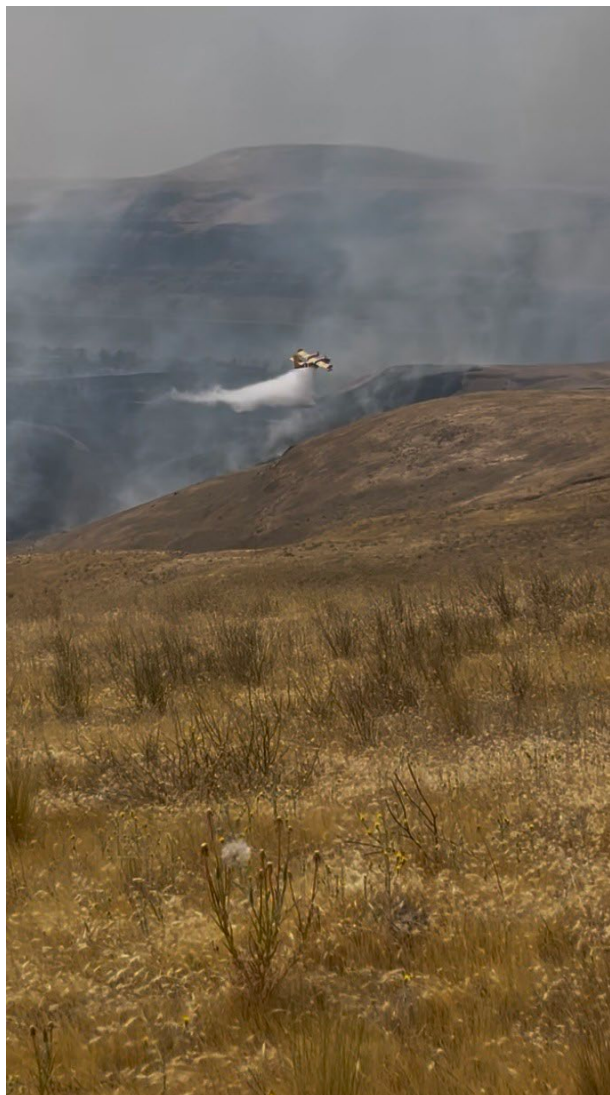
Fixed-wing aircraft attempted to slow the advancing fire and protect the Landing Zone area. As conditions worsened, the crew recognized that the drops were not creating a secure holding area and that there was no road access from their location. The HMGB and HMGB(t) requested that the engines return, including through an Air Attack relay. However, the engines did not arrive before the burnover occurred. At this point, the Helicopter Manager moved farther into the black to reestablish communications.

***Aerial suppression operating near the fire.***
