# Aviation Investigation Final Report

| <b>Location:</b> | Cabazon, California | <b>Accident Number:</b> | WPR23FA302 |
| <b>Aircraft:</b> | Bell 407 (A1); Sikorsky S-64E (A2) | <b>Aircraft Damage:</b> | Substantial (A1);<br>Minor (A2) |
| <b>Defining Event:</b> | Midair collision | <b>Injuries:</b> | 3 Fatal (A1); 2 None<br>(A2) |

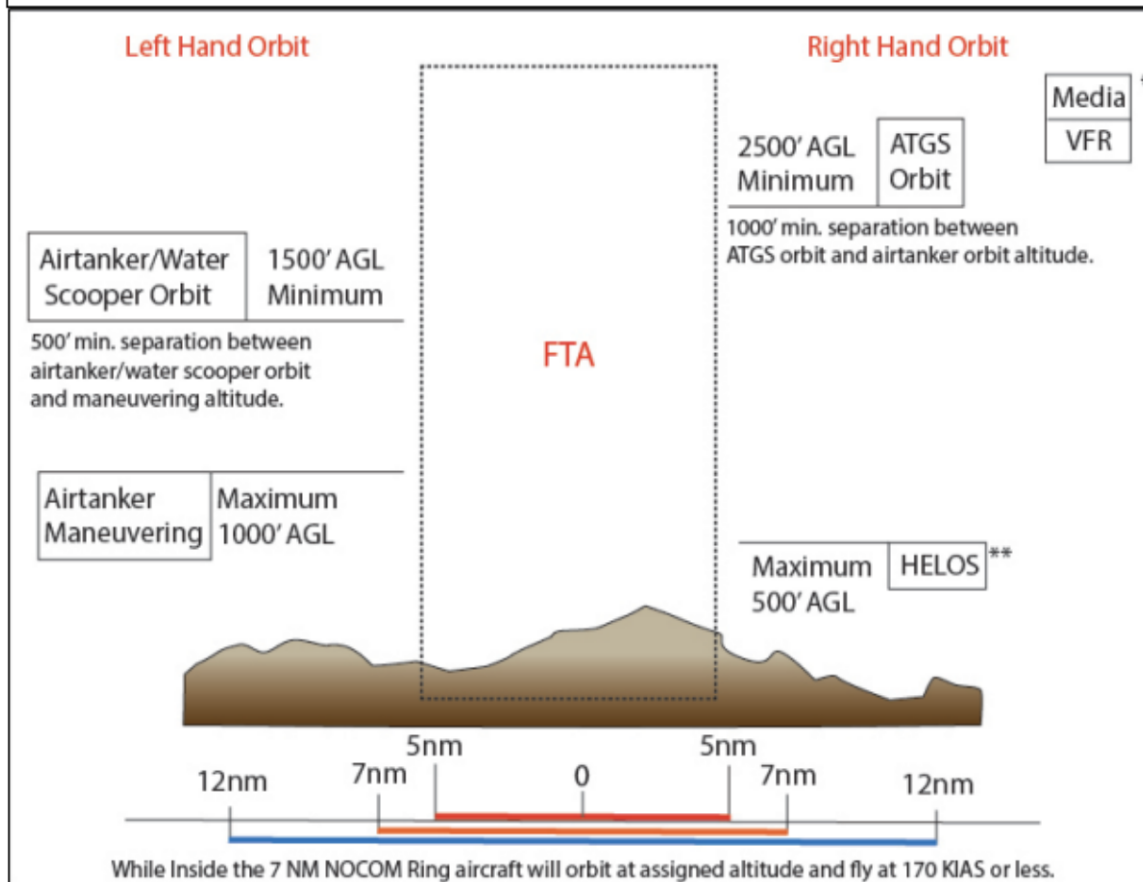
No Radio Contact: Hold a minimum of 7 nm from the incident.

Note: Airtanker maneuvering altitude determines minimum airtanker and ATGS orbit altitudes. Assigned altitudes may be higher and will be stated as MSL.

\* Media and IAA Aircraft: Maintain VFR separation above highest incident aircraft or at the altitude assigned by the controlling aircraft.

\*\* Helicopters: Fly assigned altitudes, orbits, and routes.
