# Rapid Lesson Sharing

**Event Type:** Snapped Wheel Studs

**Date:** August 1, 2026

**Location:** U.S. Route 6 South of Castle Gate, Utah

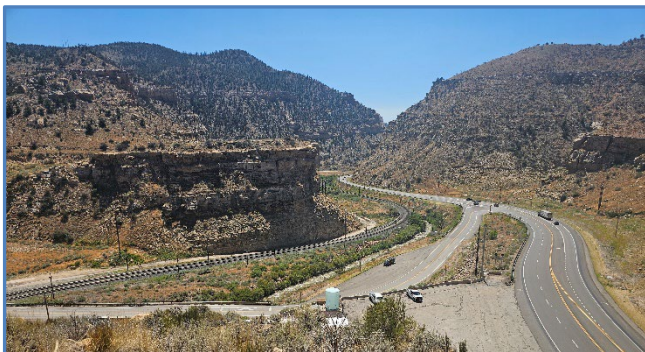
*Looking south toward Helper, Utah from a mesa above U.S. Route 6. Engine 323, seen parked in the turnout on U.S. Route 191, was heading north when a vibration was felt by all crewmembers, prompting the driver to pull over. The entire stretch along which the vibration was felt (less than ¼ mile) is seen in this photo.*
