Rapid Lesson Sharing

Event Type: Blasting a Hazard Tree

Date: July 13, 2015

Location: Rogue River-Siskiyou
National Forest

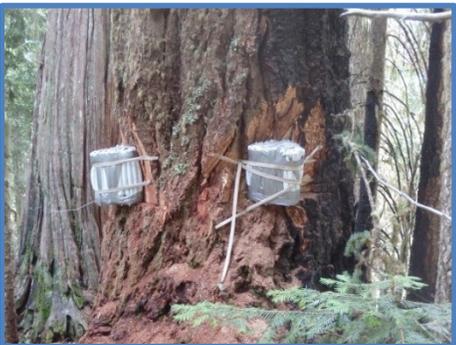
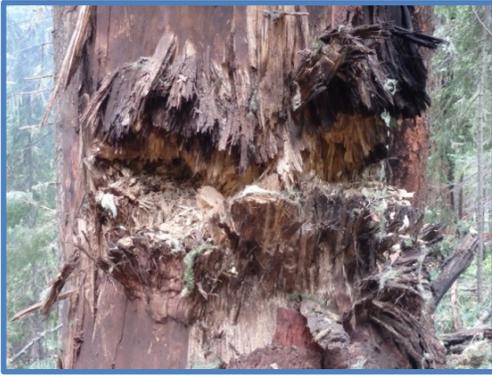
1154 Bark removal began - 25 minutes were spent at the base (approximately 6-8 minutes were spent removing a piece of wood that had bound the chain. See “Observations”)

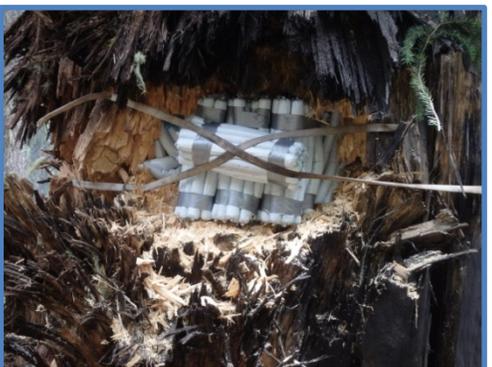
1527 Blasting 4 was called—with no boom heard

1528 Lead Blaster and one trainee returned to the detonator to diagnose the problem.
