# Informational Summary Report of Serious or Near Serious DFFM Injuries, Illnesses and Accidents

# GREEN SHEET

## Burn Injuries

Laguna Fire

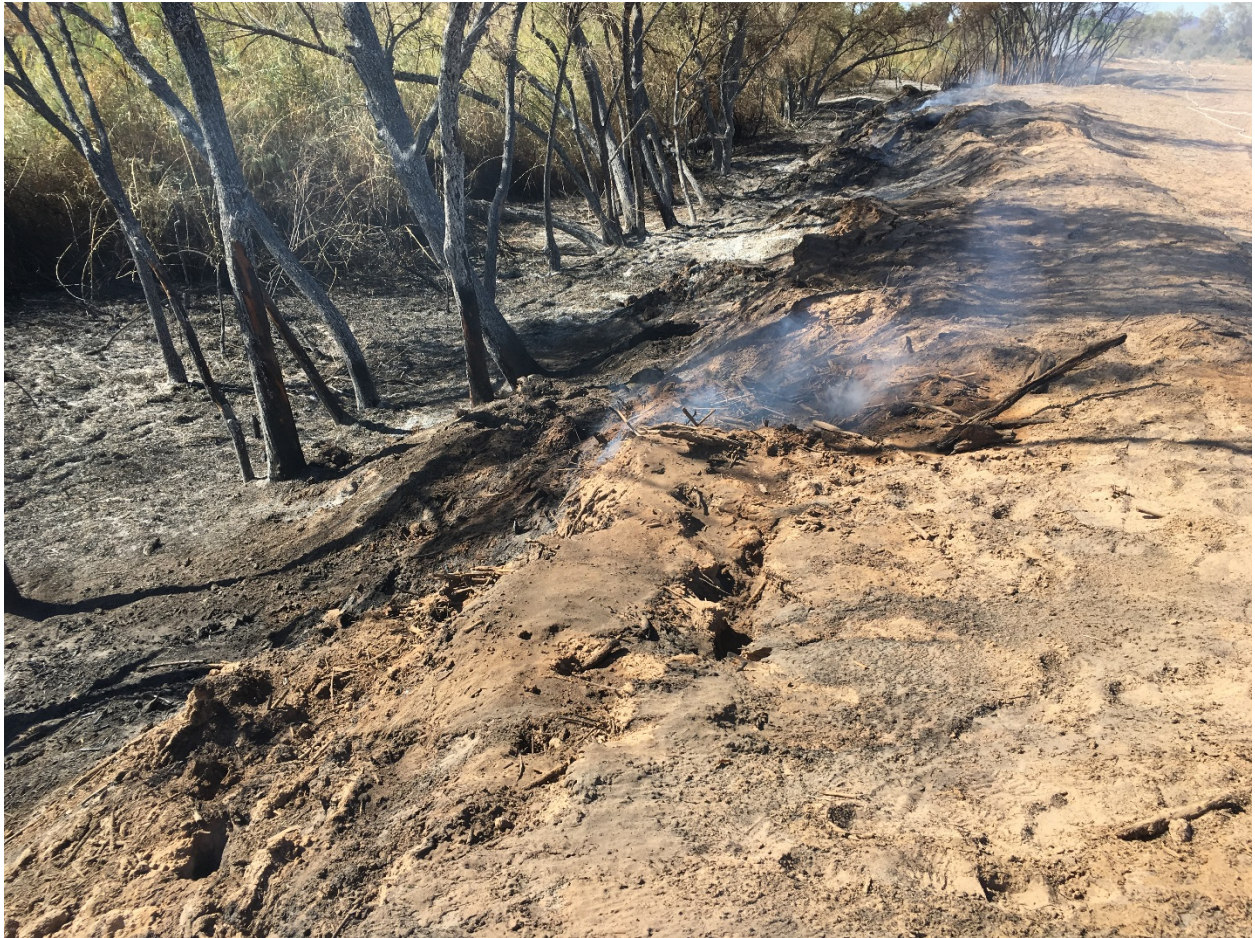
At approximately 1010 a crew member from the type II crew fell into an ash pit, after ground gave way on a mechanically constructed berm the crewmember was mopping up with a branch line (photo 2). The crewmember advanced a hose line up the berm and upon reaching the top the employee stepped toward the downhill side facing the Colorado river and berm gave way (photo 3). The employee went down to approximately the knee level in a void space created by burning material being consumed under the crust of the berm. The employee fell forward towards the downhill side adjacent the Colorado River (photo 4). The employee had forward inertia and momentum which continued him downhill with a section of ash and dirt. The section was approximately 38 inches wide and 18 inches long. The employee extended their hands and arms to provide protection while falling forward. The employee because of body weight and that inertia sunk into the hot ash pit and displaced debris sunk up to approximately the armpit and shoulder, additional hot rolling material followed the employee downslope encompassing lower extremities and upper torso. As the employee was falling and adjacent crewmember heard the employees screaming. The witness employee was approximately 6 feet to the south

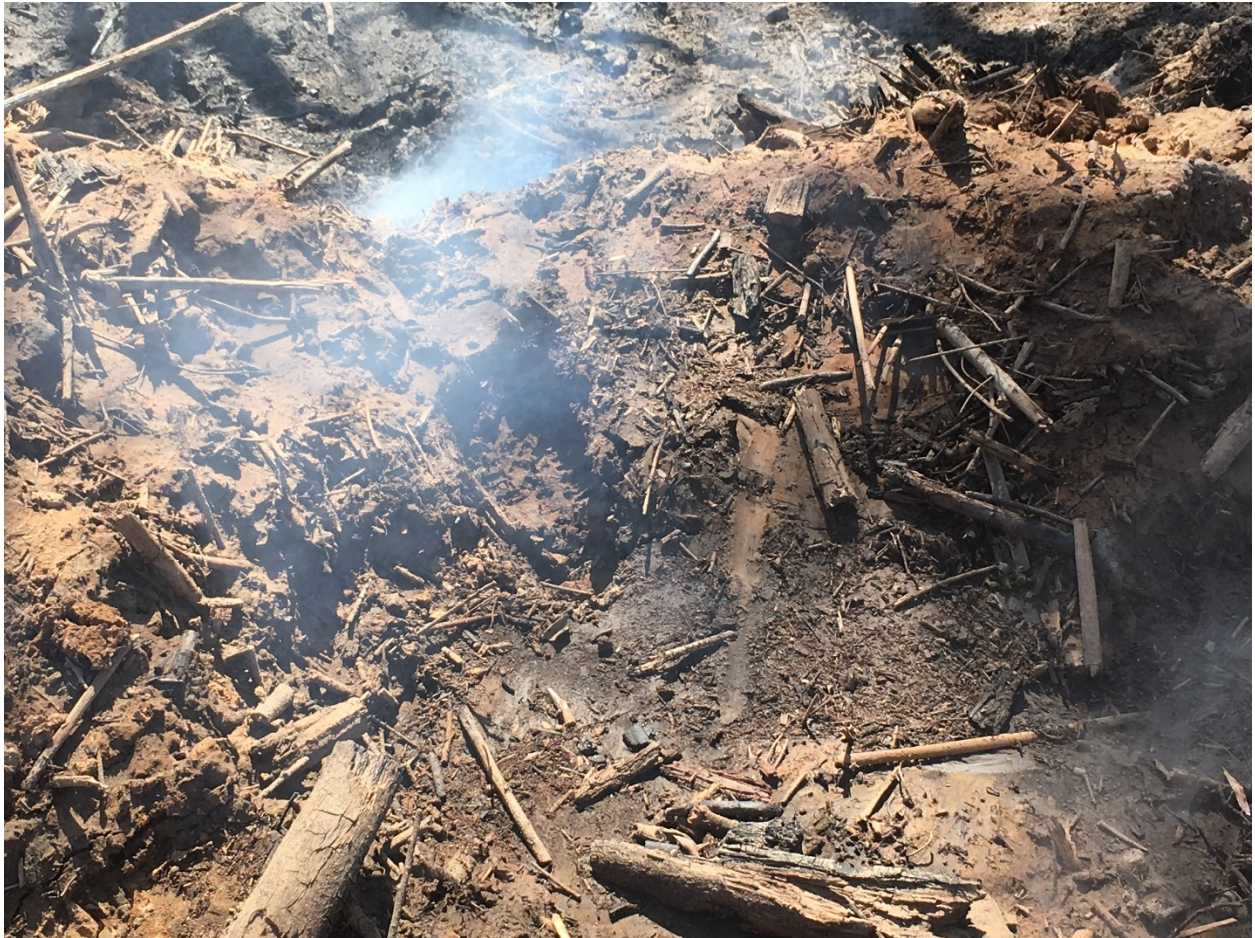
on the same berm as the employee who fell. The witness employee stated that they did not see the original fall; however, observed the employee who fell sinking up to the armpits and shoulders and then rolling forward. The employee also recounted seeing the employee who fell struggling to get out of the ash pit, and then once self-extricated beginning to walk/run around trying to get hot material off the employees' body and personal protective equipment (photo 5).
