United States Department of Agriculture
Forest Service

Little Fire Shelter Use San Bernardino National Forest Facilitated Learning Analysis

Little Fire—Personal Protective Equipment Procedures and Analysis Report

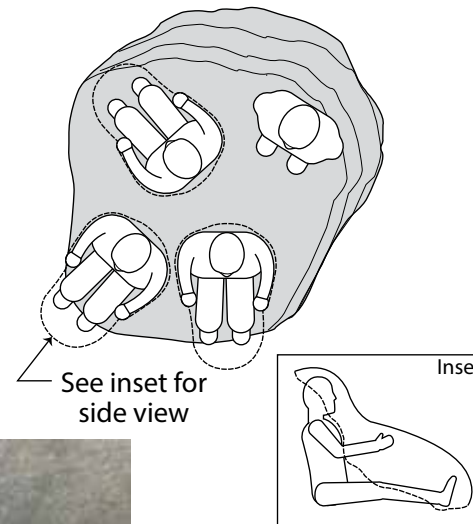
Figure 3: Big Rock.

When they arrive at Big Rock (figure 3) there is room for all four of them atop it. Div-A remains standing and the firefighters sit down. The fire's edge is approximately 75 feet to the east of this

new location. Even though they are a good distance from any active fire, and 7 feet above the ground, they are still experiencing a lot of radiant heat from the ground. They are also still in the thick of the smoke with poor visibility. As this event unfolds they remain calm and in intermittent radio communications with the IC and Operations. While on Big Rock, Div-A tries to get some bucket drops to cool down their area but, with the thick smoke, he isn't having any success. After

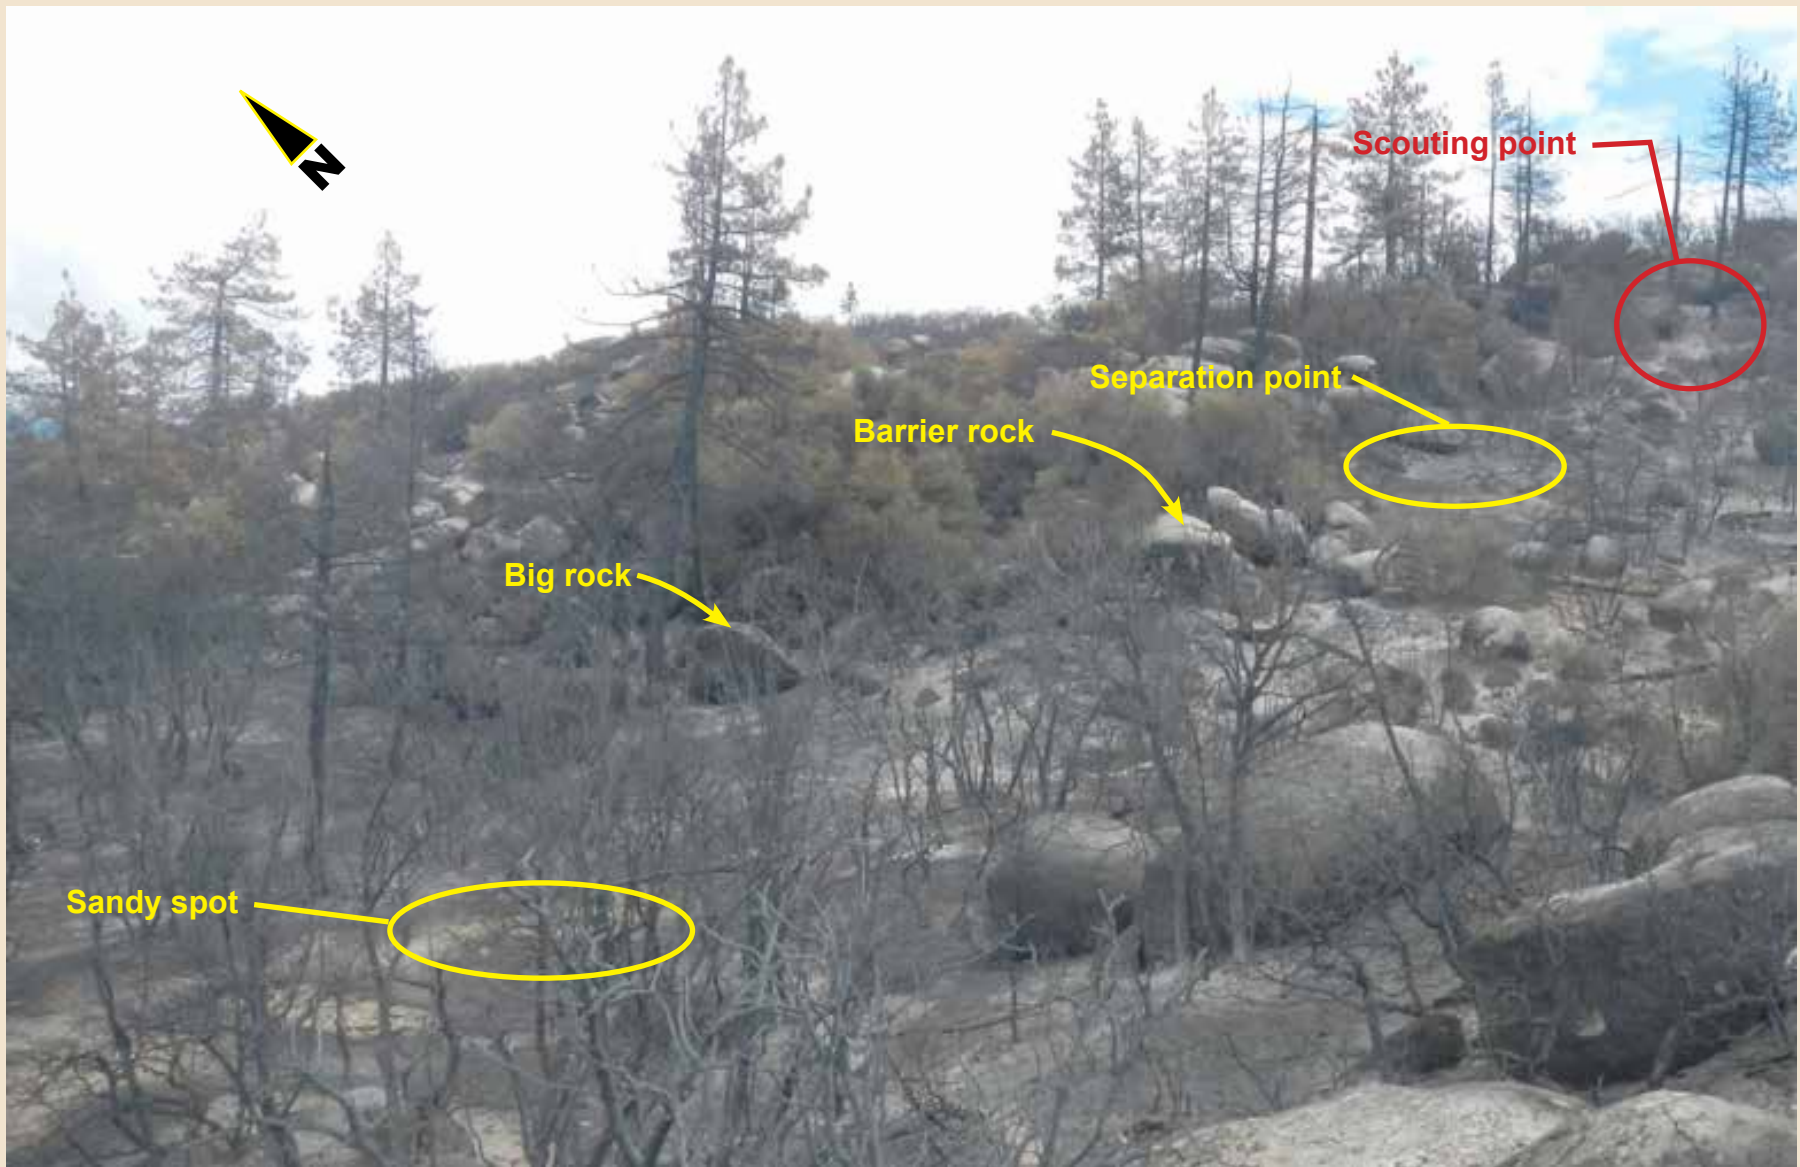
Figure 1: Little Fire area overview

Four firefighters were performing initial attack on the Little Fire. Fire activity increased, preventing egress back to their engines. The firefighters went into their predetermined safety zone. The safety zone was the “black”. The brush and small trees in the area were already consumed. Areas of duff were still smoldering and had residual heat, figure 1.

After the four firefighters were separated and committed to the safety zone, they took refuge behind Barrier Rock (figure 1). This barrier provided some relief by partially shielding them from the heat but also obstructed their view of the main fire. The increase in the fire behavior prompted the firefighters to begin a shelter deployment sequence.

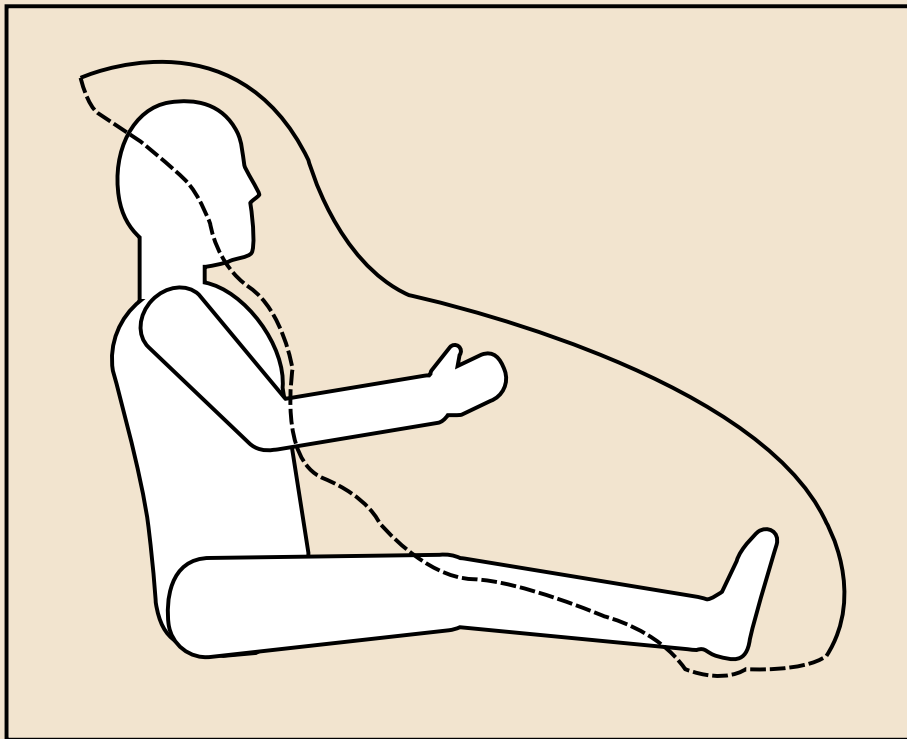
Figure 2: Seated deployment position on Big Rock.

3. Fire shelter deployment—Three used the shake handles to fully open the shelters. Shelters were used from a seated position on top of Big Rock. The firefighters used the shelters intermittently; sticking their heads inside for relief. One firefighter did not deploy the shelter and remained standing on Big Rock, figures 2 and 3.

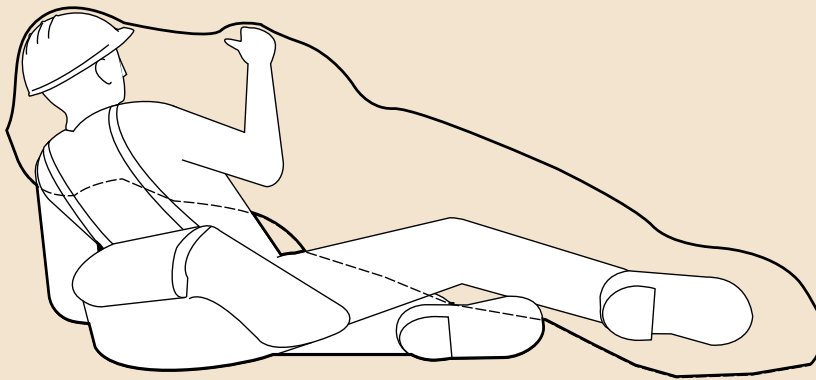
The firefighters spent about 30 minutes on Big Rock before moving to Sandy Spot. Shelters were held upright, as shields, while walking from Big Rock to Sandy Spot. This sandy area was free of smoldering duff and was less smoky, but the ground was still hot. One firefighter sat down on a shelter; one sat down on the hard plastic shelter liner, and one alternated between standing and sitting on the ground. One firefighter used the shelter for protection from blowing ash and smoke by intermittently lying on his side, figure 4.

Figure 4: Firefighter lying on his side at Sandy Spot. Shelter is dashed line.
