# GREEN SHEET

## **Firefighter Burn Injury**

**July 8, 2017**

**17-CA-BEU-003551**

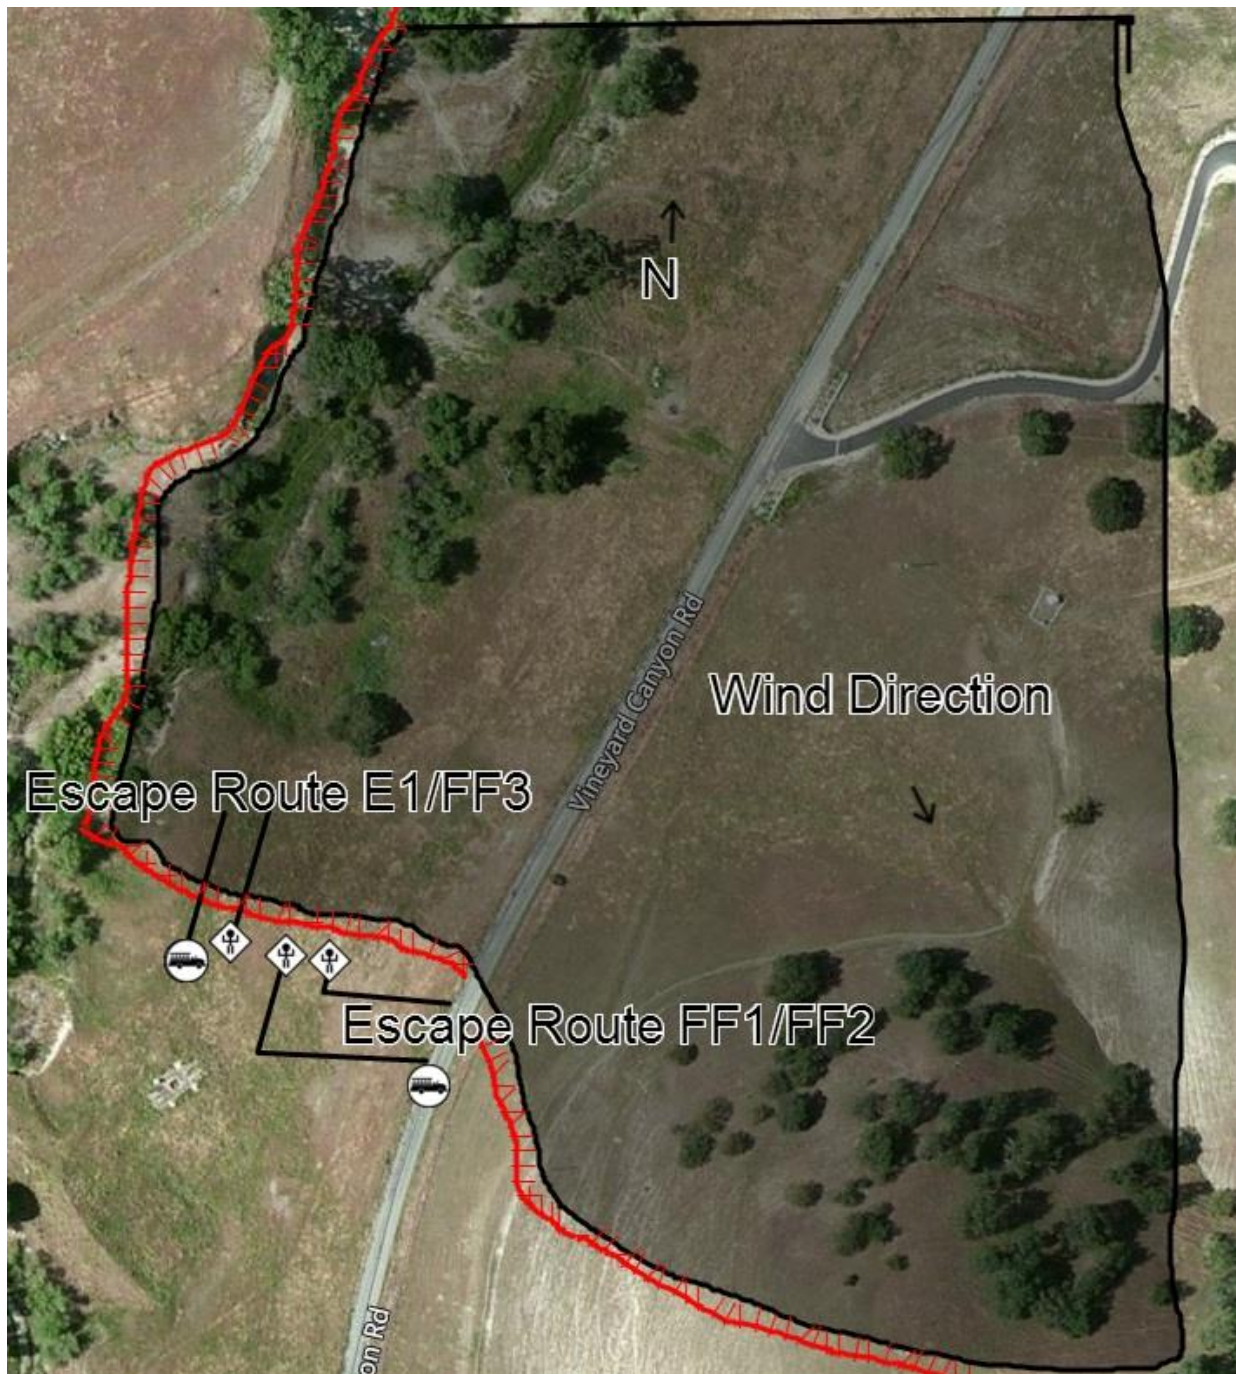
FF1 fell a second time approximately 75’ from the location of the first fall. The rate of spread had slowed at this point, likely due to a decrease in wind-speed and available fuel loading. At some point during the escape, FF1’s helmet was knocked off. E2 with FAE1 positioned nearby on Vineyard Canyon Road directed FF1 towards the location. FF1 was assisted into the cab of E2 and emergency medical care was initiated. FAE1 notified FC1 of a firefighter burn injury via the tactical radio channel. FC1 notified BC1 who requested through Monterey ECC one ground ambulance and one air ambulance.

FF1 suffered minor burns to the face including nose, lips, and throat. The wildland fire helmet and shroud both sustained moderate burn damage. No visible damage was noted on the wildland jacket, pants, boots, gloves, or hose pack. Further investigation determined that the wildland helmet shroud was down, but not securely fastened. Sunglasses were being worn in lieu of goggles. All other PPE was worn appropriately.

- Ensure personnel wear all appropriate PPE.
- Review [CAL FIRE 4300 Handbook 4306.2.1](#) - Lookout, Communications, Escape Routes, Safety Zones.
- Maintain accountability of personnel at all times.
- Evaluate changing fire environments to determine the most appropriate strategy and tactic.

- Crews must utilize L.C.E.S when engaged in firefighting operations.
- The “Ten Standard Firefighting Orders” and “Eighteen Situations that Shout Watch Out” should be reviewed regularly.
- Maintain incident and crew accountability at all times.
- Correlate topographical features and changing wind patterns.
- Recognize extreme fire behavior indicators and anticipate the unexpected.
- Utilize proper risk management methods and procedures.
- Review the Common Denominators for Wildland Firefighter Fatalities.
