PACIFIC SOUTHWEST REGION

August 7th, 2015

Rapid Lessons Sharing TAIL ROTOR STRIKE

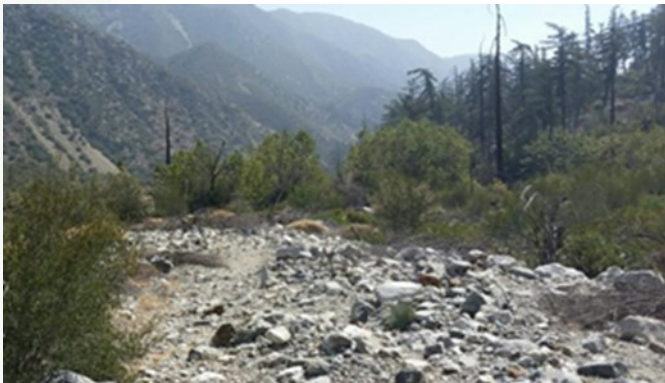
Aware that he had the snorkel deployed he initially planned to land at a large turnout next to the river, but he found the spot was now occupied by "crew buggies". The pilot then flew to the original landing spot, but found it compromised by a hose lay running through it. He then circled several more times, evaluating potential sites, finally selecting one slightly down canyon. He pulled into a hover over the spot, carefully placed the snorkel pump on the ground and eased forward, descending until the tails of the skids were touching the riverbed. At that point he determined that the aft CG (center of gravity) attitude of the helicopter, combined with the down sloping ground, made for an unfavorable landing combination. He elected to lift and find another spot.

Alluvial river beds, like those in Lytle Canyon are very common LZs in this area, and are often the only viable places to land.

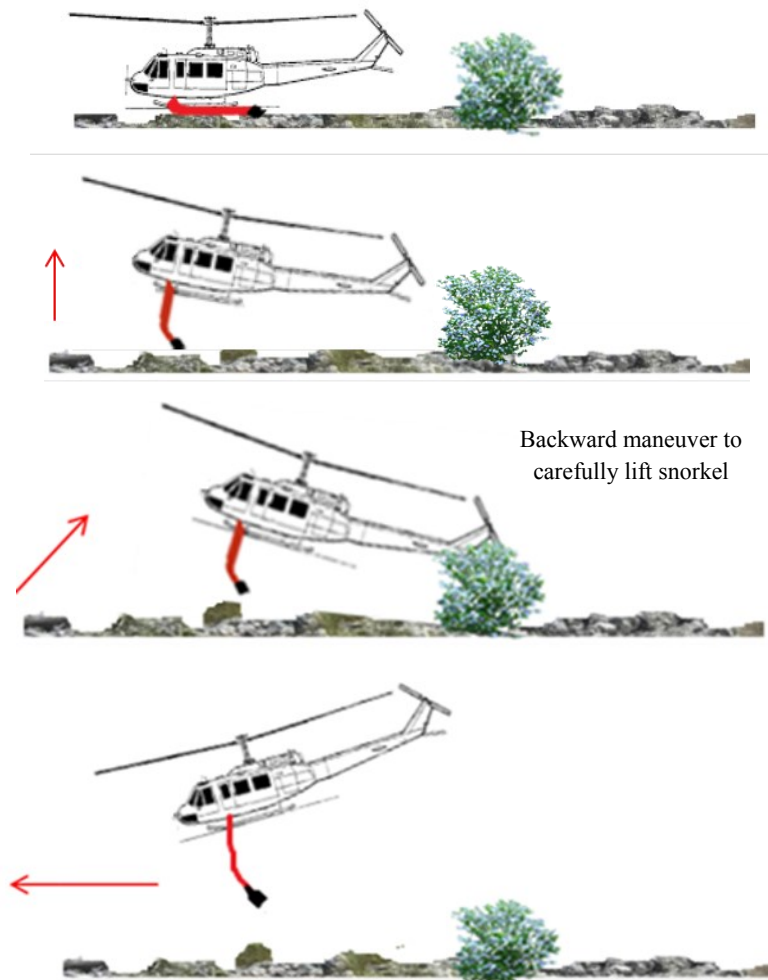
The Pilot determined that the aft CG attitude of the helicopter, combined with the down sloping ground, made for an unfavorable landing combination, so he decided to lift and find a better spot.

Lifting the skids, while keeping snorkel stationary on the ground

Backward maneuver to carefully lift snorkel

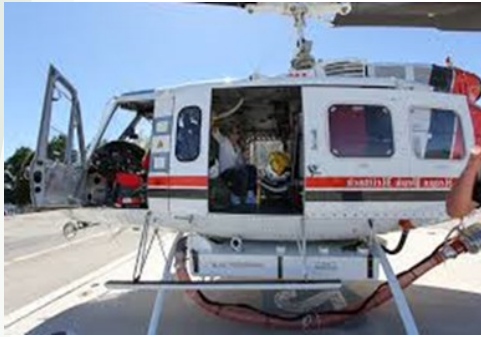
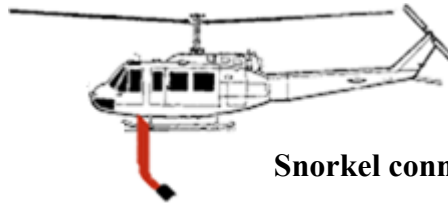
Isolair Tank System

Snorkel connected at front of the tank

ISOLAIR CONSIDERATIONS (connected to tank on front)

- When landing, the snorkel is placed on the ground, then the pilot moves **forward** into the LZ
- During take-off the pilot must move **backward** to ensure that the snorkel is not “drug forward” against the rocks, prior to initiating forward flight.
