**Technology &  
Development  
Program**

# **Toolbox Complex Fire Shelter Deployment Accident Investigation**

*Factual Report and  
Management Evaluation Report,  
September 6, 2002*

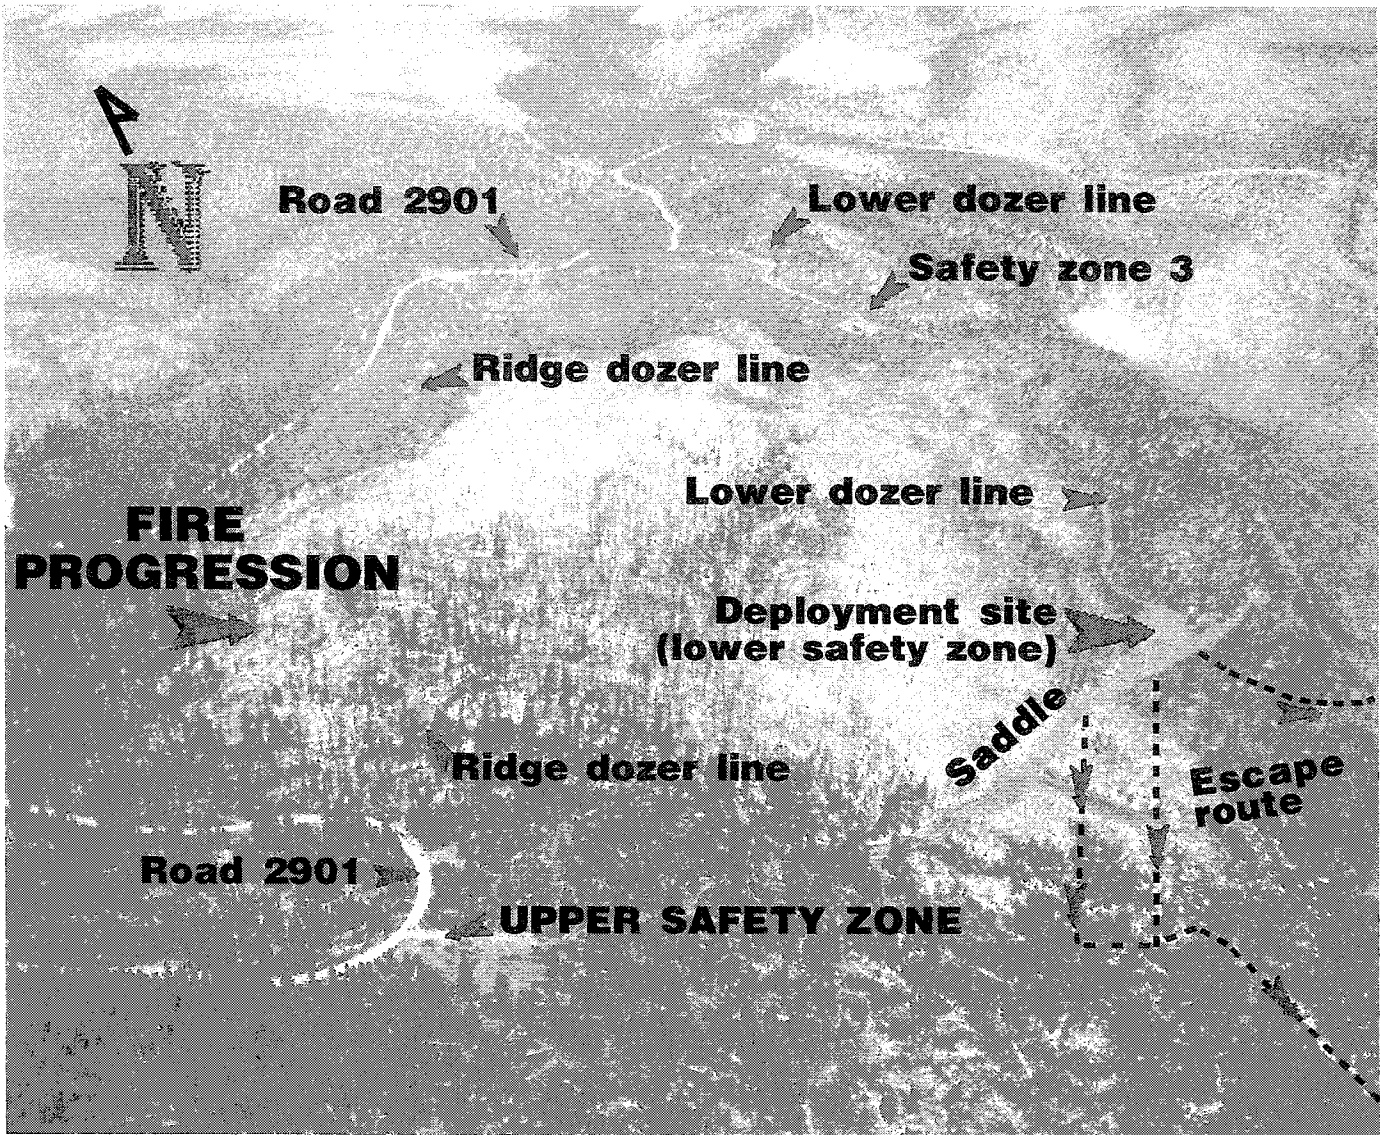
Toolbox Fire fire shelter deployment site.

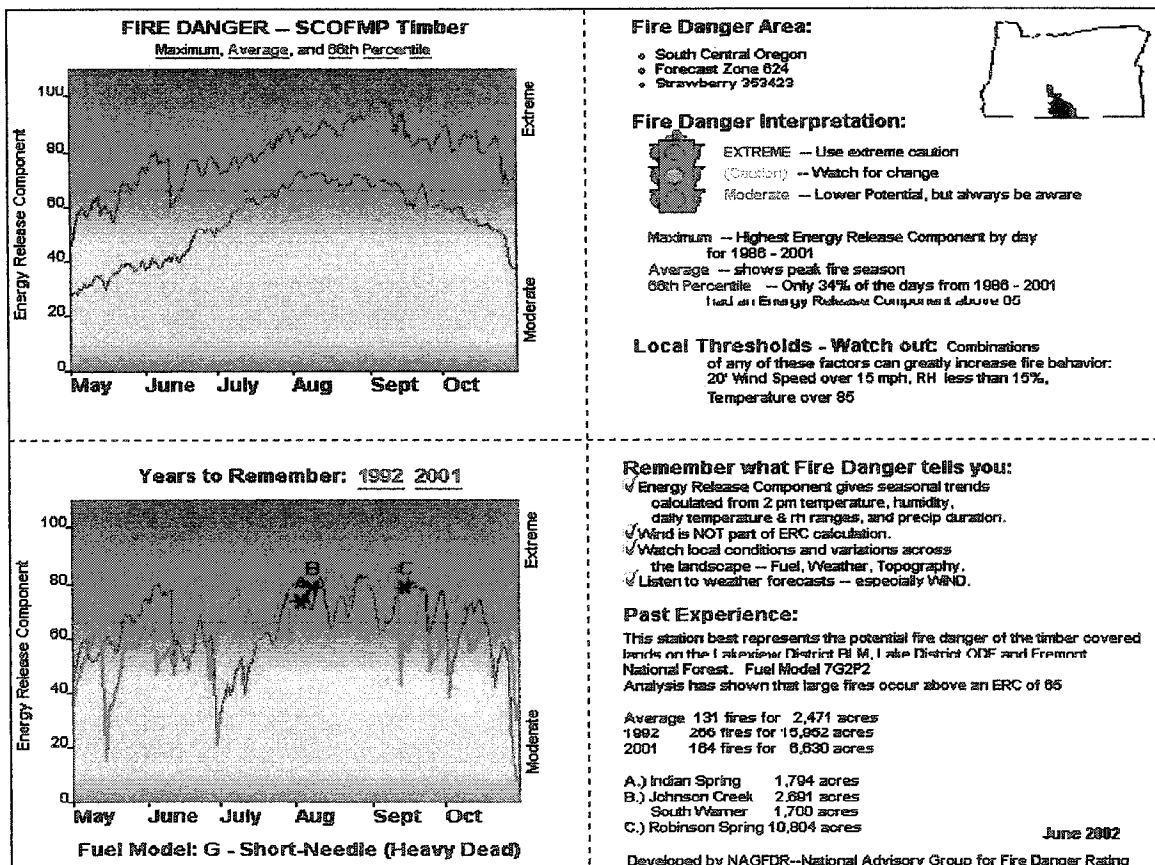
Personnel were made aware of the energy release component (ERC) during shift briefings. A copy of the local unit fire danger pocketcard was included in each incident action plan (IAP). This pocketcard posted the observed ERC for the previous shift and the forecasted ERC for the current shift. Additionally, the average ERC for the date was posted for relative comparison. ERC for fuel model G (heavy dead) was forecasted to be 82 on July 24, compared to an average for that date of 60. The local pocketcard further stated that large fires (more extreme fire behavior events) occur at ERC values above 65. (Pocketcard displayed below)
