Event Type: Tractor Plow Burnover

Date: May 7, 2017

Location: West Mims Fire, Georgia

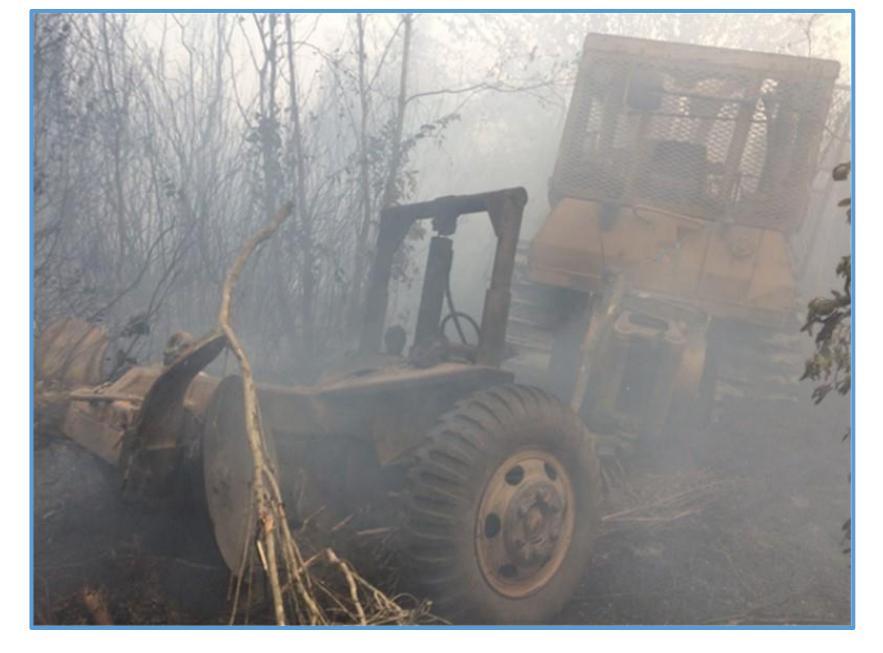
This tractor plow unit shown stuck on stump just as a wind shift caused the flanking fire to become a head fire—which was now moving toward this stuck tractor plow.

Almost immediately after this announcement, a call was heard over the radio that a tractor plow unit was stuck on a stump.

By this time, the wind had shifted (from 304 degrees to 338 degrees with gusts up to 15 mph, according to the nearby Eddy Tower RAWS). This wind shift caused the flanking fire to become a head fire—which was now moving toward the stuck tractor plow.

- Tractor plows working in heavy fuels should keep their blades close to the ground to reduce the chances of getting stuck on stumps.
- Tractor plow operations during high to extreme fire indices need to be modified to provide for the safety of operators, especially in heavy fuels.
- In the event of a potential emergency, insure that the radio channel is cleared for emergency traffic only. Insure notifications are made through the Chain of Command when reporting and when the issue has been resolved.
- Insure the incident Communications Plan is the primary form of communications while obtaining information concerning the incident. Avoid using non-incident channels when communicating to the Chain of Command and surrounding resources.

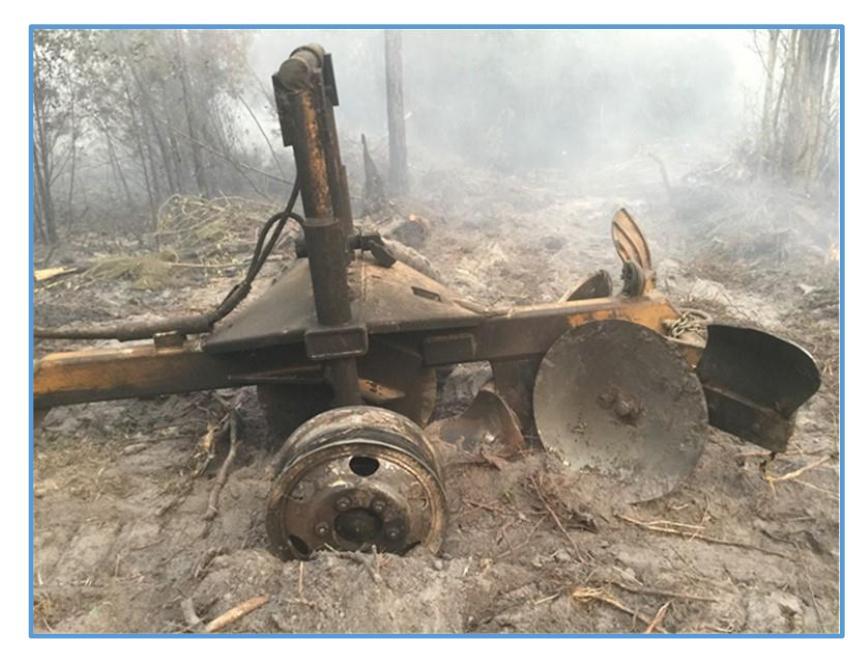
As the helicopter cleared the area, a Type 1 Air Tanker constructed a retardant line from the tractor plow back to the road to which all forces had withdrawn.

The only damage to the tractor plow was the loss of a tire on the fire plow.

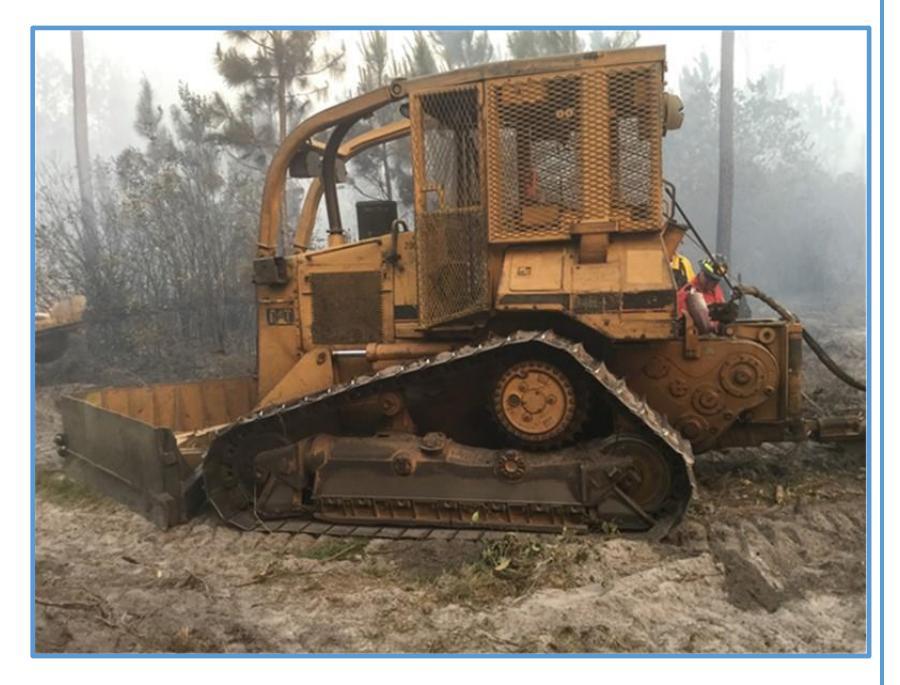
Mechanics went to the tractor plow and determined that it was still functional. They then started the machine and drove it back to its transport. The only damage to the tractor plow was the loss of a tire on the fire plow.

The tractor plow after being driven back out to the road.
