Rapid Lesson Sharing

Event Type: ATV Incident

Date: Aug. 26, 2016

Location: Soberanes Fire, Los Padres National Forest, California

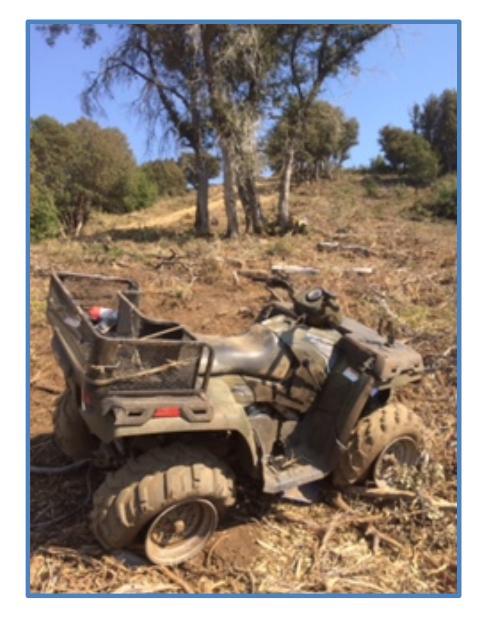
The ATV after it rolled.

The ATV rolled several times on its way down the hill where it eventually stopped just off the dozer line. The ATV sustained moderate damage. The operator was not injured.

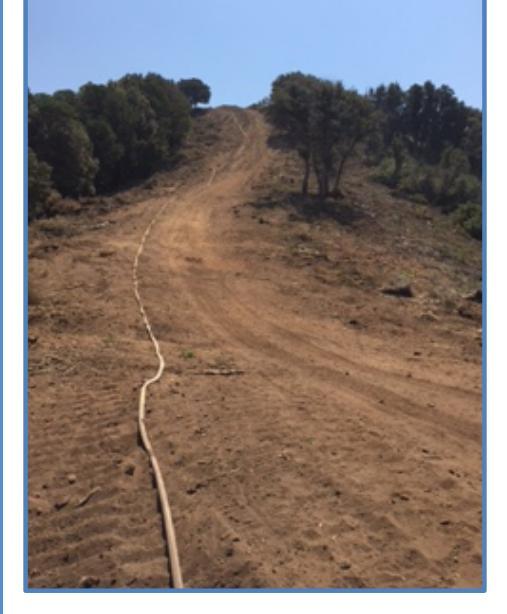
Looking up the second hill.

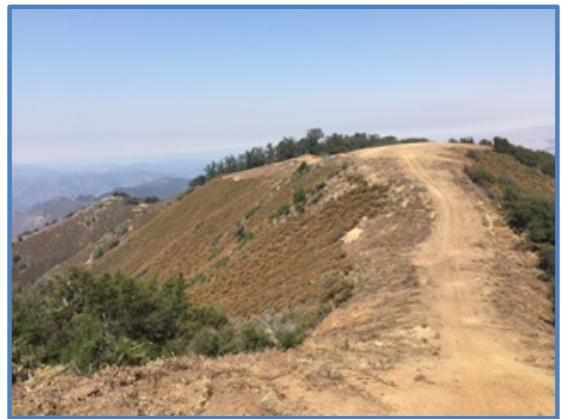
Looking back down the dozer line from the first hill.

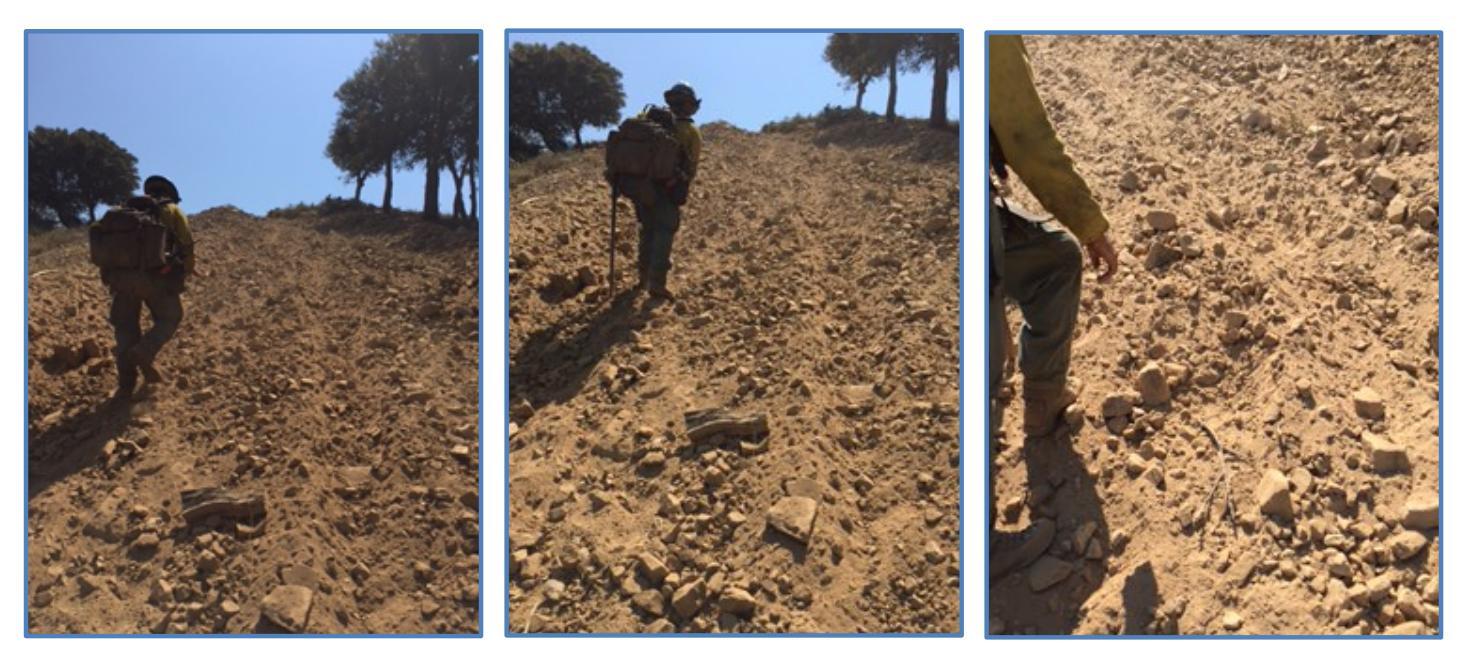
As the operator rode straight up the line the ATV continued to slow down due to the deep sand and rocks. About ¾ of the way up the hill he was barely moving when all of a sudden the rear wheels of the ATV shifted to the left just as it came to a complete stop. This left the ATV on a side-slope angle. The operator was holding the brake, but felt the ATV was about to roll sideways. The operator stepped off and moved quickly away. Almost immediately, the ATV began to roll on its side.

The area where the ATV stopped near the top of the hill.

Where the rear tires slipped.

- ✓ Don't underestimate the power of deep sand to slow your progress.
- ✓ Just because you have done something similar many times doesn't mean this time will have the same outcome. Don't let your past experience cloud your current judgement.
- ✓ Don't hesitate to step away and let equipment sustain damage—better it than you.
