Engine 492 Rollover

Facilitated Learning Analysis (FLA)

USDA Forest Service

Medicine Bow – Routt National Forest &

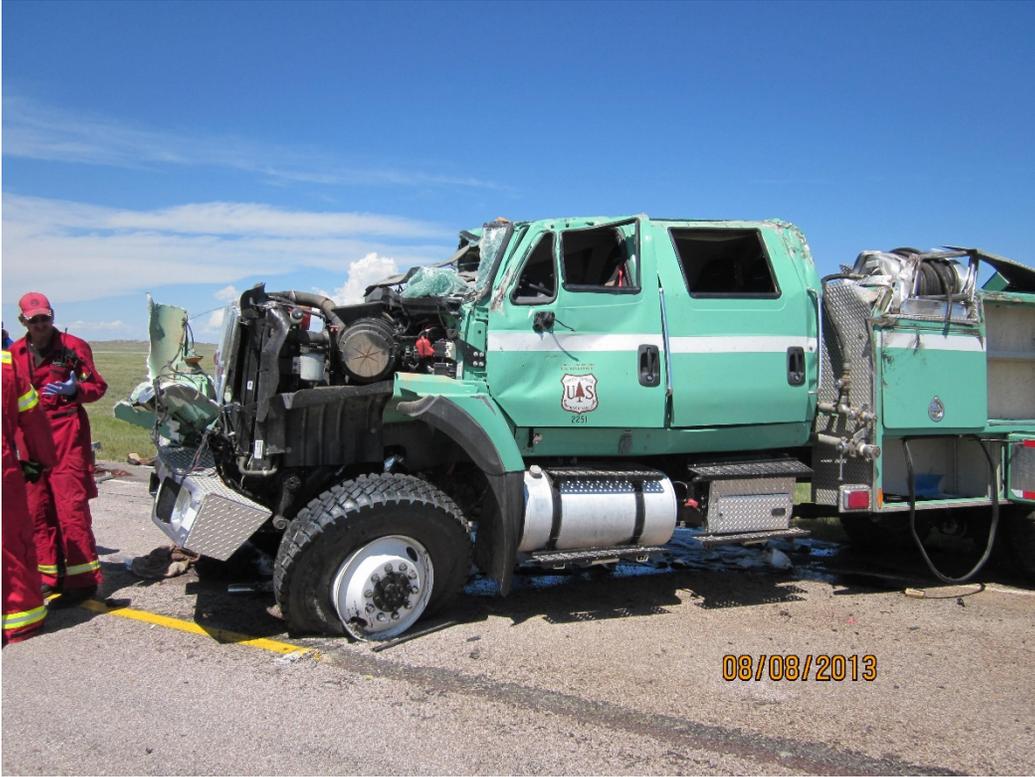
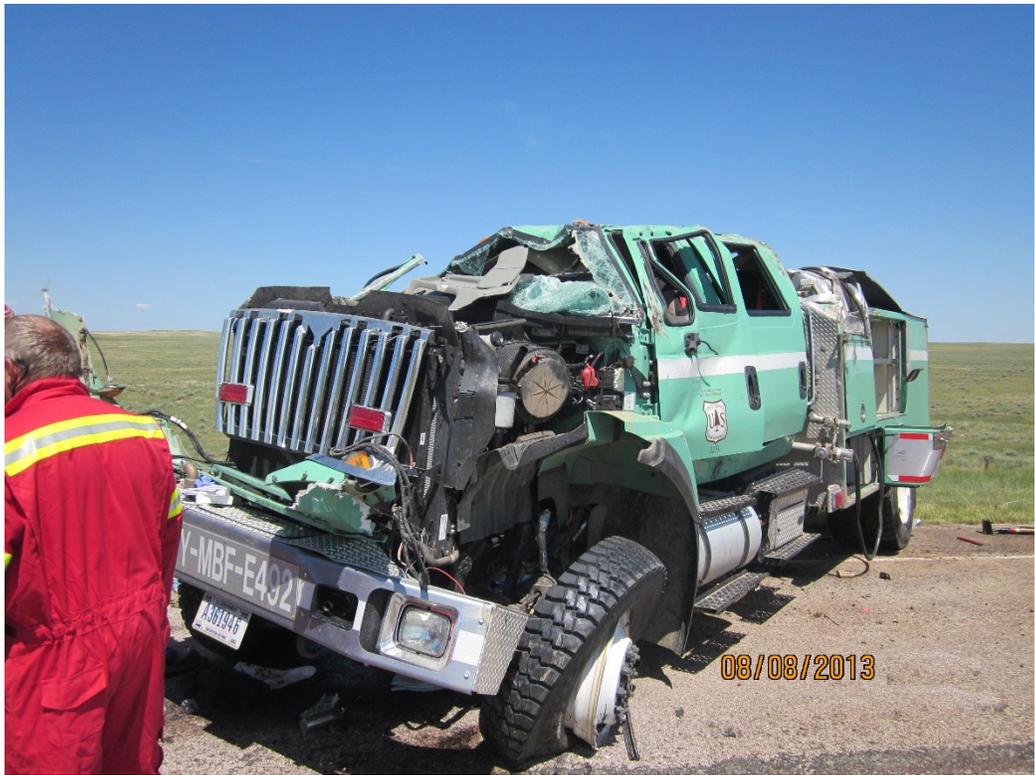
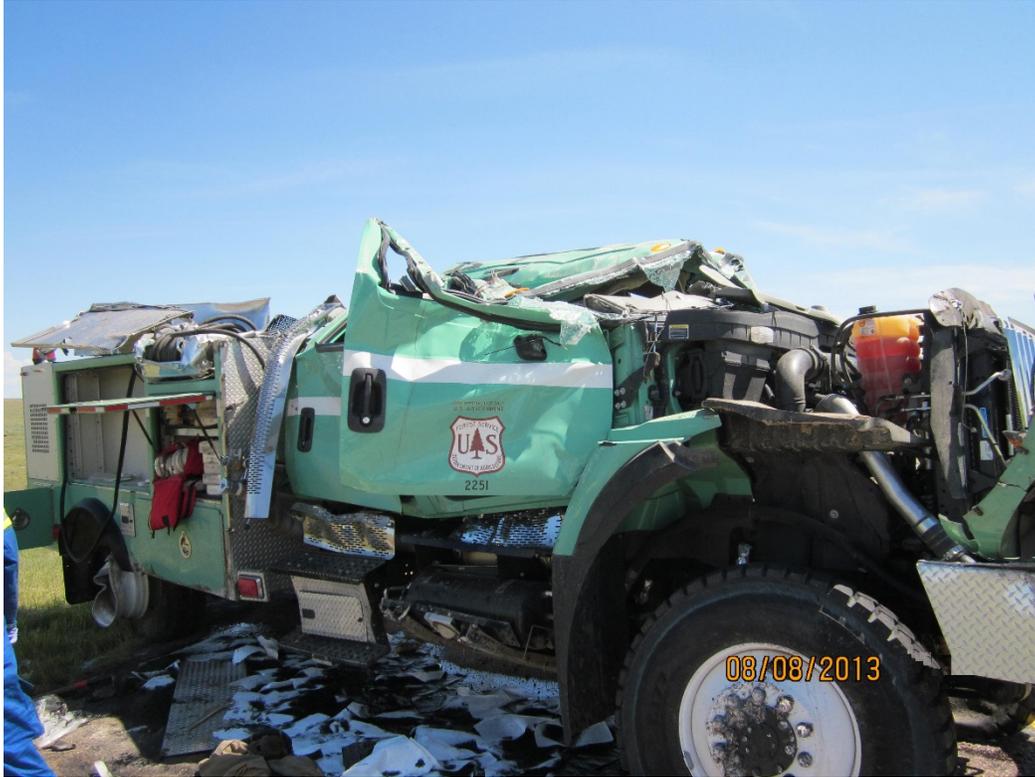
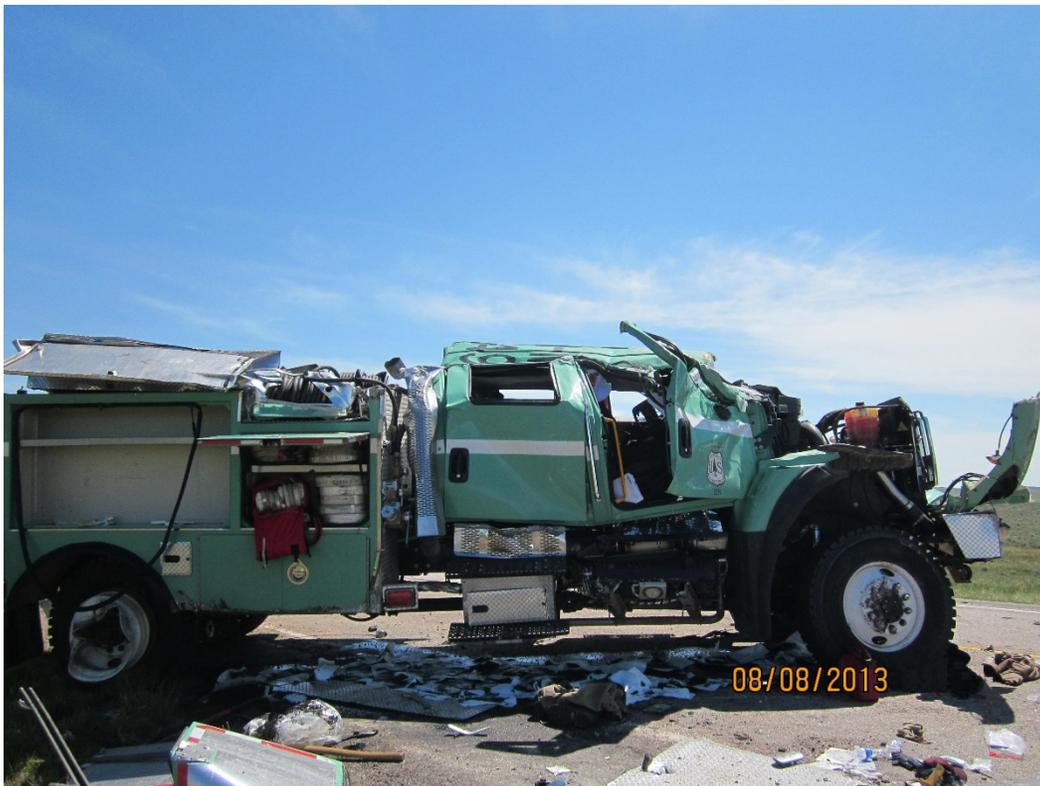
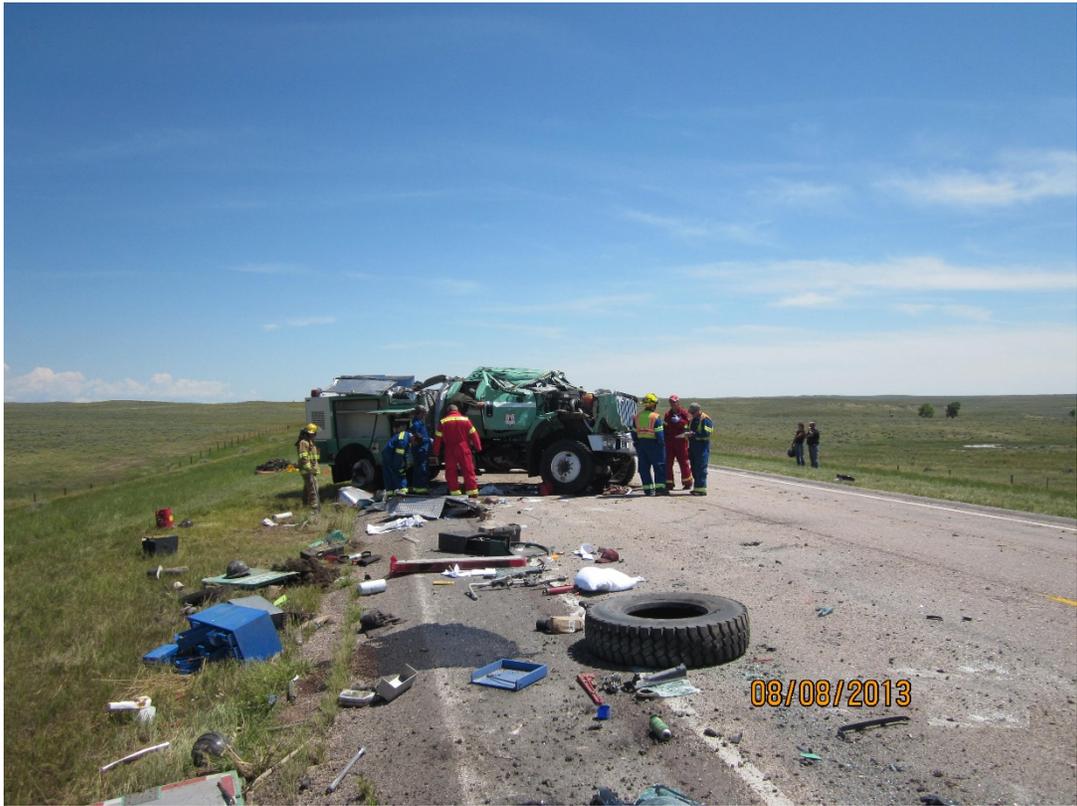
The engine left the highway, veered slightly to the right side of the road hitting a paved apron to a side gate, with the driver seeking to decelerate and regain control of the engine. The engine returned to the road, with the engine brakes being heavily applied, then redirected back to the highway, which resulted in crossing the center line and going to the opposite road edge. Engine 492 rolled over a few times before coming to rest on its wheels (up-right).

At the time of the accident all three members of Engine 492 were wearing their seatbelts. Use of seatbelts and the integrity of the engine cab are likely the principal reasons for the survivability of this accident. All three crew members were hurt in the accident and the Type 4 engine was a total loss. Two of the crew members were transported by ambulance to Newcastle, Wyoming and the third member was transported by ambulance to the high school practice field in Wright, Wyoming where he was transferred to, and then transported by helicopter to the hospital in Casper, Wyoming. The two crewmembers that were transported to Newcastle, Wyoming were released later the same day. However, the injuries sustained by the third member resulted in a longer stay in Casper and release from the hospital on Saturday, August 10th.

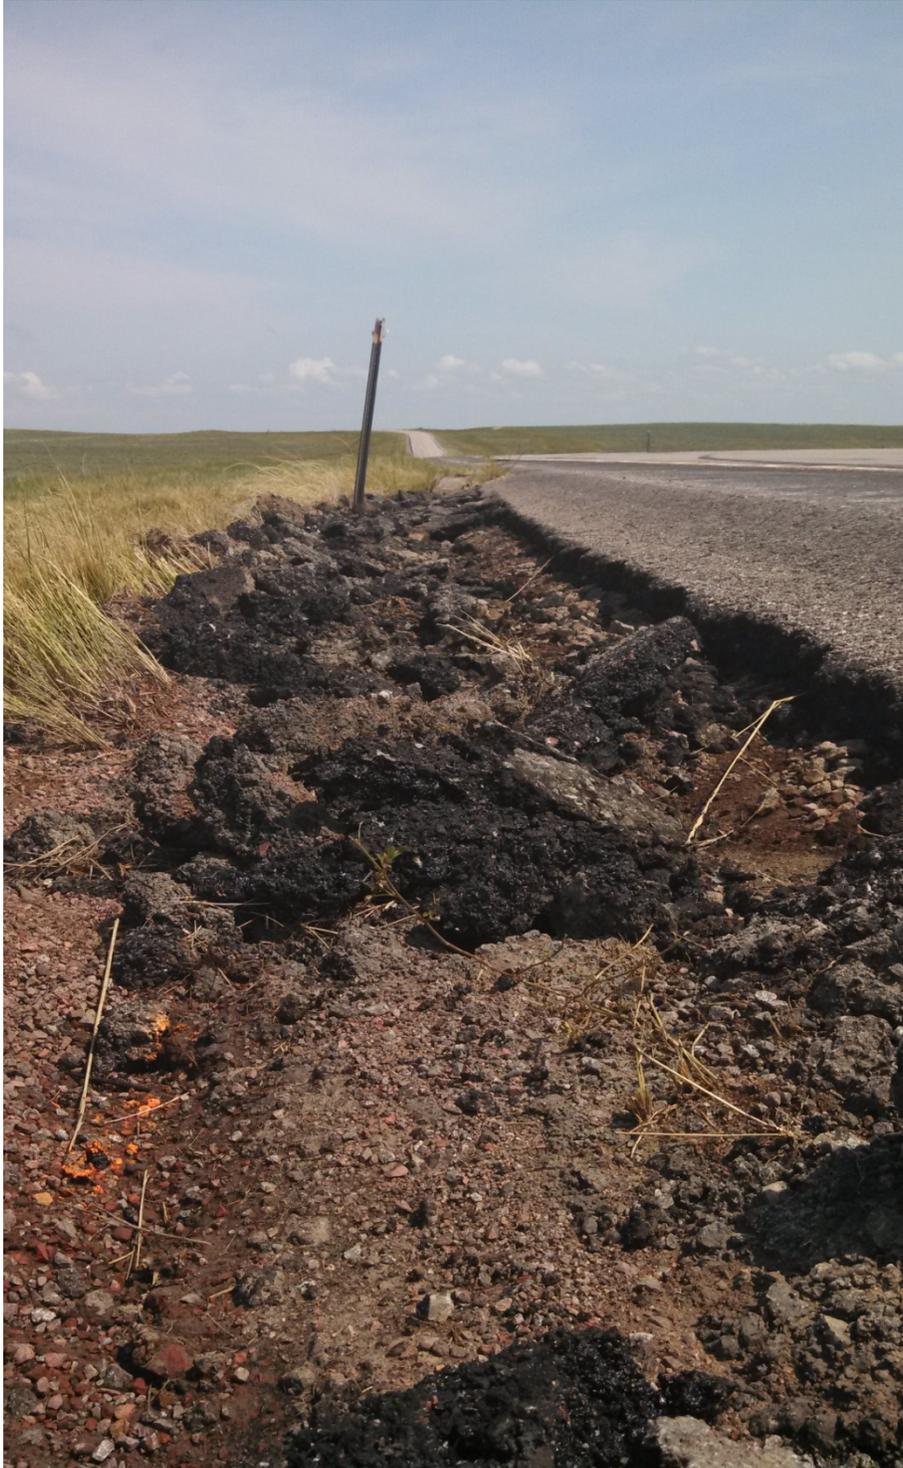
North side of Wyoming Hwy 450 – extensive shoulder slough from substrate destabilization.
First rollover initiated to the East of the slough.

1. Seasonal conditions can change the integrity of roadway conditions and subsequently the handling capabilities of heavy vehicles:

Employees recognized the area was experiencing an atypical fire season. In previous years there was high expectation for the engine crew to have worked on many initial attack incidents with dry conditions and little rain fall. During the 2013 season, the Thunder Basin area had experienced approximately a month with substantial rainfall occurring several days in a week. Numerous personnel with the Forest Service commented on never having seen the surrounding vegetation “this green” during the summer time. In addition to unusual fuel conditions, the rainfall had softened the substrate at the shoulder of the highway. The collapsing of the road shoulder contributed to a lack of vehicle control as noted by the engine driver: “I could see the vehicle was on the road but it felt as if I were off in the ditch.” For future operations, significant rainfall and saturated soil conditions have the potential to alter both off-road and highway conditions.
