# Rapid Lesson Sharing

**Event Type:** Heat from Fire Causes Engine's  
Air Brake Failure

**Date:** April 14, 2016

**Location:** Tallgrass Prairie National Preserve  
Kansas

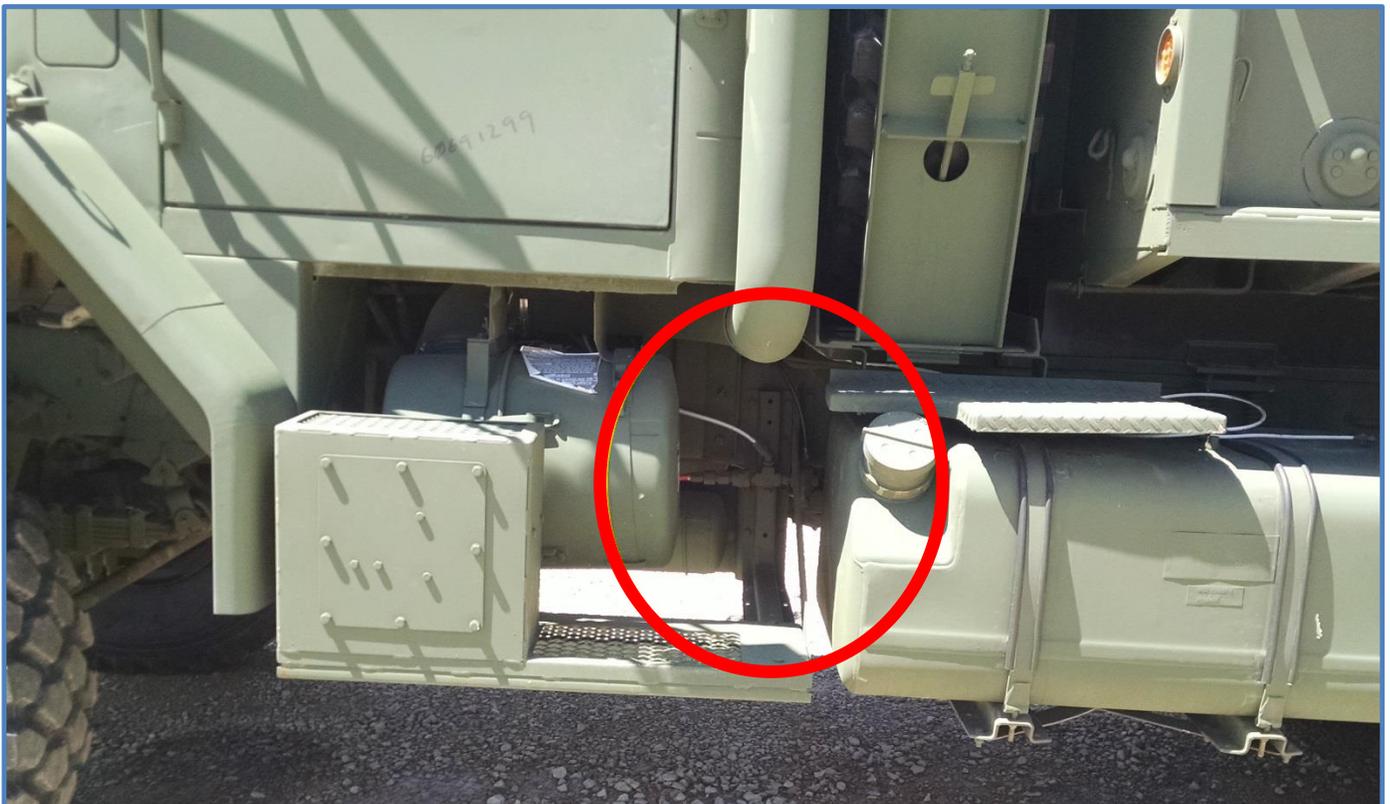
Subsequent investigation revealed that while engaged in direct attack heat resulted in the small melted holes in the plastic air system lines located under the driver's door, causing a loss of air pressure and the locking of the air brakes.

***The airline manifold—located under the driver's door—is circled in red. (This is a truck/engine similar to the one involved in this incident.)***

- ✓ After the fire, the Fire Chief and his staff rerouted these air lines located under the driver's door so they are more shielded from heat.
  - ✓ This unit is currently investigating additional methods for insulating or shielding these air lines.
  - ✓ They are also re-emphasizing the importance of working inside the black whenever possible.
  - ✓ Because these M-900 trucks are used all over the country as wildland engines—and other models of wildland engines may also have these exposed plastic airlines—it was determined that this lesson should be shared outside the local agencies that were involved in this incident.
  - ✓ Any wildland engine with air brakes that is used in a direct attack should be inspected for exposed brake lines that could be in danger of melting and locking the brakes in an unsafe location.
-
