Rapid Lesson Sharing

Event Name: Type 4 Engine Tire Blowout

Date: July 2, 2012

Location: Interstate 90 – Four miles west of Butte, Mont.

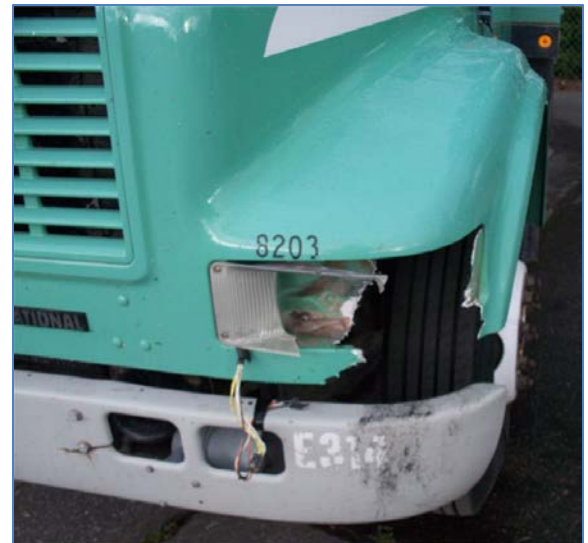
While traveling at a speed of 62 mph, with three firefighters on board, the left front tire on this Type 4 Engine blows out.

The engine immediately pulled to the left. But the driver was able to safely negotiate the engine to the right shoulder of the road.

The engine crew displayed safety triangles and cleared debris from the blown-out tire off the roadway.

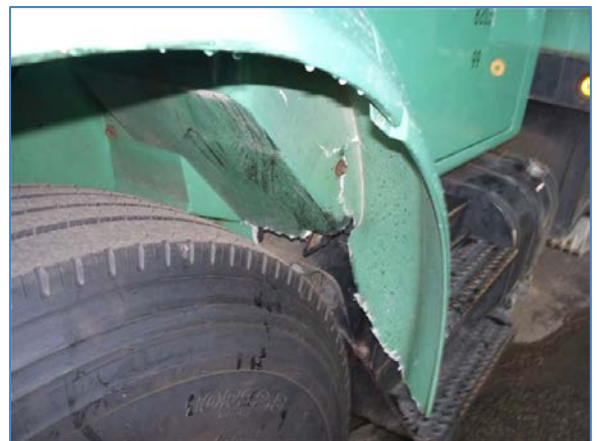
During the months previous to this incident, numerous steps were taken to ensure the safe condition of the engine's tires (annual inspection of entire vehicle, monthly pm checks, inspection at tire shop). There were no apparent defects or problems with the tires.

The engine was travelling with a full 750-gallon tank. There is a question as to whether traveling with an empty tank would be safer. While the tires might receive less wear-and-tear, the brakes are designed to perform best when the vehicle is at its GVW.
