# EXPEDITION FIRE- BURNED DOZER

## FACILITATED LEARNING ANALYSIS

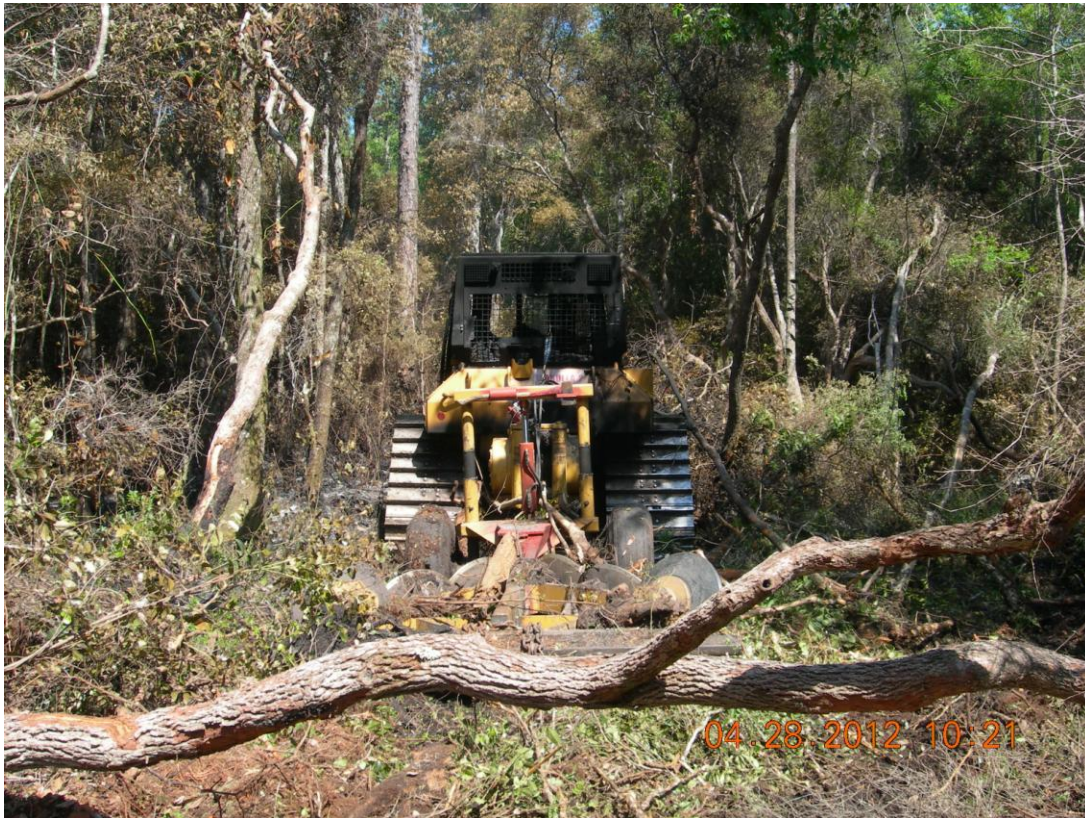
Figure 1: Wakulla 2 Tractor Plow post incident

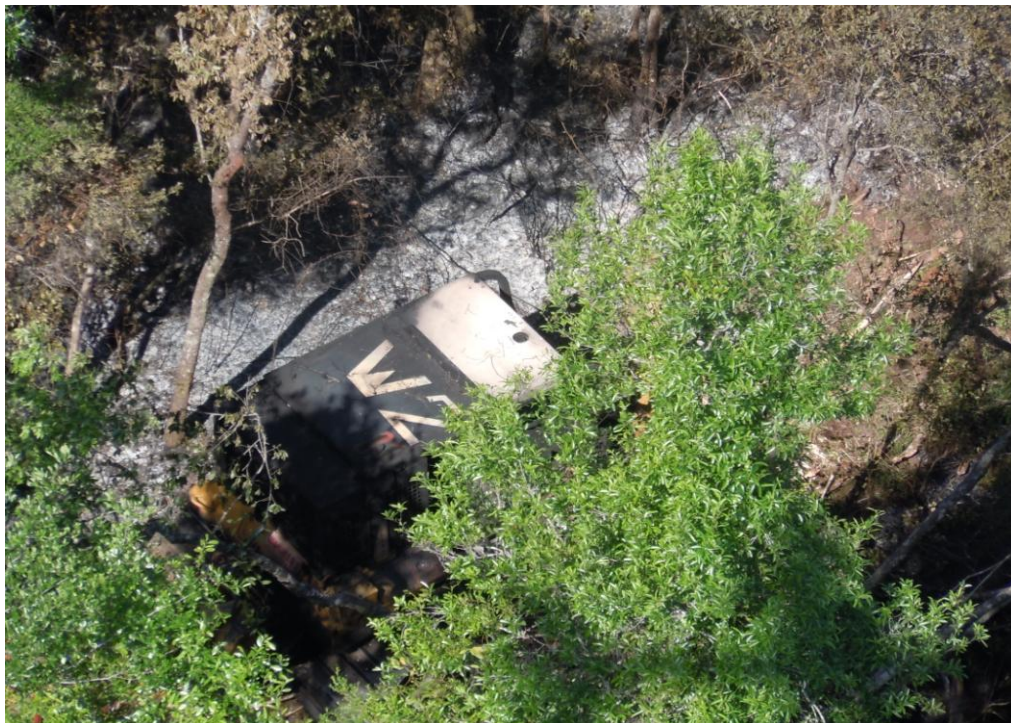
Figure 2: Tractor plow post incident as seen from helicopter

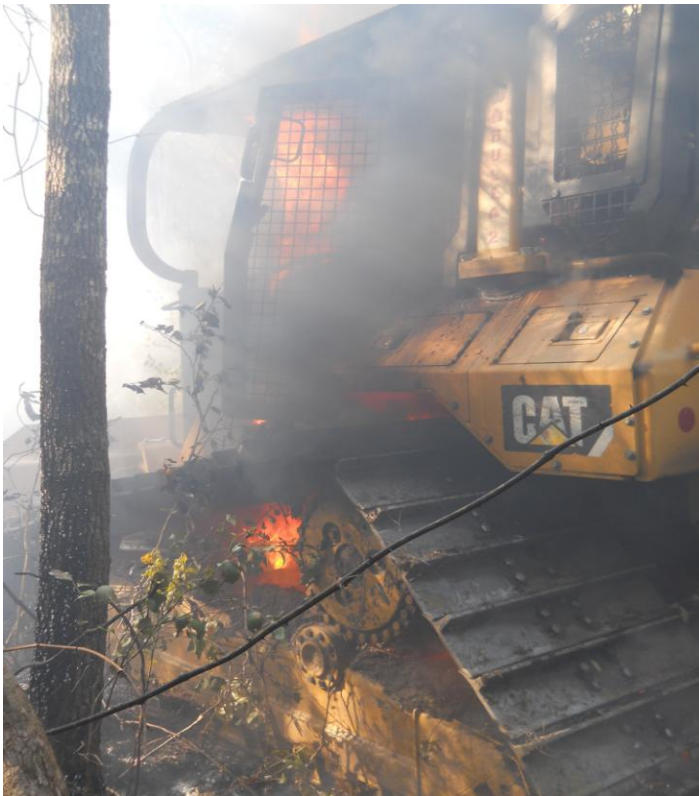
The operator continued building fire line to the north. Due to fuels and soft ground conditions on this flank the operator had to knock down trees and back up to clean the line out with the plow. While backing up, the operator noticed flames at the peak of the tracks coming from under the tractor on the right side. The operator immediately stopped the tractor and decelerated to get off and access the water suppression system. Once off, the operator heard what sounded like a hose rupture and witnessed the engine compartment become fully involved. The operator was unable to suppress the engine compartment fire due to toxic fumes and smoke that were now filling the cab. Due to these conditions the operator was only able to reach in the cab long enough grab the fire pack and turn off the ignition. The operator moved away from the burning equipment and then determined that nothing more could be safely attempted. The operator safely exited with his required PPE. He was unable to call the IC because he did not have his

**Figure 3: Tractor on fire**

The Zone FMO made the decision to order specialized dozer operator packs that can be worn in the cab to ensure operators have all required safety equipment, including hand held radio on during fire operations. All the Forests in the National Forests in Florida will be using the new packs.
