# FACILITATED LEARNING ANALYSIS - KLAMATH NATIONAL FOREST

While in route to the Berry Point Fire (Oregon) from the Lake Fire (Modoc National Forest (MDF), a Klamath National Forest (KNF) engine was involved in a Motor Vehicle Accident (MVA) with no injuries and little damage to the engine. They were reassigned to the Berry Point Fire as an immediate need strike team leaving from a drop point on the Lake Fire.

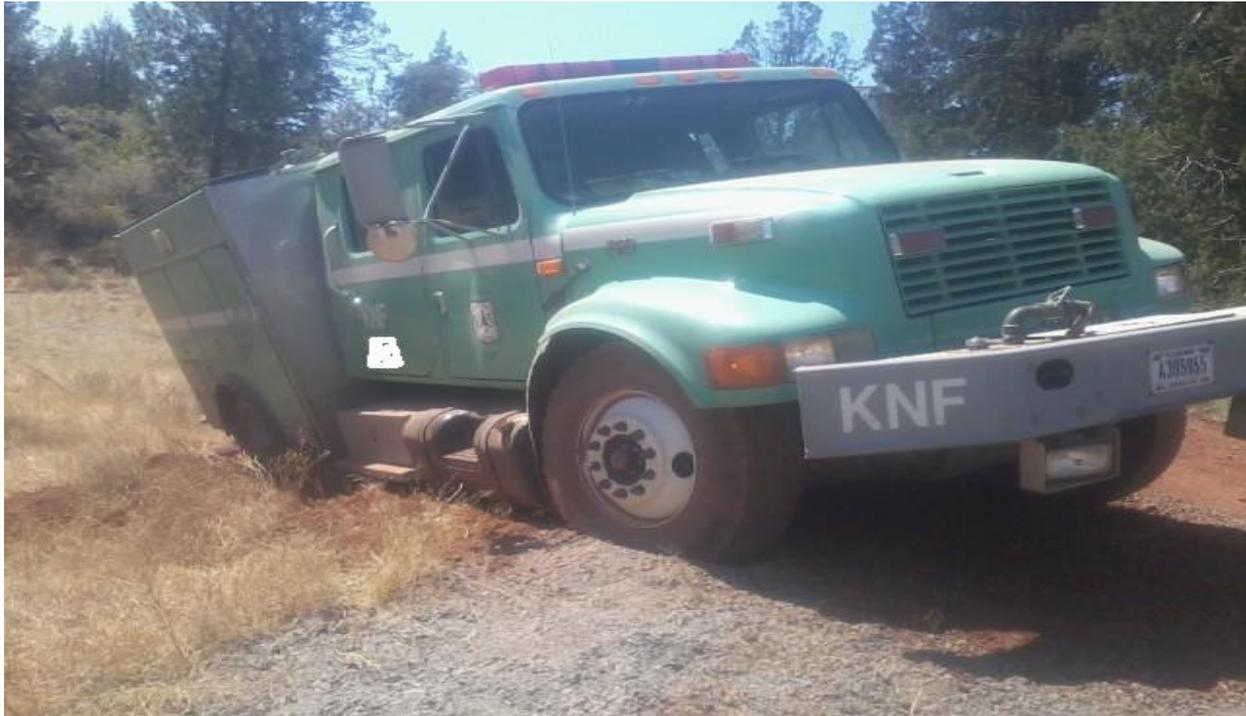
While in route to the Berry Point fire an engine from a strike team from (KNF), was involved in an accident. On August 11<sup>th</sup>, a KNF strike team of engines was traveling in a convoy of vehicles on a MDF road and the last engine in the strike team had a near miss MVA.

“The incident occurred while traveling northbound on a freshly graded cinder dirt road. My engine was traveling with a strike team of engines and about three or four other engines and a hand crew in 5 pickups. We were in the middle of the convoy on a two lane cinder road. Before the S turn where the near miss happened there is about a mile of straight road. Normally on single and two lane dirt roads I always try to stay on the right side of my lane. The road made a turn into a steep ravine that instantly turned into a one lane road with a narrower spot at the low water crossing at the bottom of the ravine. I was already going slowly when I hit the top of the S turn. Midway through the S turn, I saw that the road

turned into a skinnier one lane road at the bottom of a ravine. I was on my right side of the lane when I saw this.

“As I began to turn to the middle of the lane at the bottom I felt the back right duals do a dip effect. Dip effect means the feeling of when your rear duals go into a pot hole, or when your duals sink into mud or sand. Instantly as I felt the dip effect, the rear of the engine started to get pulled to the passenger side. At this point I fell into recover mode. As my rear end started to be sucked off the road I knew I had to keep the two front tires on the road to keep from a potential rollover. So I turned the wheel away from the side that was sucking the engine off the road and throttled the engine by pressing the accelerator pedal. In doing so this kept the front right wheel on the hard pack of the road right in front of the low water crossing thus keeping the engine upright even with the rear dual off in the soft cinder shoulder.

“Without rain or watering before road grading, the grader leaves a soft or false shoulder. On this particular out turned corner that led up to the crossing, there was almost three feet of soft shoulder that looked like hard pack road base. So when I was turning thru the turn to enter the low water crossing I was not alarmed by the road width until my back dual started to sink. I am constantly going through driving tactics in my head when I drive, like backup plans or escape routes. What would I do if a car pulled in front of me or what would I do if my front tire blew and on my district, what would I do if my rear dual got sucked off the edge as in the Stanza accident. As soon as this episode started it was over with both of my front tires on the road and my back duals off the road. I instantly exited the engine with the crew and I went into damage assessment.

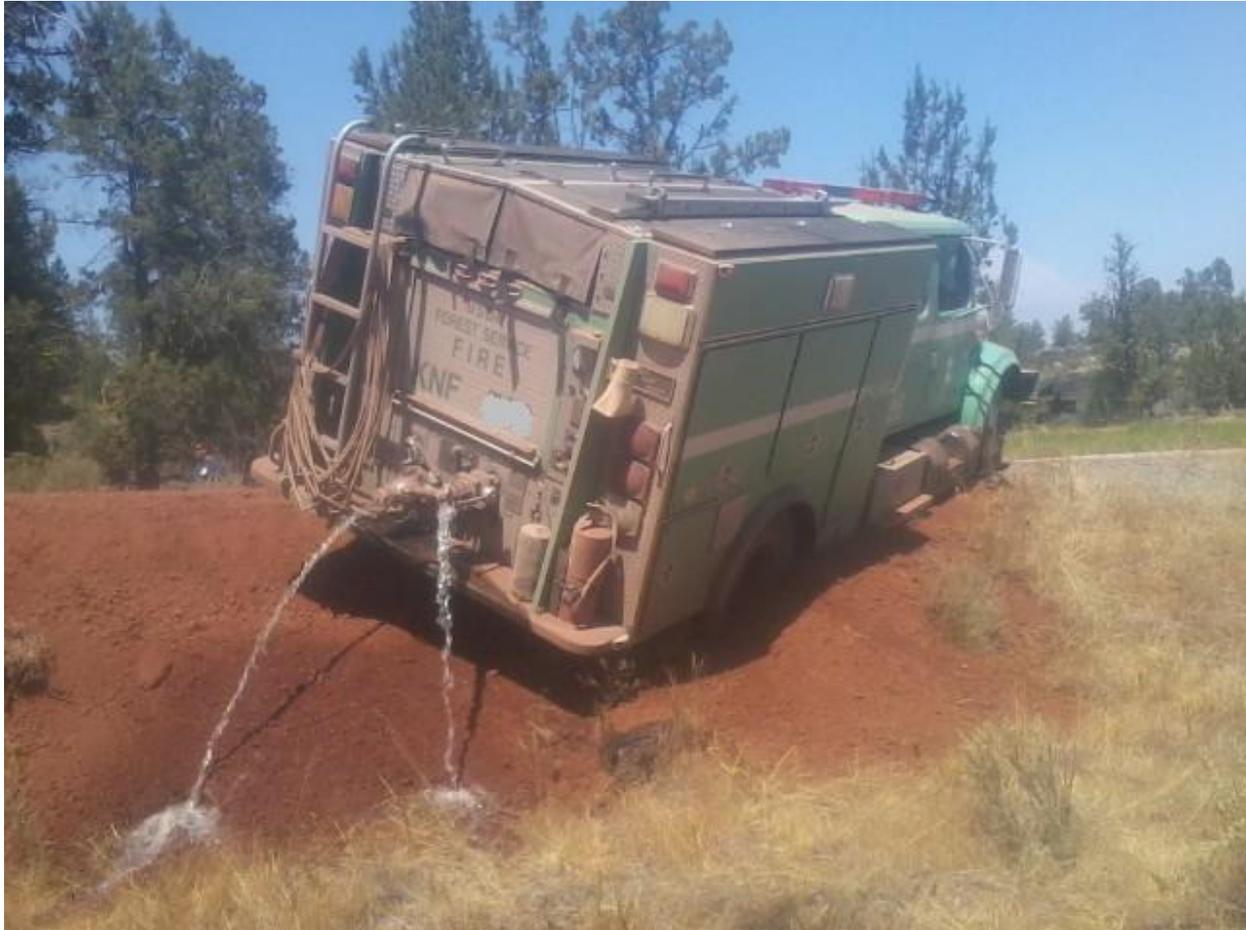
“At this time the captain assessed the scene for safety and ordered the crew to exit the vehicle with most of the crew leaving the vehicle on the uphill side. I then dumped the water out of my tank to prevent possibility of continued rollover due to the soft pack. After the certified mechanic and I did a damage assessment investigation, we found the only damage was the petcock on the bottom of the pump was broken off. We had spares on board since this may happen occasionally on backwoods roads.

“When the incident occurred it was day 13 of our assignment. The previous day’s shift was 16 hours and the night before the incident I had approximately 7 hours of sleep and I was off shift for 8 hours thus meeting my 2:1 work rest ratio. On August 5th thru the 8th of the assignment we were in initial attack staging, the 10th and 11th we started mopping up on the Lake fire. The 6 days before the incident were relatively light in physical and mental operations combined with sufficient sleep for an assignment. The road we drove was unfamiliar to us but at the same time was driven with the same caution as any other road. After the MVA incident, the ICT 4 of the Lake Fire who was also at scene, told us there had been potential near misses because of the newly dry graded cinder roads in which two other vehicles left the hard pack.”

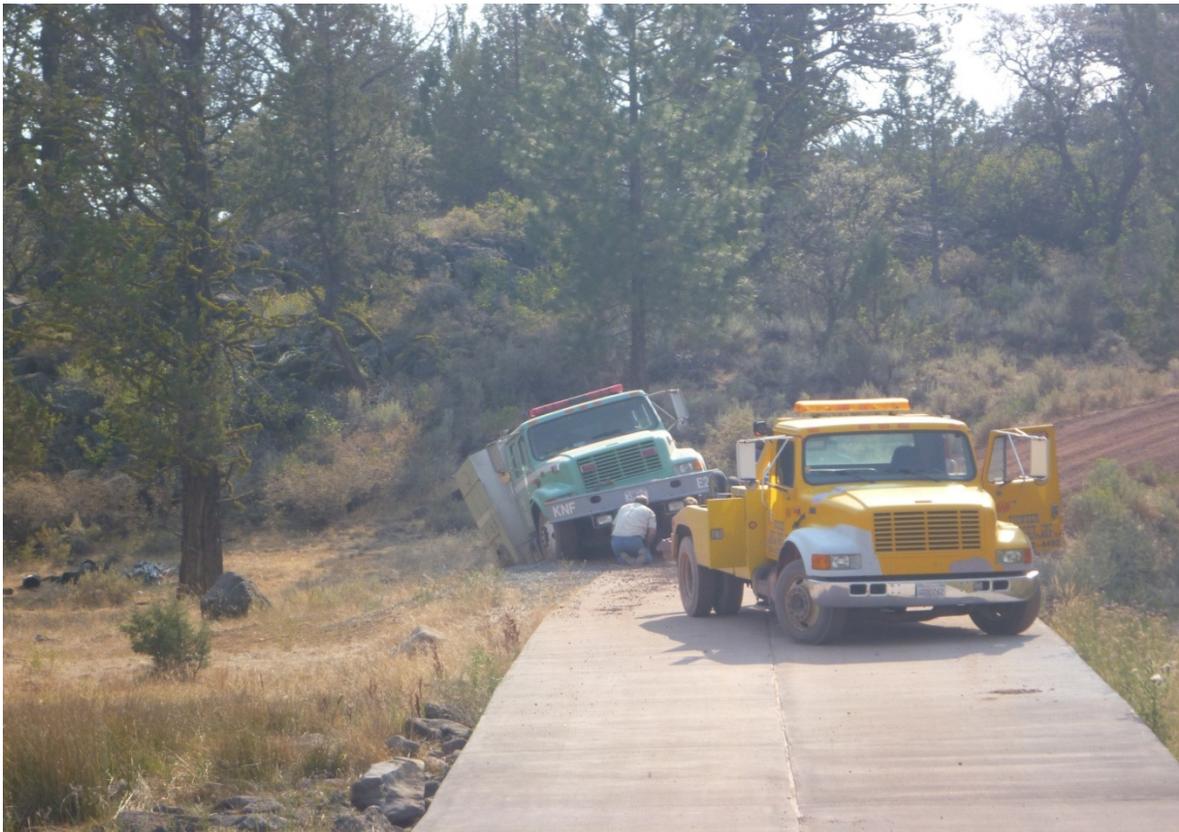
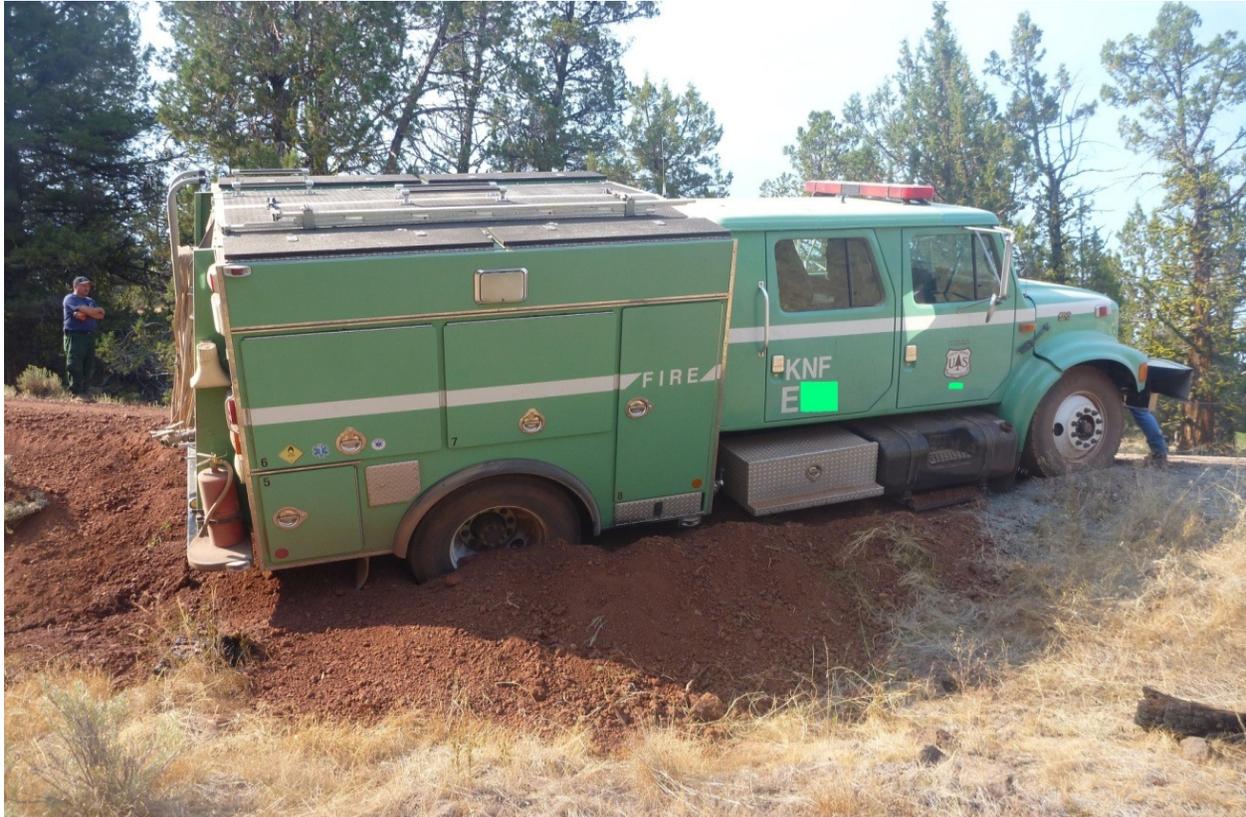
1. Driver's training and experience helped keep the engine upright after leaving road way. Emergency Vehicle Operations Training (EVOT) and Engine Academy instruction influenced a positive outcome.
2. Captain and driver remained calm during the incident.
3. Captain assessed the scene for safety and then led a calm and organized egress of the vehicle.

- 4. Driver unfamiliar with road and hazards associated with it.*  
Ask local units about roads and the hazards associated with them and if no one is available to talk to then drive slower than usual to give yourself ample time to react to the hazards.
- 5. Driving too far to the right side of the road when on gravel roads.* When on narrow roads it's a good idea to drive towards the center of the road to give you more reaction time and distance. Always keep in mind that traffic could be coming towards you when on narrow roads, so drive accordingly.

7. *Forest road hazards need to be marked with flagging, traffic cones or signs to ensure that hazards are identified and they need to be communicated to others. Do not make the assumption that people know or have seen the hazard, pass any hazard awareness information on to other resources or people to ensure it is known.*
