# Rapid Lesson Sharing

**Event Type:** UTV Rollover

**Date:** Oct. 11, 2016

**Location:** Mingus Mountain, Arizona

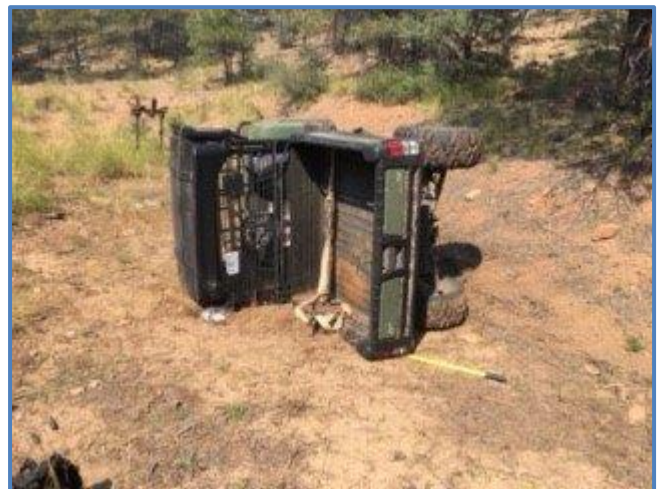
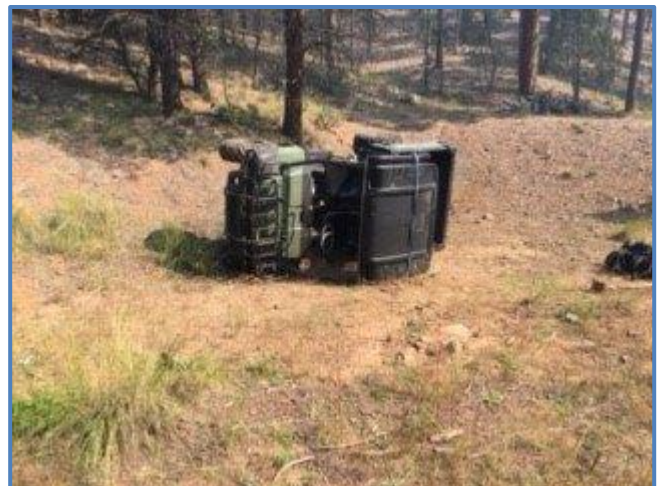
*“The steering wheel was ripped from my hand, turning the UTV sharply into the bank,” the operator explained. The operator tried to maintain control and quickly stopped the UTV—but it was too late. The UTV came to a quick stop and was precariously leaning with the driver’s side on the down-slope side of the incline.*

***“The UTV just seemed to lean over and hang there for about five seconds.”***

*“The UTV just seemed to lean over and hang there for about five seconds,”* the operator said. This gave the operator an opportunity to unhook his seat belt and try to walk away—but at the same time, the UTV started a slow roll onto the driver’s side.

The driver hunched down as the ROPS (roll cage) slowly came over him and the UTV came to an immediate stop. The operator was hunched over within the ROPS framing and simply walked through the ROPS enclosure to safety. The ROPS prevented the UTV from flipping completely over and trapping the operator.

The operator quickly realized that he would not be able to roll the UTV back over onto all four tires. He requested assistance from other firefighters in the area assisting with the RX planning. The UTV was quickly rolled back over and restarted. It only had minor damage to its plastic sun cover.
