# Rapid Lesson Sharing

Montana DNRC  
August 1<sup>st</sup>, 2019

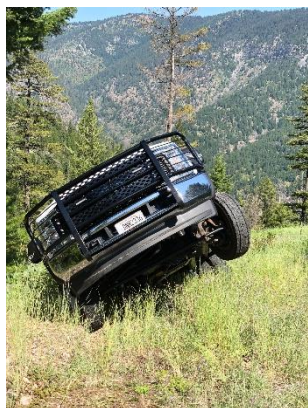
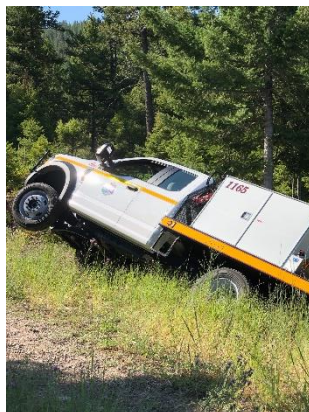
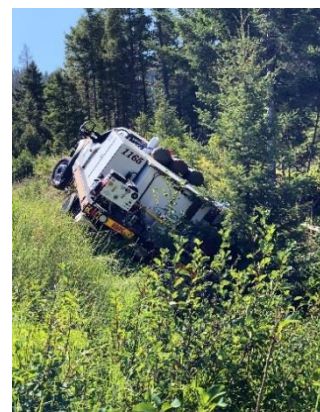
**Summary of incident:** On August 1st, 2019 at approximately 0915, a DNRC engine crew was responding to a smoke report located off an old logging road system. Weather conditions were clear with a temperature of 65 degrees and the road was dry and in decent shape. The crew decided to back up ~50 feet to flag the intersection in case additional resources were needed. The engine crew relied on mirrors and a backup camera and did not to use a spotter for the maneuver. While backing up the driver was following the contour of road using his passenger side mirror, unaware of the sharp turn and steep slope of the road on the passenger side of the engine. This resulted with the engine backing off the road near the intersection. The engine crew notified the Unit AFMO and Missoula Dispatch of the situation and reported no injuries or major damage to the vehicle. A response was initiated by the AFMO with a towing company from town. The engine was successfully pulled out of the ditch with the aid of a tow truck and driven into town for an inspection.

1. Always use a spotter when backing up!
2. Situational Awareness- Be aware of your surroundings at all times.
3. Do not rely on modern technology (backup camera) to take shortcuts.
4. Consider risk management in all decisions- If you see something, say something!
