# Rapid Lesson Sharing

**Event Type:** Retardant Drops Protect Vehicle

**Date:** Aug. 21, 2016

**Location:** Cherry Road Fire, Oregon

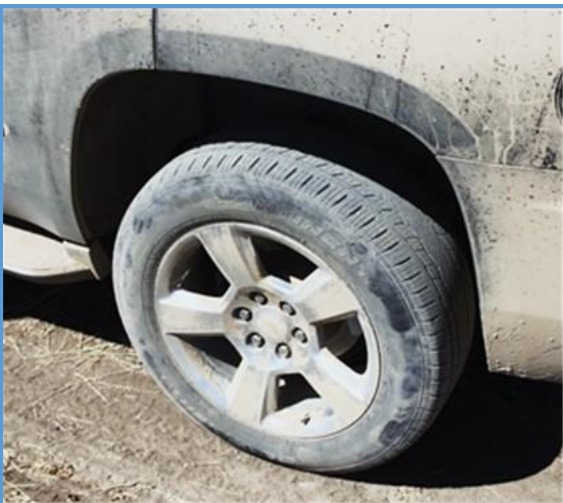
Before the Task Force was halfway down, the passenger side rear tire on the TFLD's rental vehicle sustained a three-inch gash in the sidewall. The TFLD was able to pull the vehicle off the narrow two track road to let a second local engine (not part of the Task Force) pass to proceed to the bottom of the drainage.

***Far Left – Rental vehicle tire not intended for off-road use.***

- ✓ Use the right tool for the job.
  - ❖ Rental vehicles that are equipped with highway-grade tires are not appropriate for wildland fire assignments, especially in the type of terrain represented on the Cherry Road Fire.

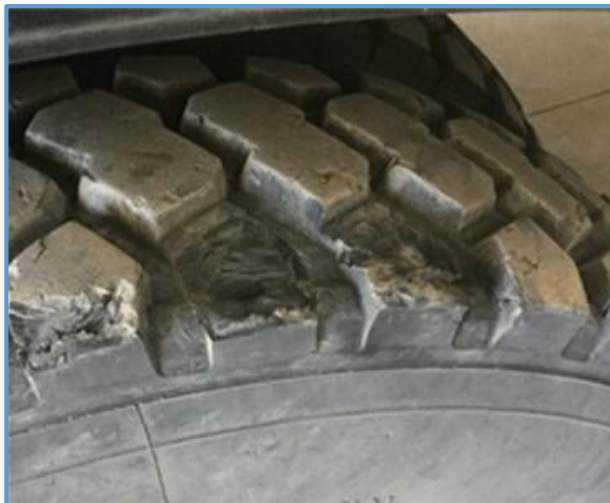
Once assured that they could safely proceed, TF1 began slowly moving down the steep, rocky road toward the heel of the fire. Right away, one engine blew a tire. The TFLD advised that engine to return to the top and find a safe place to change the tire.

***Near Left – Vale BLM Engine tire showing severe damage that occurred on the Cherry Road Fire.***

- ❖ Allow contingencies for equipment failures in difficult terrain.
- ✓ Know your equipment. Take the time to learn the location, function, and accessibility of the safety features.
