Rapid Lesson Sharing

Event Type: Vehicle Accident

Date: July 31, 2018

Location: South Umpqua Complex
Tiller, Oregon

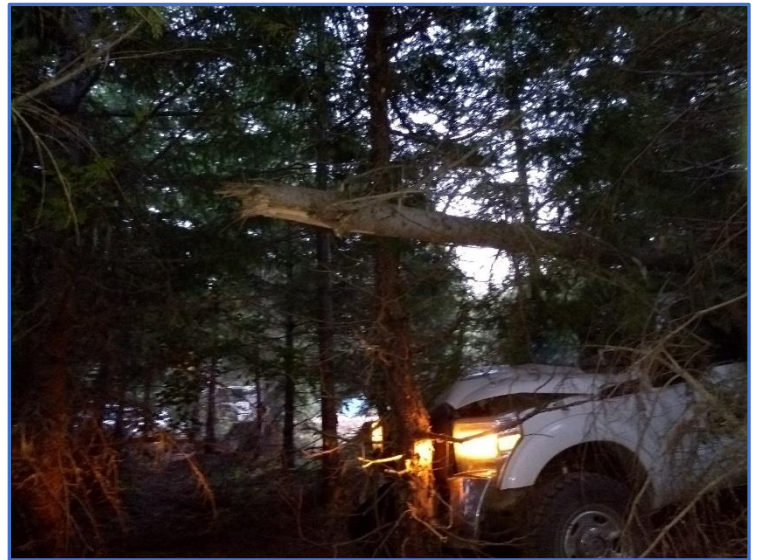
At this time, the pickup engine suddenly started revving as the pickup raced across the Drop Point approximately 170 feet, slamming into the trees just south of Road 1610. The pickup just missed hitting a vehicle parked to the right, then struck and broke off an 8-inch diameter 40-foot tall tree, then traveled an additional 35 feet into the timber.

The horizontal tree above the vehicle is the tree they struck and broke off.

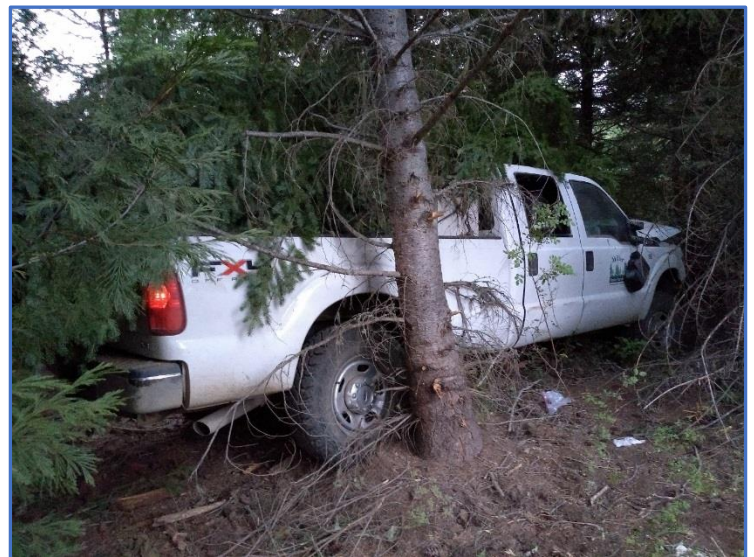
As you can see, they also barely missed hitting this tree.
