# UTV Accident Facilitated Learning Analysis

Region 4

## Background

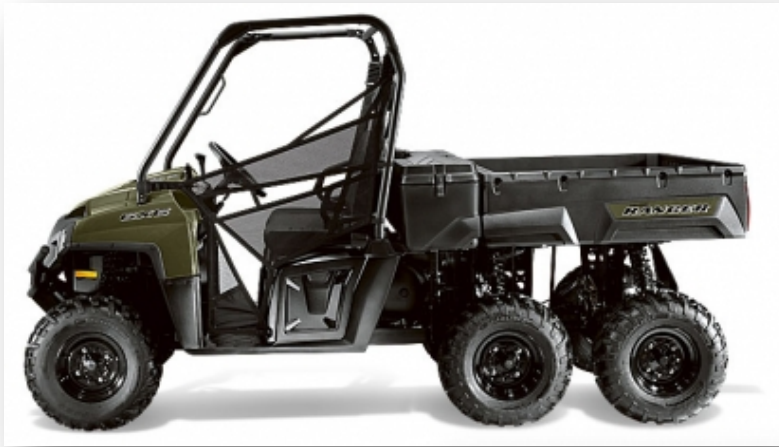
One of the vehicles, a Polaris Ranger 800 6x6 (6-wheeled) UTV (as pictured on the front of this report), was a new piece of equipment for the crew and had about 11 hours of use on it since newly purchased that spring. Crew members had used and were trained on ATV operation, but there was no unique training yet offered for UTVs, and none of the crew members had much or any experience with this type of vehicle. Some members of the crew had reviewed the operator’s manual and DVD that came with the equipment.
