Rapid Lesson Sharing

Event Type: ATV Training Accident with Injuries

Date: June 3, 2021

Location: Chugach National Forest,
Seward Ranger District

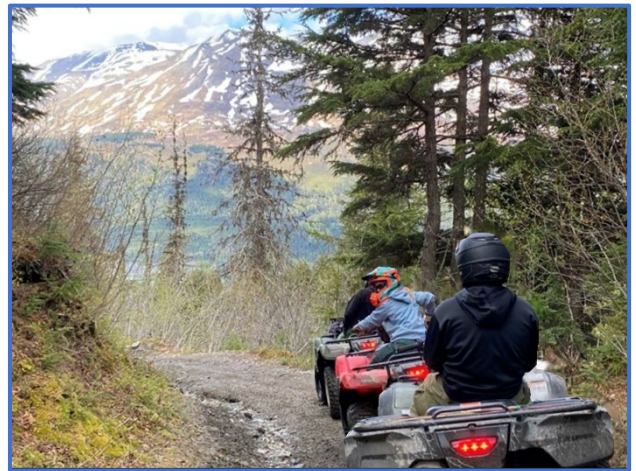
U.S. Forest Service employees participate in ATV training on the Crown Point Mine ATV Trail on June 3, 2021.

This is a typical ATV trail managed by the Forest Service as a Class III ATV Trail with maximum grade not to exceed 30 percent. This trail includes switchbacks, short and steep climbs/descents, and loose rocks. The trail was mostly dry this day, although there were large puddles in low spots and snow on some parts of the trail. Student 1 did note that *“after the fall, my clothes were pretty soaked in mud and water.”*
