Rapid Lesson Sharing

Event Type: Bulldozer Low Water Crossing Submersion

Date: April 6, 2022

Location: Sand Creek Fire,
Amarillo, Texas

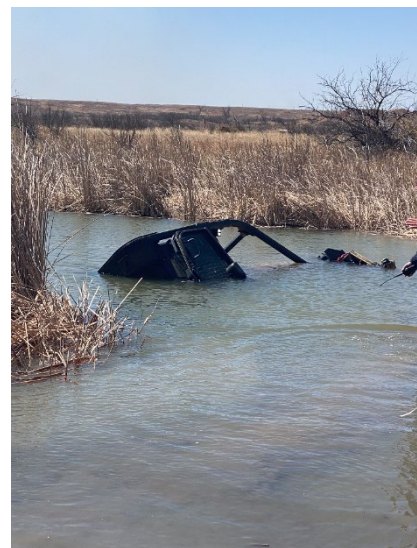
**The dozer submerged in the water
after the "rip-rap" gave way.**

The TFLD(t)—an experienced Initial Attack Dozer Operator and Heavy Equipment Boss—began giving the DZOP(t) hand signals to keep him centered as he made his way across the rip-rap. The TFLD(t) noticed that the DZOP(t) was slightly left of center of the rip-rap and began to signal for him to center the dozer. At about that same time, the DZOP(t) began to feel the bulldozer starting to sink. The DZOP(t) placed the dozer in reverse and felt the end raise up as the tracks began to cut the rip-rap away. He remembers the feeling when he saw the water at the window line. *"I did not want to get stuck, but I was going nowhere,"* he said. *"The water started to rush in."*

1. **When crossing near or over areas of water with the potential for the equipment to become submerged, keep the doors open and your seatbelt on.** The doors are extremely heavy, and if they are closed when you become submerged, they will be nearly impossible to open—just as they were in this incident. Even in normal conditions, when on a moderate angle, the bulldozer doors are cumbersome and hard to open due to their heavy weight. You should not take your seatbelt off, as it will keep you oriented and safer when the dozer rolls or slides into the water.

2. **Always have a designated swamper or spotter when operating in adverse terrain or near water.** You will need this extra set of hands and eyes to spot risks. If a dozer becomes submerged with the door closed, an extra person is needed to help open the heavy doors due to the added suction of the water.

3. **When crossing areas with unknown water depth on the sides of the travel path, mark the edges with flagging.** Although the TFLD(t) was guiding the dozer across the low water crossing, had the route been marked with flagging, this would have provided the operator a visual path to follow.

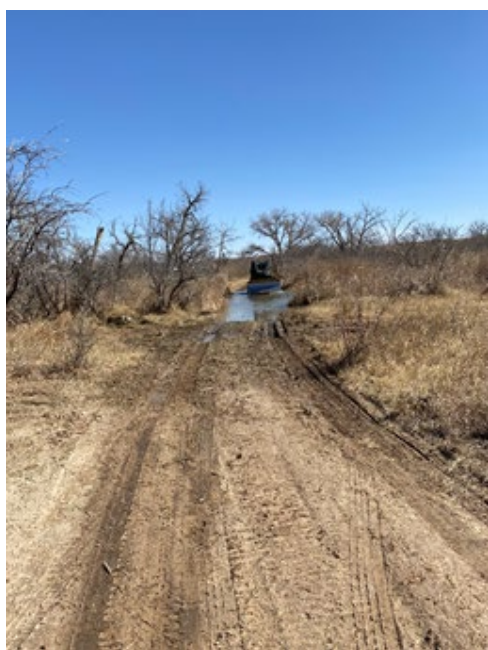
**Image shows the vehicle tracks at the "rip-rap"
low water crossing. In the distance, the dozer
can be seen starting to cross the waterway.**

A private landowner had placed a concrete "rip-rap" crossover, which previous vehicle traffic had used to access the area across a drainage. (Rip-rap is human-placed material used to protect streambeds and shorelines from wave damage and erosion). The TFLD(t), who was a Heavy Equipment Boss, walked across the drainage and found the concrete sturdy. It appeared to be between eight to ten feet wide, with the water level at shin-deep across the filled-in area.

There were also previous vehicle tracks, indicating the rip-rap concrete that was pushed in by the landowner had been solid enough for heavy equipment to cross. As the TFLD(t) walked across the rip-rap, the shin-high water was still and clear. There were no concerns about the dozer's

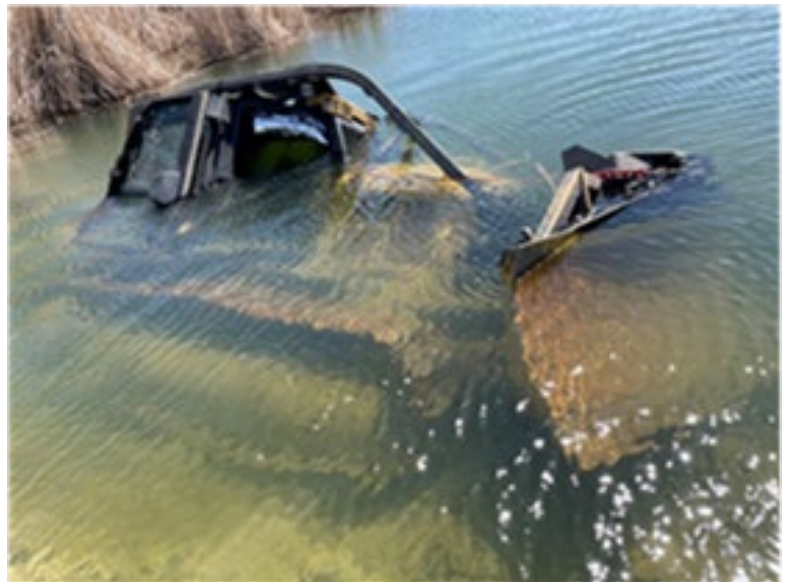
Picture taken from the "rip-rap" where the TFLD(t) jumped in to assist the DZOP(t).
