Rapid Lesson Sharing

Event Type: ATV Near Miss with Fire

Location: Red House/Crusher Prescribed Fire,
Tallgrass Prairie National Preserve,
Kansas

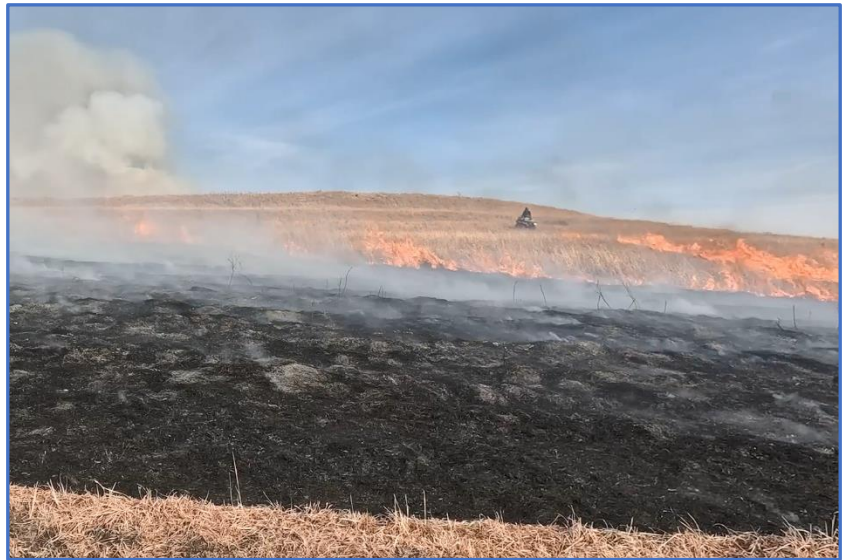
ATV operator igniting a strip on the day of the incident.
