Informational Summary Report of Serious or Near Serious CAL FIRE Injuries, Illnesses and Accidents

GREEN SHEET

Fire Engine Rollover

TCU September Lightning Complex

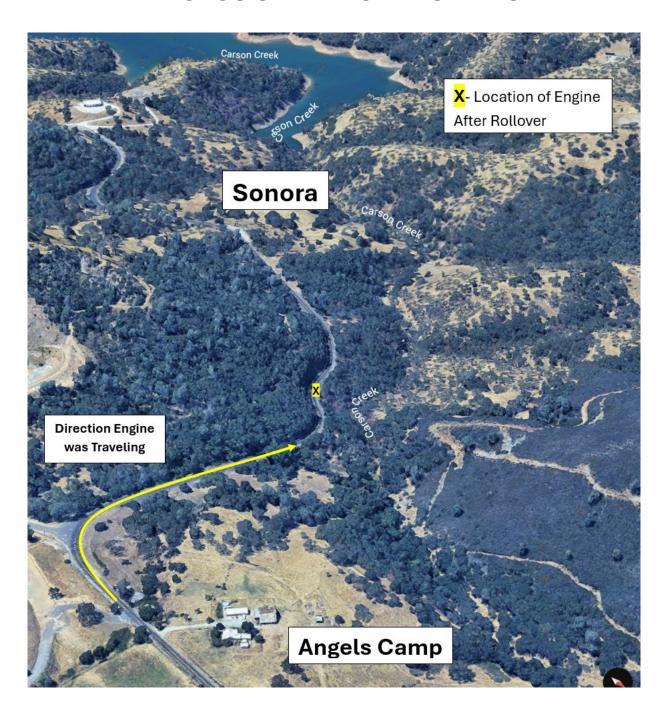
While traveling south on State Highway 49, E1 approached a sharp "S" curve with a recommended speed limit of 30 mph. During the turn, the rear tires lost traction, and the engine began to "fishtail". FC1 attempted to regain control to avoid driving off a steep embankment on the right side of the road. The engine then struck the opposing hillside, causing it to roll onto its passenger side. All three occupants were wearing their seatbelts at the time of the incident.

- FF1 suffered minor injuries and was transported to a local area hospital, where they were treated and released.
- FC1 and FF2 were uninjured.
- E1 sustained major damage, resulting in complete loss of equipment.

- Know the size and performance limitations of your vehicle.
- Follow all traffic laws and drive at a safe speed for road conditions.
