Rapid Lesson Sharing

Event Type: Engine Wheel Stud Failure

Date: April 14, 2026

Location: Washington & Jefferson National Forests, Virginia

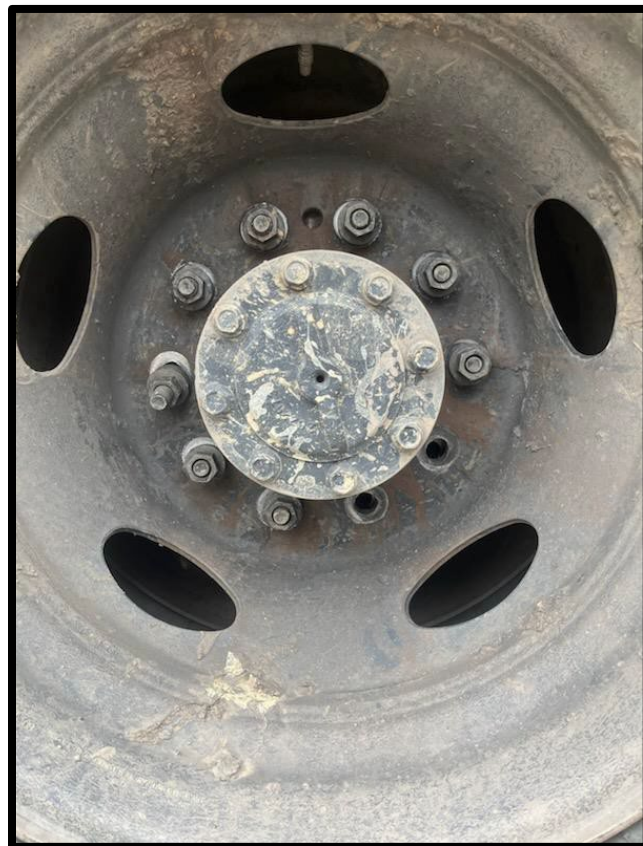
It sounded like “a loose tire hitting asphalt, almost like a bouncing,” the engine operator noted. He immediately pulled to the side of the highway, where a visual inspection of a rear tire revealed that two of the wheel studs were completely sheared. One was partially sheared and the remaining studs showed signs of additional wear. Although they did not have cell service, one crew member used a Starlink connection from his personal phone to call dispatch and have the engine towed to a service station.

Photo 1: *The wheel rim of a rear tire shows two missing lug nuts.*

- 1. The transition from forest to paved road is an important checkpoint.**
When transitioning from dirt or 4-wheel-drive roads to asphalt, operators should do a 360-degree visual inspection of the vehicle, paying special attention to undercarriage, wheels and tires, loose gear, and tools. Any broken, missing, or loose items can be mitigated prior to travel.
- 2. Detailed inspections are critical.**
Daily pre-use and post-incident inspections are an important part of the operational shift and will

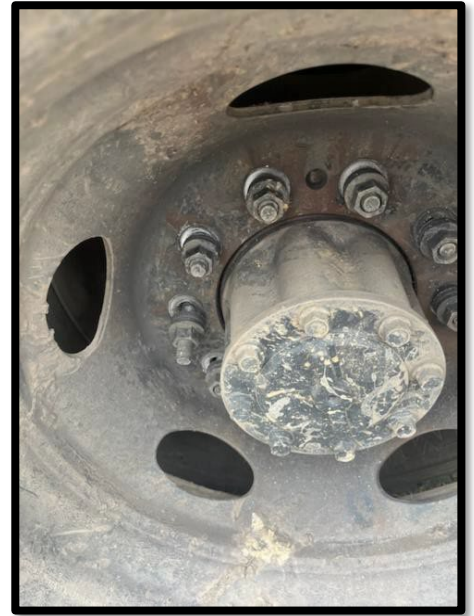
Fresh scratches or shiny metal around a lug nut usually indicate movement. Damage to the paint can reveal new wear by exposing bare metal underneath. Keeping wheel rims clean and freshly painted helps operators quickly identify any exposed metal near the lug nuts. If rims require repainting, they should be painted while mounted on the vehicle or the contact area where the lug nuts seat against the rim must be masked off. This prevents paint buildup that can compromise proper seating and potentially lead to wheel loosening, even when correct torque is applied. Overtightening of lug nuts is difficult to detect. Overtightening lug nuts on heavy-duty vehicles like wildland engines can damage wheel studs and lead to failure. While torque wrenches ensure proper tightening, damage from previous overtightening can only be identified through inspection and correct service practices.

Photo 2: Note the exposed metal around the tops of the lug nuts.

Simply “checking torque” without loosening and resetting can gradually increase clamping force over time. Each partial adjustment may add a small amount of additional torque, which can cumulatively result in overtightening and eventual stud failure. Always follow the full loosen-and-re-torque process using the correct sequence and specifications from the vehicle's owner manual.
