Rapid Lesson Sharing

Event Type: Chipper Work Incident

Location: Kalaupapa National Historical Park,
Hawaii

The Story and Lessons from Injuries Received While Working with a Chipper

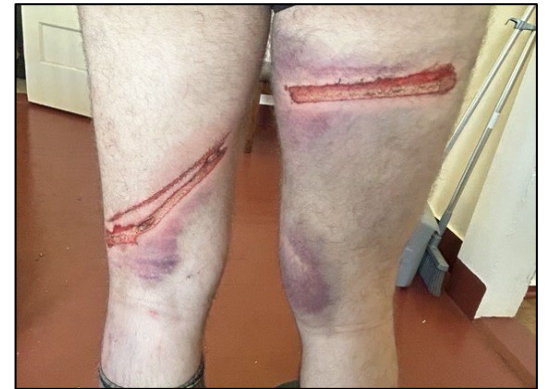
Injuries from Wire

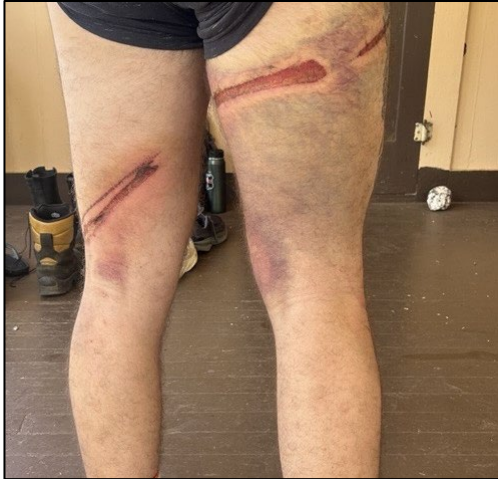
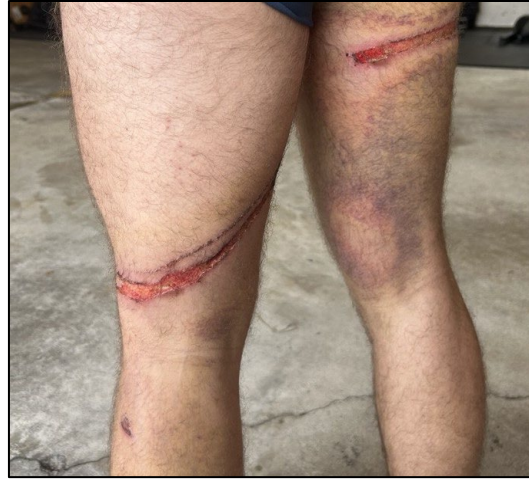
Wire was present throughout the work area from old fences. Some wire was grown into trees and brush, and some was lying on the ground.

Injuries from Wire
