## Narrative

The Cherokee 7966 Wildfire was reported mid-afternoon on September 1<sup>st</sup>, 2026. Texas A&M Forest Service resources from the Jacksonville Fire District were requested to respond to a new start in central Cherokee County. Requested resources included (2) tractor plow units, (2) chase trucks, as well as a Type 6 Engine from a neighboring office. Once on scene, dozers worked to complete line construction around the fire; however, due to steep terrain, it was determined that a small portion (20-30 ft) of the fire would need to be completed with hand line. Additionally, a burning snag observed on the edge of the black would need to be felled by hand. The 1500 temperature reading at the nearest Remote Automated Weather Station (RAWS) was 103 degrees.

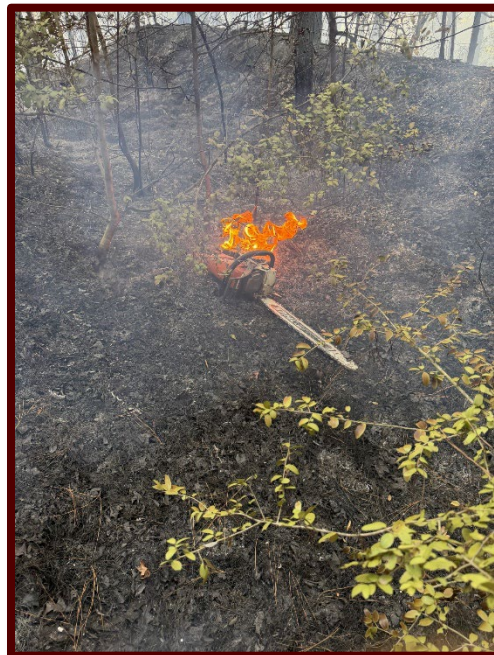
**BURNING CHAINSAW AFTER FAL2(t) TOSSED IT INTO THE BLACK, REPRESENTATIVE OF WHAT THEY WERE STANDING IN WHEN IT IGNITED**

a Stihl 462c chainsaw. It took less than 10 minutes of saw work to open the area enough for the hand line to be completed. Upon completion of the brushing, FAL2(t) loaded the chainsaw onto a UTV and proceeded to address the burning snag. After conducting a thorough size-up of the tree, FAL2(t) attempted to start the chainsaw. FAL2(t) observed that the chainsaw would not turn over or stay running. Believing that they were standing in cold black, FAL2(t) began to troubleshoot the fuel system, beginning with the fuel tank. Understanding that the tank was likely pressurized (vapor locked), FAL2(t) angled the powerhead away from their body and slowly opened the quarter-turn cap to vent the tank. The pressure inside the tank was greater than expected. Upon venting, the fuel mixture overflowed out of the tank, knocking the fuel cap off the powerhead, and spilling on the ground. The fuel mixture quickly ignited, catching both the chainsaw and FAL2(t)'s right glove on fire. FAL2(t) responded

immediately, tossing the chainsaw, and removing their right glove.

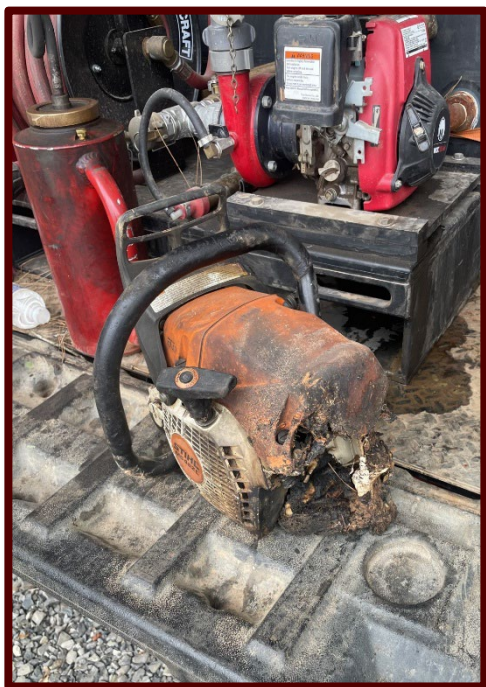
**CHAINSAW POWERHEAD AFTER FIRE WAS EXTINGUISHED**

Incidents involving fuel geysers during chainsaw operations are well documented in wildland fire. Variables such as fuel composition, environmental conditions, and equipment type are all contributing factors; however, it is a combination of fuel, heat, and pressure that causes this reaction.

**Fuel** – Fuel geysers can occur regardless of fuel composition. To minimize volatility, it is recommended to avoid using fuel that is older than one month. Do you have a system in place to track the age of saw fuel?

**Pressure** – There is a correlation between an increase in operational temperature in the powerhead and the increase in operational pressure within the fuel tank, thus, increasing the likelihood of a fuel geyser. Are there any steps that the chainsaw operator can take to reduce heat buildup in the powerhead during chainsaw operations?

**Heat** – Although fuel geysers can occur in different environments, the introduction of a heat source increases the risk of fuel ignition, potentially resulting in injury. Do you have established Standard Operating Procedures (SOPs) for troubleshooting fuel system-related issues on the fire line? Vapor Locked vs Flooded? What are symptoms of each condition? How can each condition be safely diagnosed on the fire line?
