Rapid Lesson Sharing

Event Type: Excavator Tip-Over

Date: June 15, 2021

Location: East Troublesome Fire – Suppression Repair,
Kremmling Field Office,
Bureau of Land Management, Colorado

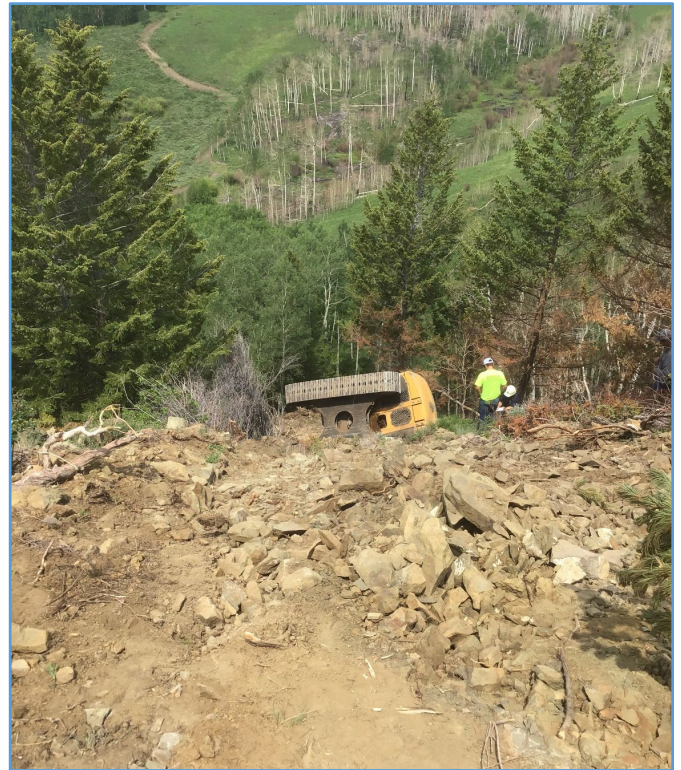
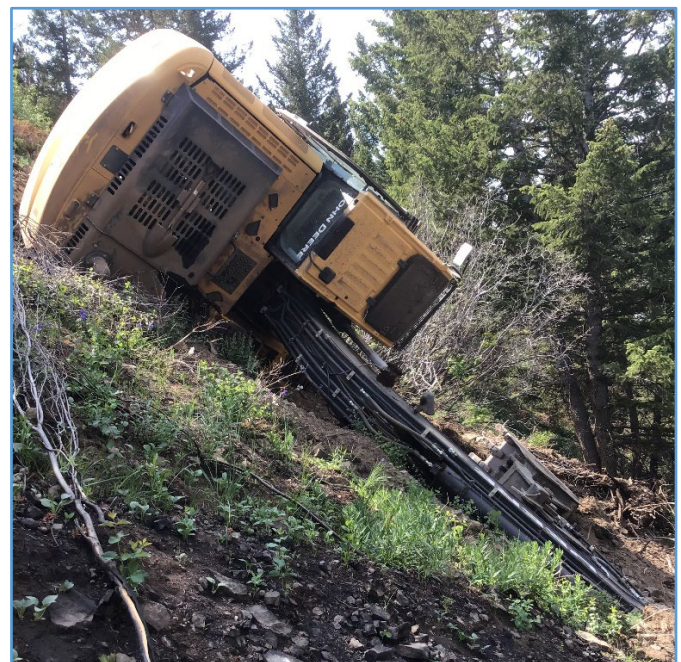
Once the ridgetop line was complete, the operator started down the steep 70-80% slope when the excavator’s tracks started to slide approximately 35 feet down the slope before the machine tipped over onto its side.

The operator had been working other steep slopes on previous days without any problems. The operator reported that: *“I felt I could safely proceed down the hill to a large spruce tree and work back to the top from that point. I feel like the rocks were the difference.”*

- ❖ The estimated slope at the accident site was approximately 70-80%.
- ❖ The steepest portion of the dozer line had large amounts of rock scree and loose materials on the dozer line.

- ❖ Limit the use of heavy equipment for fire suppression repair to slopes that are recommended in the Fire Suppression Repair Plan.
- ❖ Consider using hand crews on slopes that exceed the equipment limitations that are identified in the repair plan.

- ❖ Adequately brief operators on the right to refuse an assignment due to safety concerns, operator, or equipment limitations.
- ❖ Ensure that orders are clear and understood. Consider face-to-face communications where there are areas of concern.
