LESSONS LEARNED

Northern Region Aviation Safety

Helibase Fire

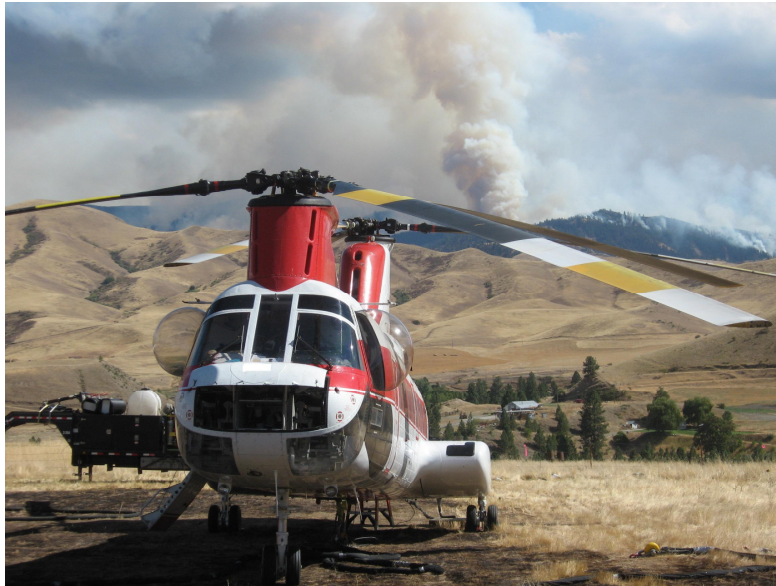
On Sept 10th 2012 around 10:00 a Boeing Vertol helicopter was dispatched to work on the fire. The helicopter was located on Pad 7 at the air strip helibase. The aircraft had just started up and the mechanics were doing the standard bucket checks and remote long line hook checks. The helicopter was running at flight idle and about ready to depart when all of a sudden there was a fire under the cargo hook. The mechanics and helicopter manager signaled for the helicopter to take off right away as the flight deck was on fire. There was very dry grass where the helicopter was parked and it appeared that when the pilots did the hook check there was either a spark from the long line or a static discharge that ignited the dry grass under the helicopter.

The rotor wash from the helicopter blew the fire in several different directions. One of the mechanics grabbed the closest fire extinguisher and put the fire out around the equipment trailer while the helicopter manager screamed into the radio **FIRE ON THE FLIGHT DECK, FIRE ON THE FLIGHT DECK** on the helibase deck frequency. The helicopter manager went to grab the second fire extinguisher and realized it was in the service van so instead grabbed a fire shovel and started to throw dirt on the fire to get the fire out from under the fuel truck. The manager was successful on the attempt as the grass had flattened down from driving on it. At that point the crash rescue vehicle showed up and deployed their hard line attacking the west flank of the grass fire that was around 200 by 300 feet and spreading in several directions. The helicopter then returned with a bucket of water and dropped around the vehicles on the east flank of the fire. This saved the vehicles and stopped the spread of the fire to the south. All three helicopter mechanics at this point had grabbed shovels and were working on the east flank of the fire that was working its way towards the highway, while the crash rescue crew attacked the west flank of the fire. Several other people and engines show up at this point and continued to attack the fire. The helibase radio operator's instructed several other helicopters to launch with their buckets. The Vertol returned with another bucket of water and continued to aid the firefighters. With the aid of 3 helicopters and several engines the fire was contained at about 1.5 acres.

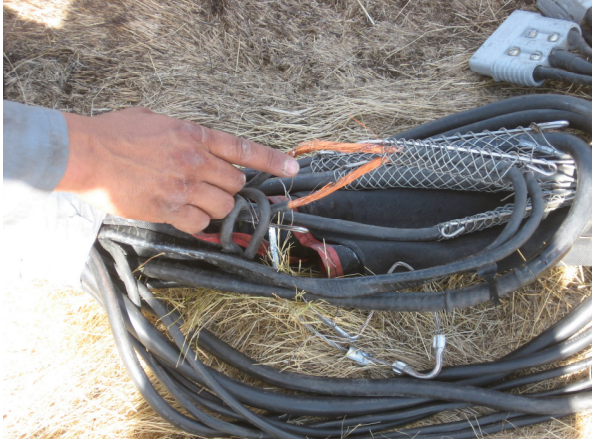
Possible cause of ignition

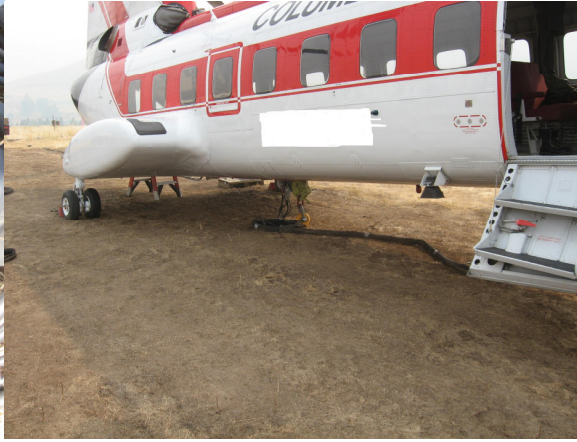
Setup prior to fire

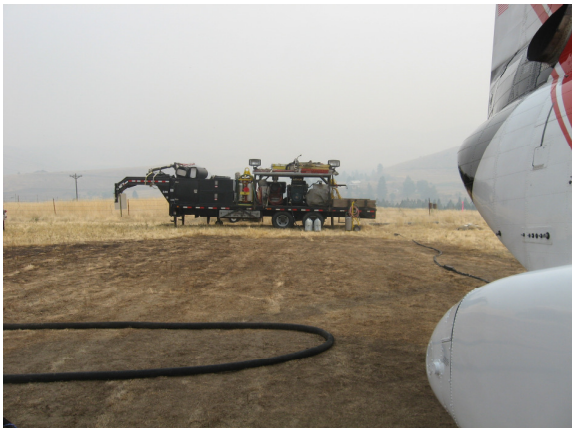
Service trailer crewmember was able to protect with the helispot fire extinguisher

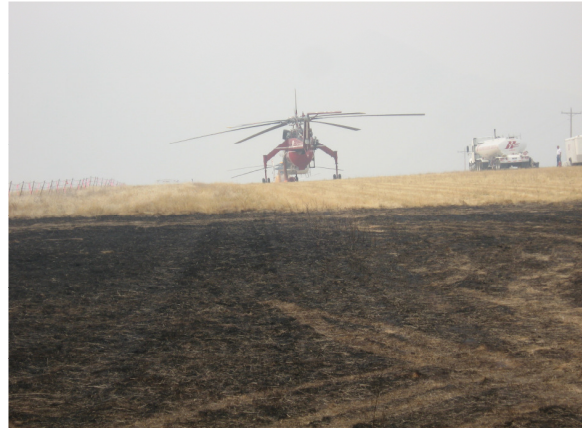
Location of 2nd Type 1 Helicopter in relation to fire

The fire moved toward another Type 1 Helicopter that was having maintenance and unable to move. Crew removed the other fuel truck from the scene.

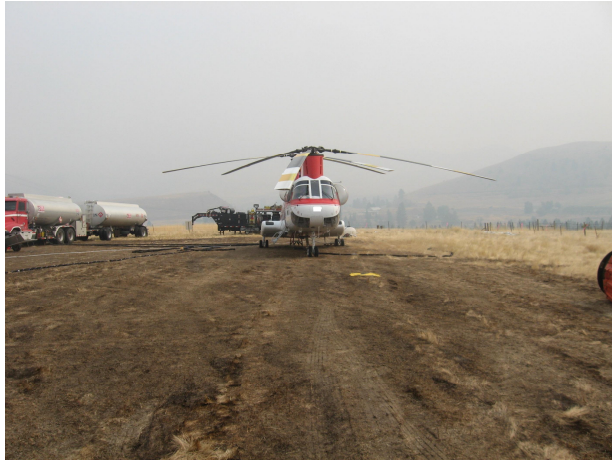
Location of Fuel Truck and Support Trailer To Helicopter

The aircraft departing blew the fire in several different directions towards the fuel truck the equipment trailer and the service van.

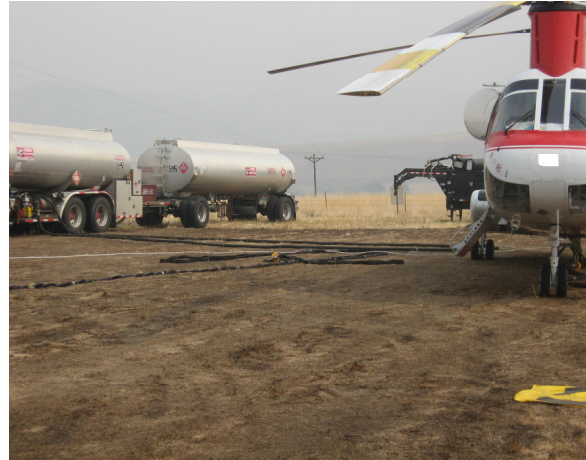
Hose and cable layout at Pad 7

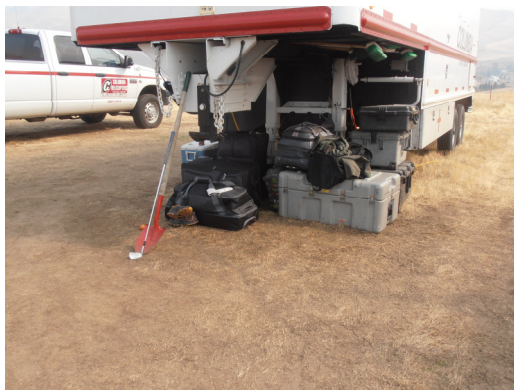
Equipment on the ground could be subjected to fire damage

Ensure helibases and area around the aircraft are policed up and keep flammables to a minimum on the ground.

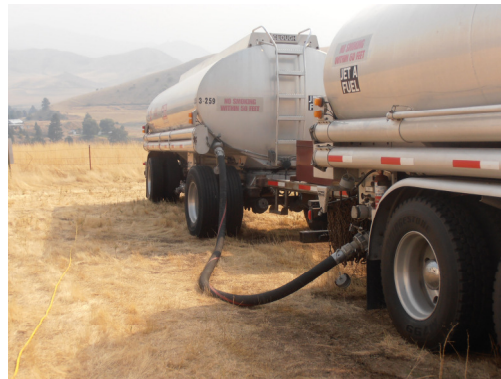
Having fuel truck hoses connected can cause problems if trying to move from flame front

In the AM startup fuel trucks to get air pressures in the truck systems up to working pressures to avoid delays if have to move truck rapidly.

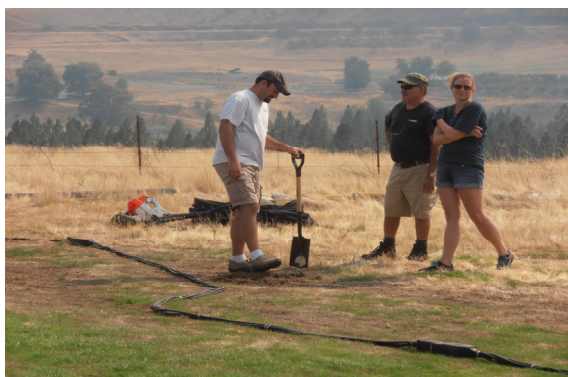
It is important to have contractors wearing PPE if operations are being conducted. Fighting fire in shorts can hurt.

Crew was wearing PPE in anticipation of operations and had been given fire shelter deployment training.

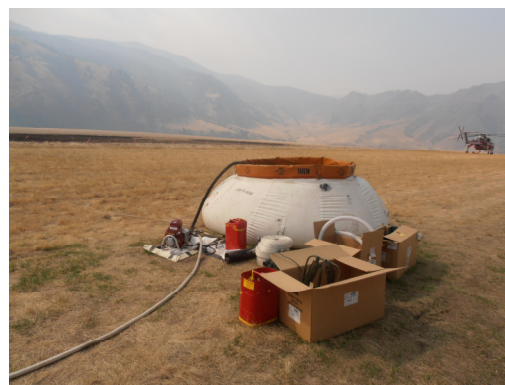
Suppression aids brought in after incident to bolster capabilities due to helibase size

As a Seasoned manager I could have had more fire extinguishers available on site (we had 2 but one was in the truck).

Add a few tools and a bladder bag to the crash rescue kit in areas where fuels are appropriate.
