**Las Conchas Fire – Division India Near-Miss
After-Action-Review NOTES
7-9-2011**

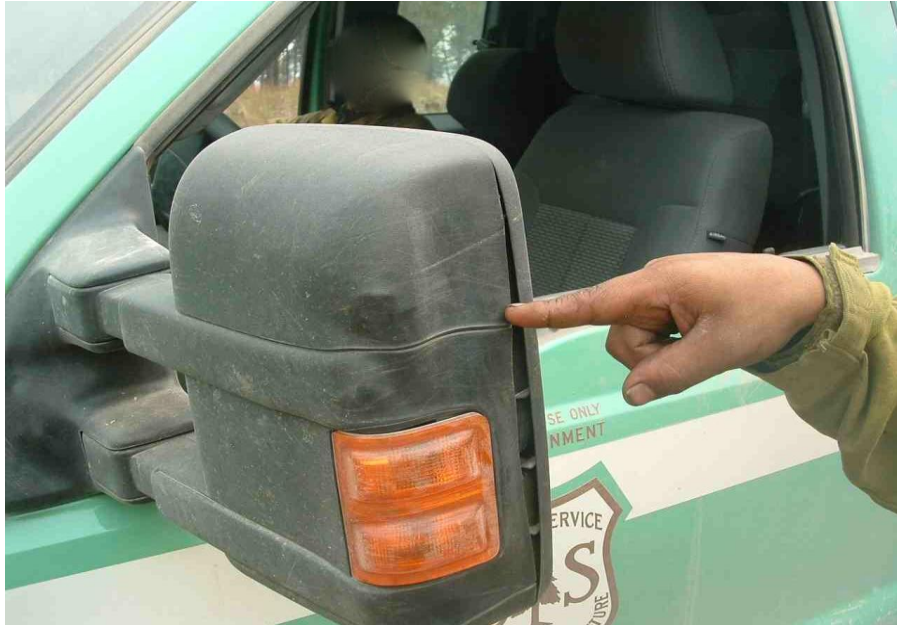
Engine 2- deformed mirror caused by radiant heat

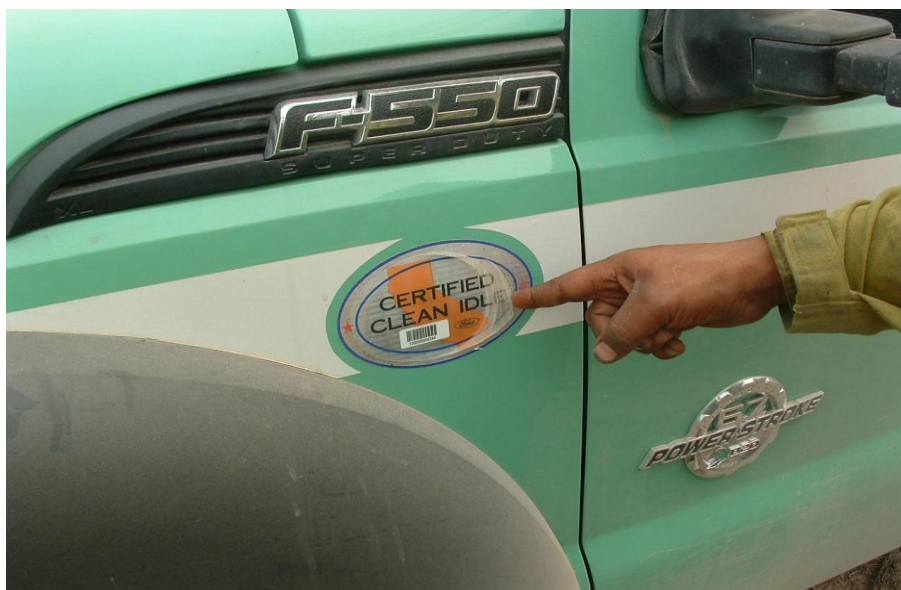
Engine 2 - delaminated decal

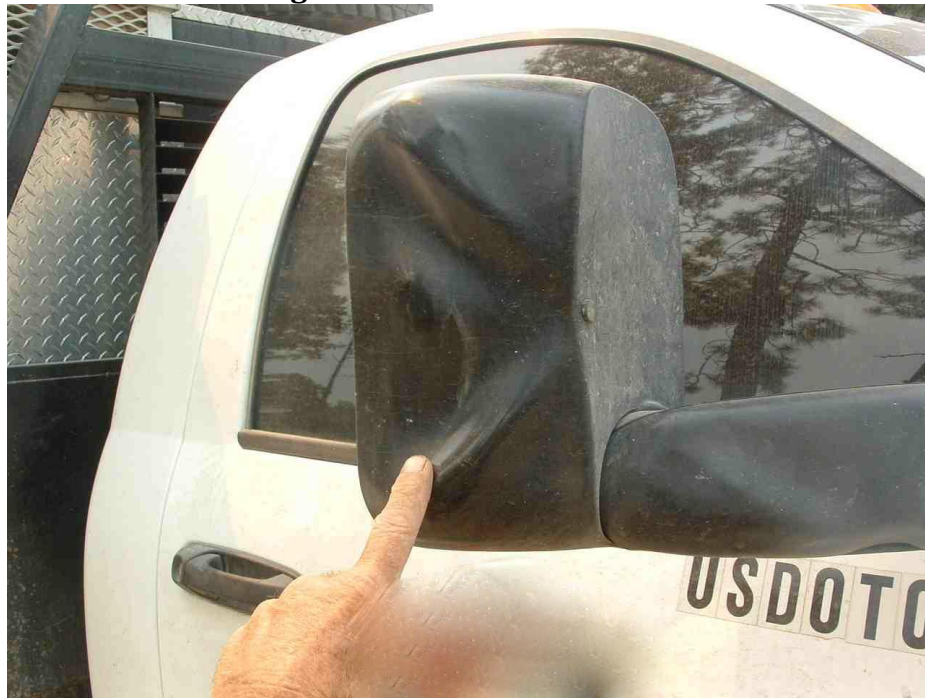
Engine 1 - deformed passenger side mirror caused by radiant heat

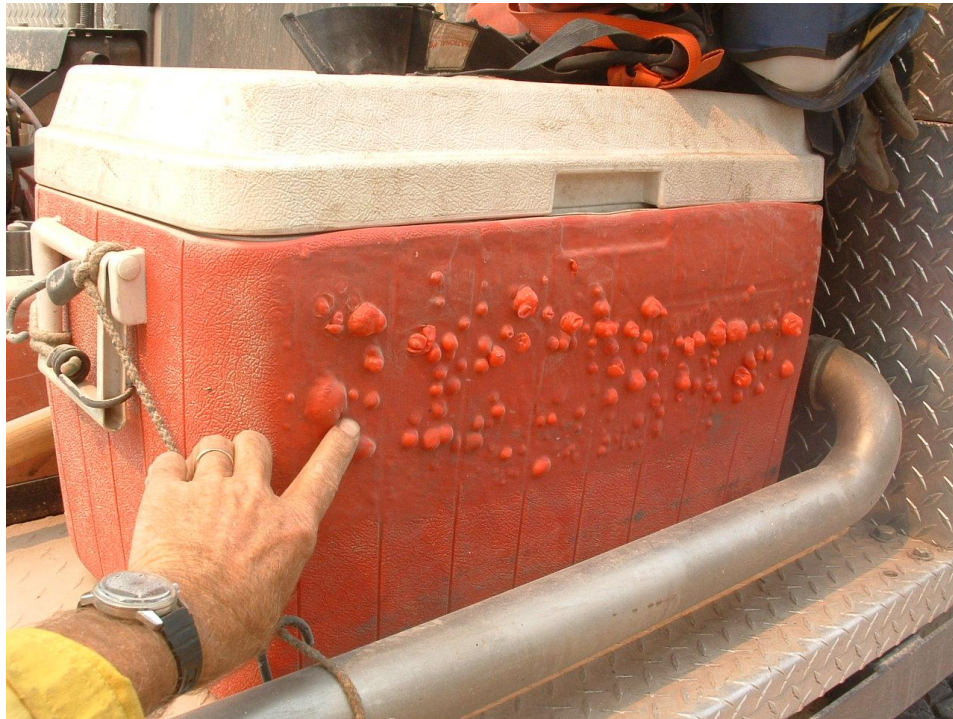
Engine 1 - bubbled ice chest

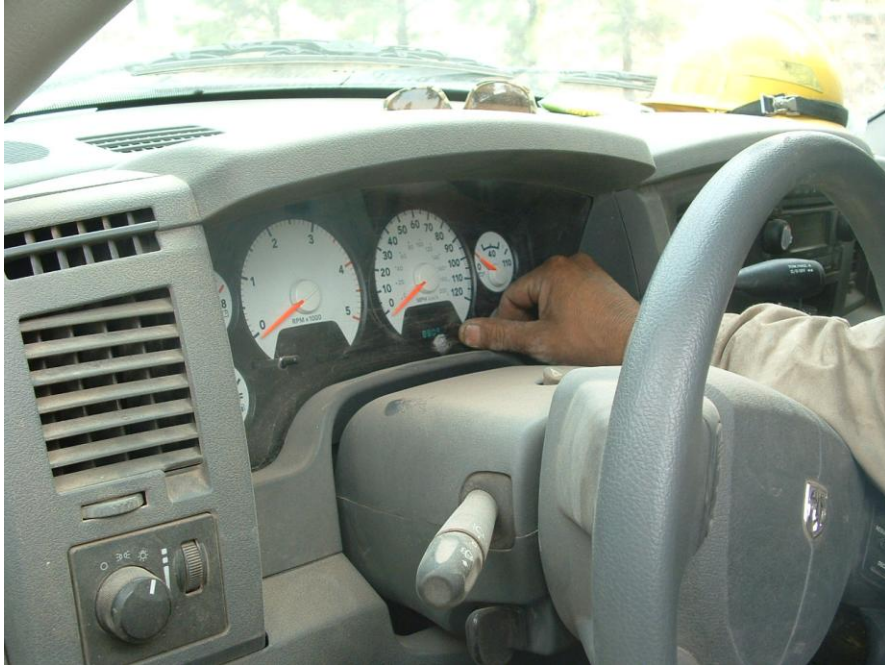
Engine 1- ember landed on instrument panel

- Trust in others, like a hotshot crew, cannot be allowed to overcome your gut feeling that things are not right or that you need more information.
- Successful burnout operations day after day can lead to complacency.
- Engines were not aware that fire had been put on the ground at both ends of that 300-foot piece of line.
- Crews need to understand the limit of engine ingress and egress and consider that when they brief incoming engine crews.
- The TFLD and DIV(T) both felt they should have provided closer supervision to this burnout operation. Someone not involved in the work needs to focus on the larger picture.
- Keep windows rolled up to protect the interior of the cab and maintain a better atmosphere in the cab.
