# Rapid Lesson Sharing

**Event Type:** Vehicle Collision

**Date:** June 12, 2017

**Location:** Dead Dog Fire, Colorado

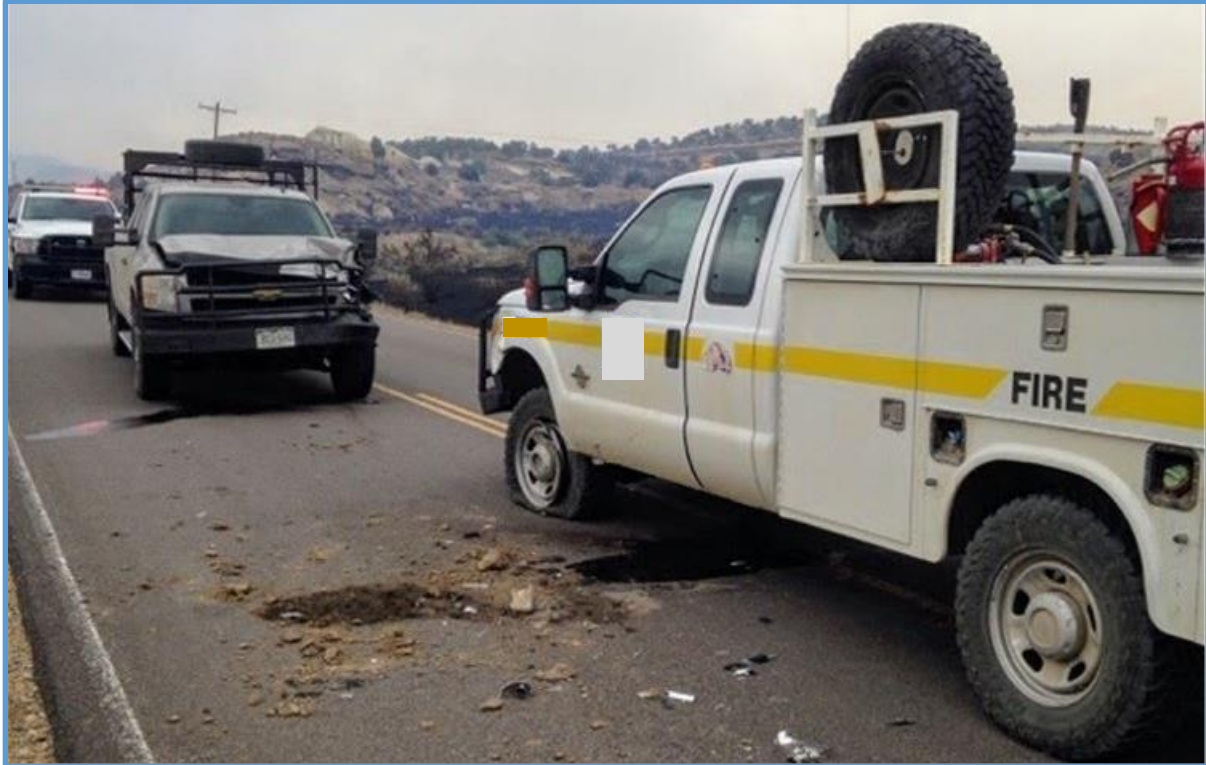
- Fire was actively burning on both sides of Rio Blanco County Route #1.
- Fuel Type: greasewood, cheatgrass and a minor amount of Wyoming sagebrush.
- Smoke made visibility very limited.
- Weather conditions (from DRAC2 RAWs) supported active fire behavior:
  - 1318 Hours – Temperature 78 degrees, Relative Humidity 10 percent.
  - 1318 Hours – Wind observations: 32.01 mph average out of the SSW with gusts up to 55.01 mph.
  - 1418 Hours – Temperature 80 degrees, Relative Humidity 9 percent.
  - 1418 Hours – Wind observations: 30.0 mph average out of the SSW with gusts up to 59.99 mph.

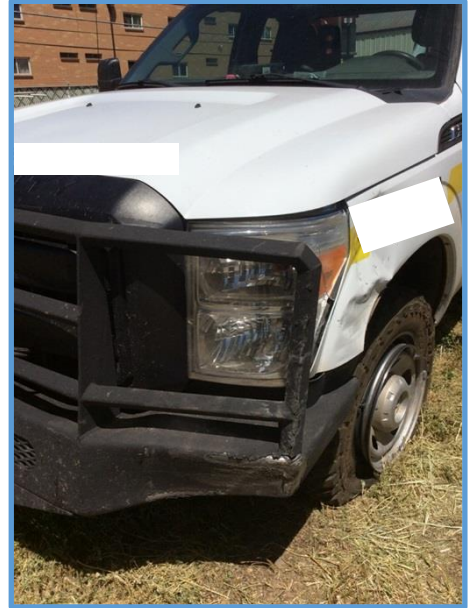
- GOV Truck-1 was traveling northbound less than 10 mph and, due to low visibility, was in the process of stopping.
- POV was traveling southbound.
- GOV Truck-1 moved approximately 20 inches into the left (oncoming) lane to avoid heat, smoke and driving off the pavement.
- At approximately 1341 Hours, GOV Truck-1 made contact with POV. Both vehicles made impact with left-front corner panels.
- Both vehicles became immobile.
- All occupants evacuated the scene due to dangerous conditions. Occupants left in two separate GOVs that were following GOV Truck-1 (Engine-1 and Chase Truck-1).
- Medical Emergency personnel were requested and sent.
- POV occupants refused medical care.
- Both operators were interviewed by Law Enforcement at a later time.
- No citations were issued.

- ❖ Close roads to public traffic early. However, keep in mind that this could be problematic when resources are limited and the definition of “early” is not well-defined in an emerging incident. Additionally, smaller spur roads that branch off from the main roads present traffic control difficulties in such limited time restraints.
- ❖ Obey all traffic laws, even in difficult or unexpected conditions.
