The Fire at Sperry Chalet

Fire Investigation Report

April 2018

Sperry Chalet
Glacier National Park
West Glacier, Montana 59936

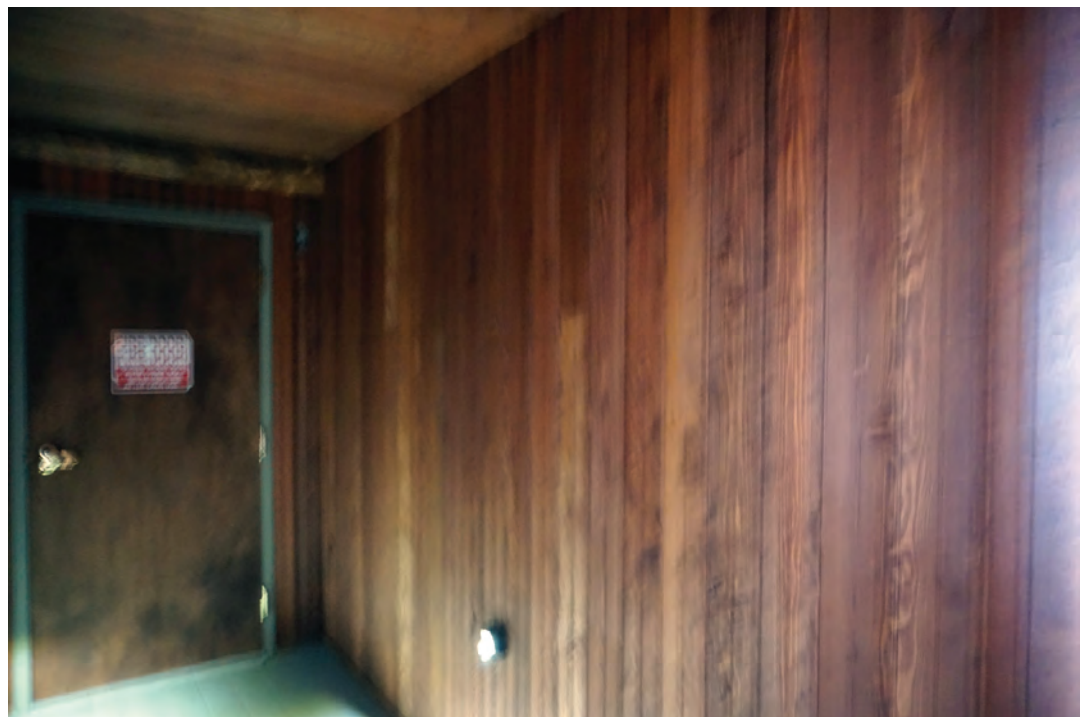
Interior of second floor hallway, fire door.

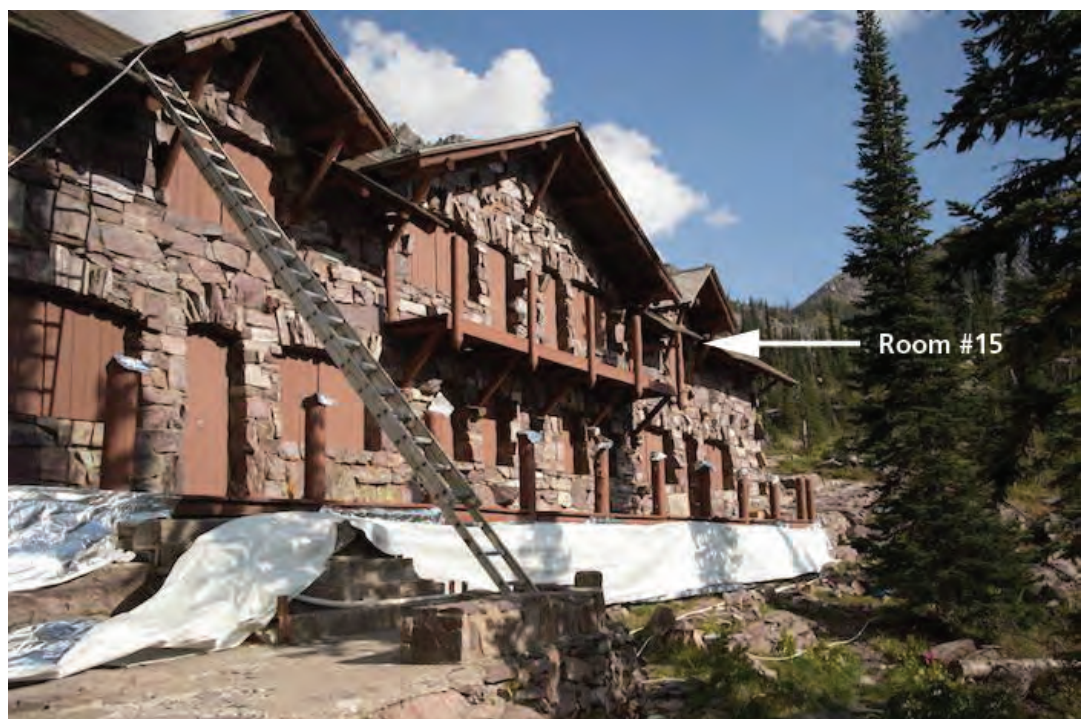
Taken from west side of dormitory on the north end. Shows heavy smoke conditions from the wildland fire.

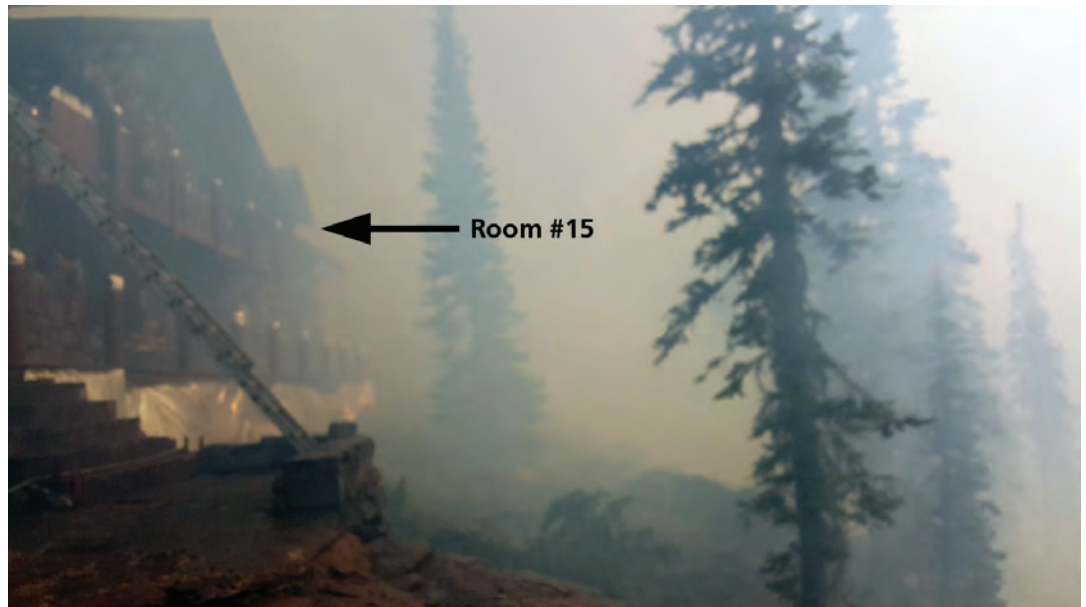
Taken from west side of dormitory, on the south end, adjacent to southwest corner of building. Shows relatively clean-burning flames coming from second story window of Room #15. Flames are observed covering the upper half of window opening. Flames are also shown reaching the underside of the dormer. The shutter from Room #15 is completely gone. It appears that possible window glass is remaining in lower right and lower left corners of the window opening. Charring of the exterior side of center window frame is noted. The first floor entry door shutter is in place over doorway.

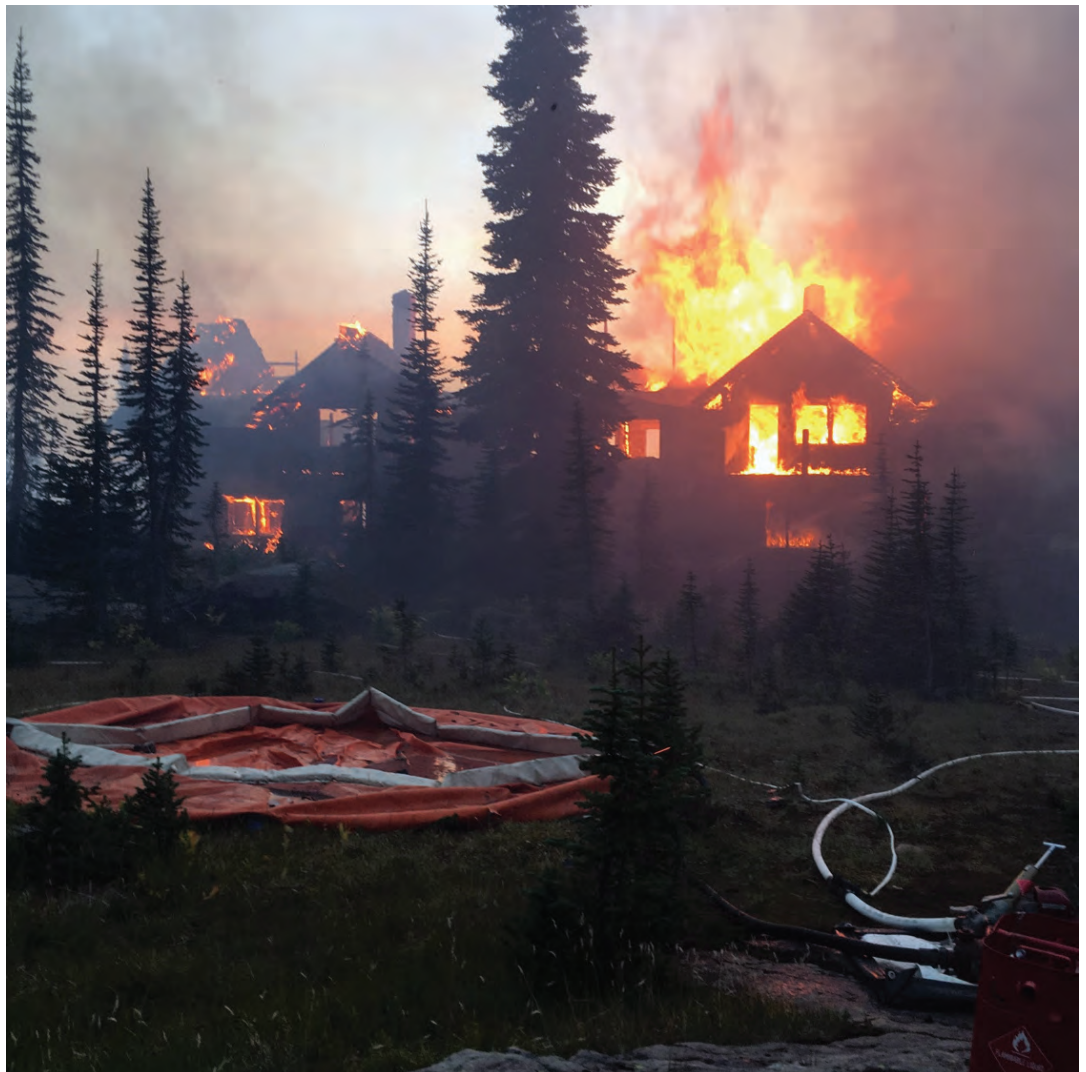
Taken from east side of dormitory, long distance from the dormitory on the east side of the empty water supply bladder (pumpkin). Shows full involvement of the north roof structure and second floor of the dormitory. Fire is visible in the first floor portion of the north end of the dormitory.

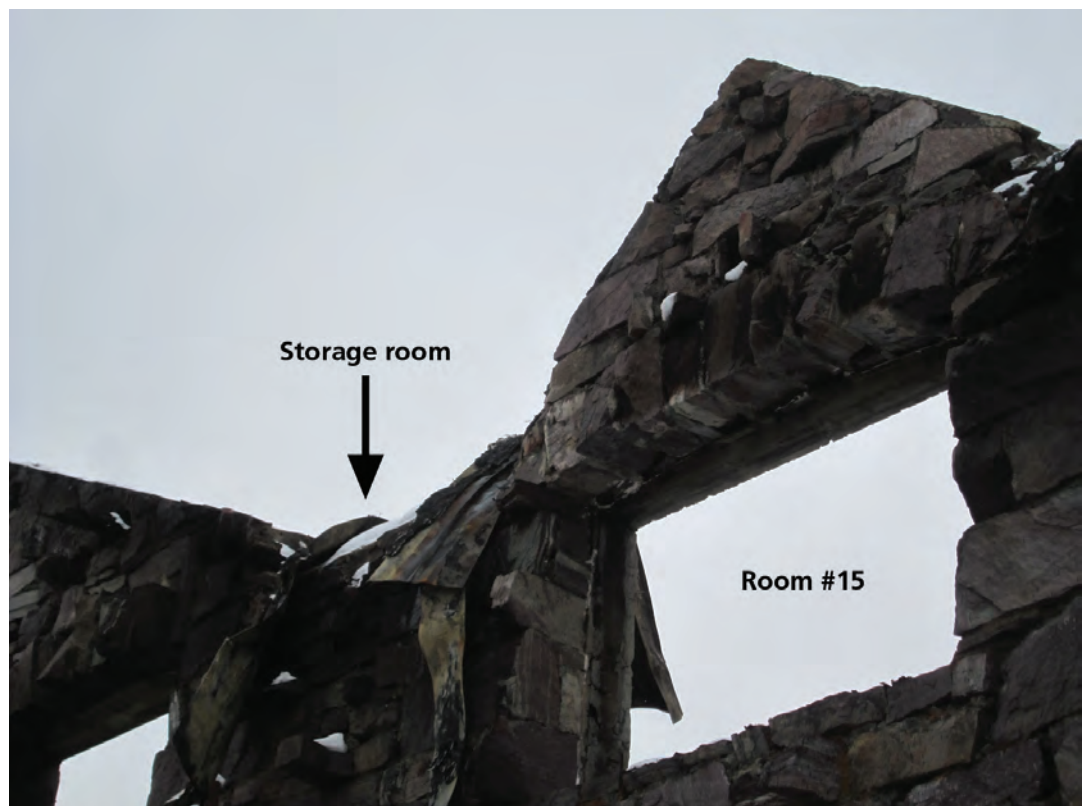
Exterior of west wall, second floor, upper area. Letter designation added for rafter location.

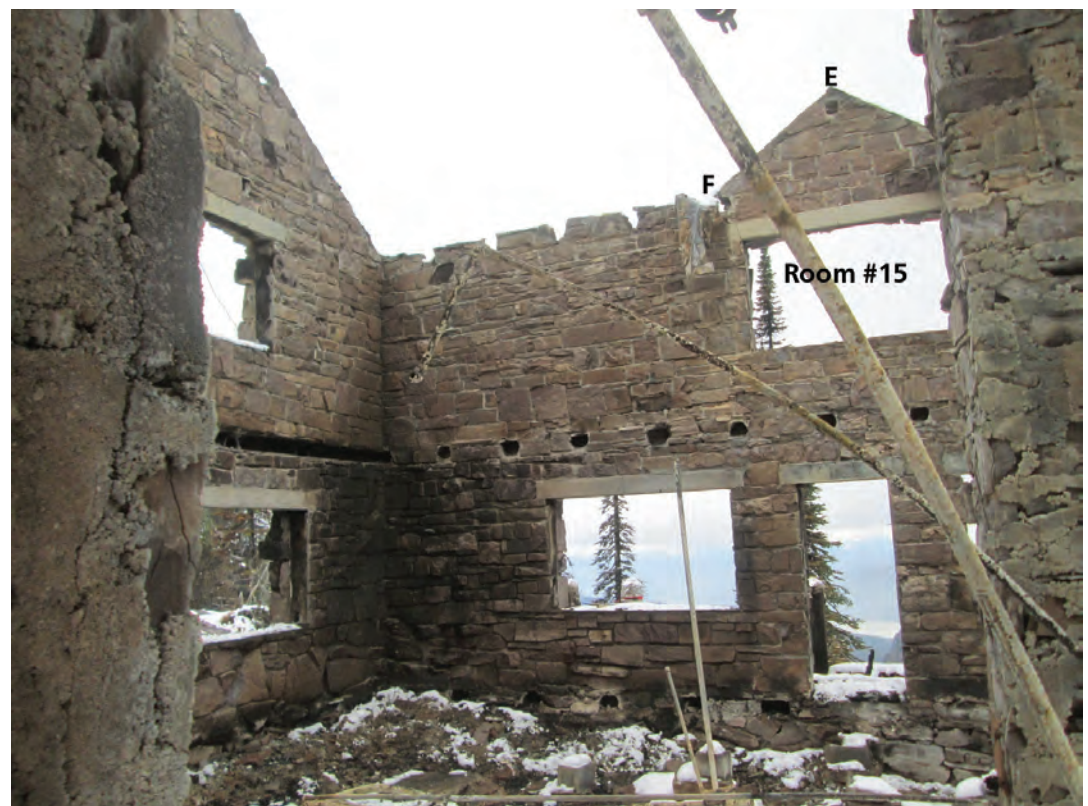
Interior of southwest corner. Letter designations added for beam locations added for clarity.

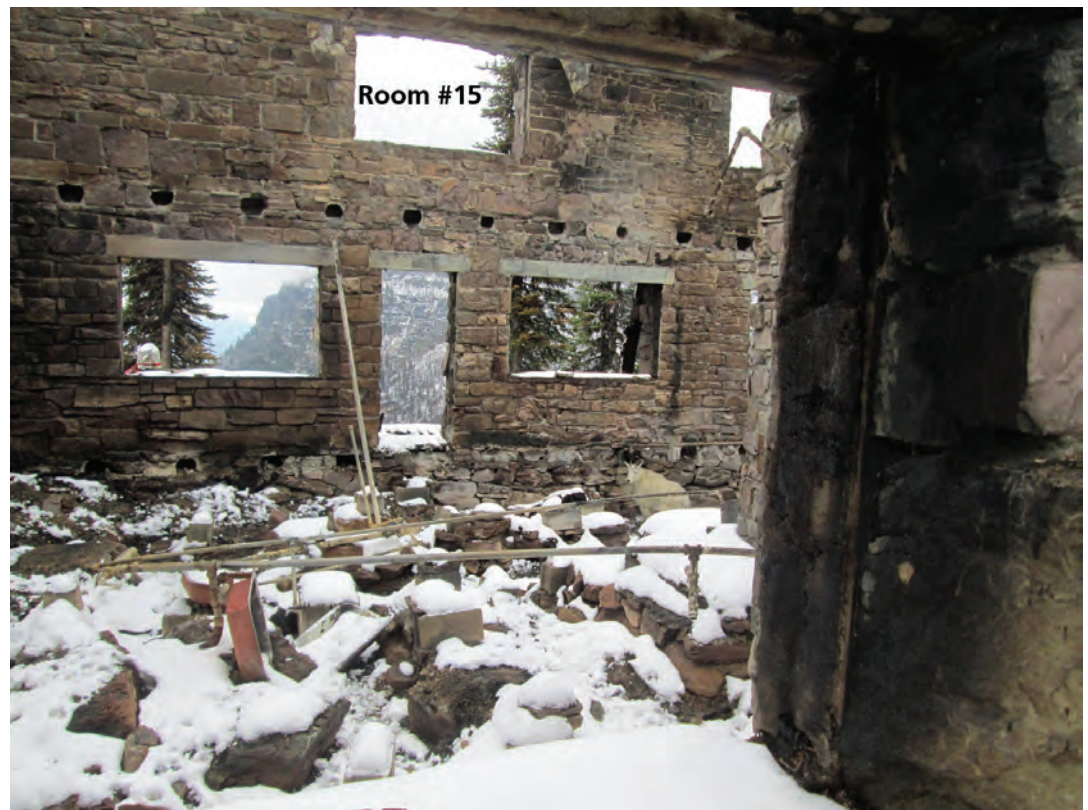
Interior of southwest corner.
Letter designations added for
beam locations added for clarity.

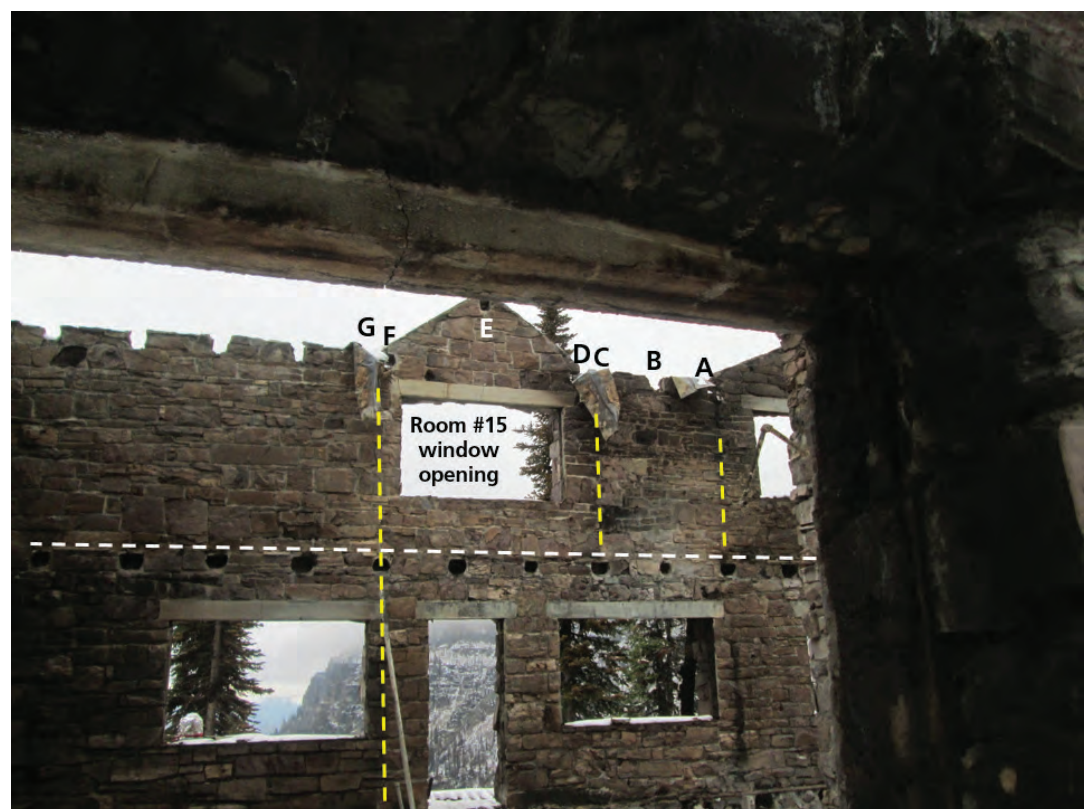
West wall, interior. Letter
designations for beam and
rafter locations added for
clarity. Delineation added to
demonstrate approximate wall
locations of Room #15 and
storage room.

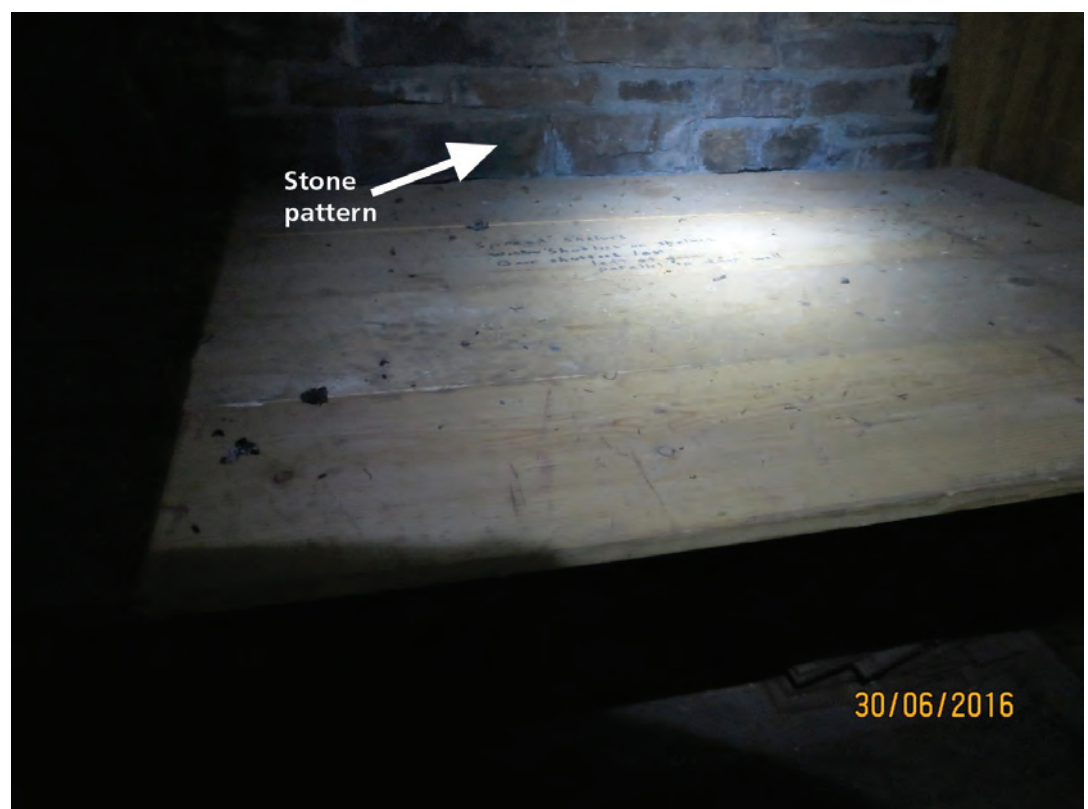
Interior of second floor storage room. Shows shelf location in relation to west wall stonework.

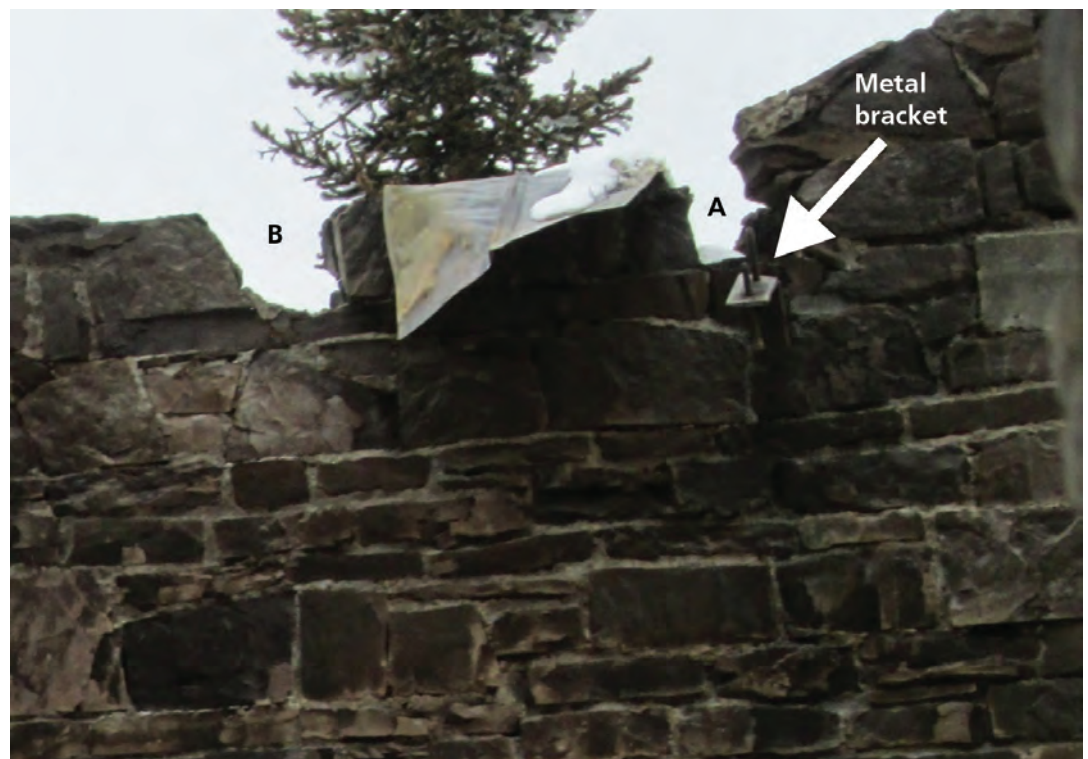
West wall, interior. Delineation added to demonstrate approximate wall locations. Note metal bracket in upper right corner.

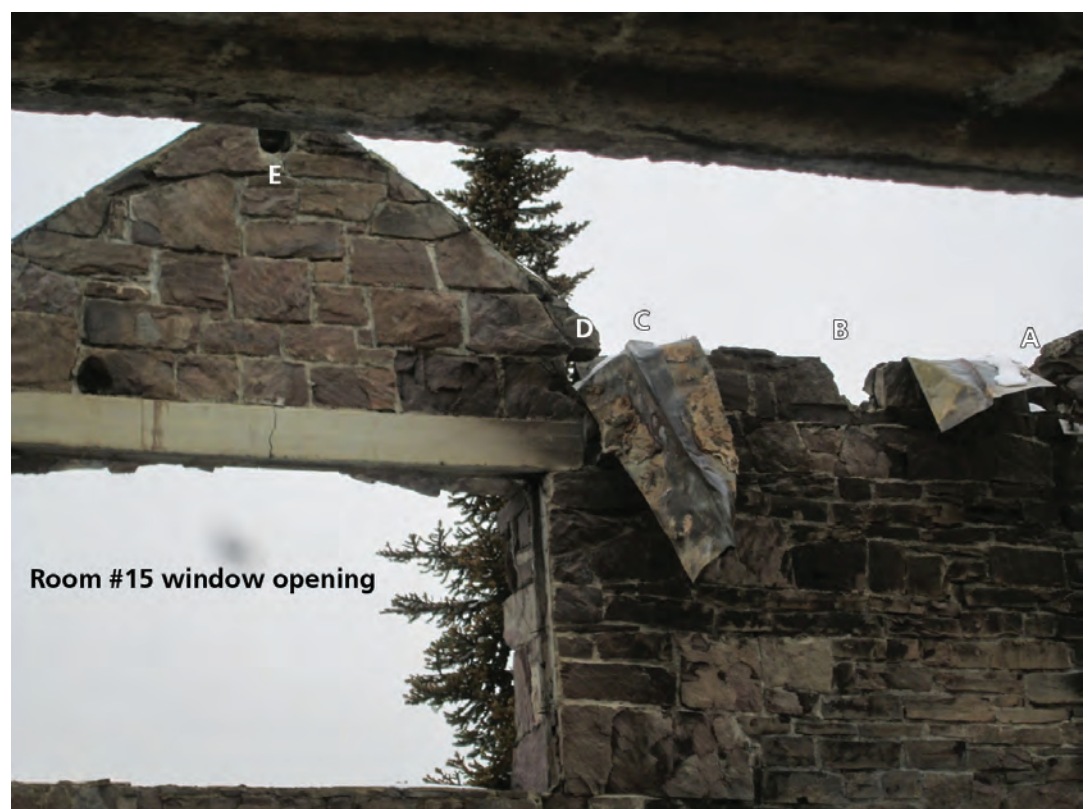
West wall interior. Letter designations for beam and rafter locations added for clarity.
